Failure Analysis after in orbit anomaly on COMEPA bimetallic thermostat TH47

5th Space Passive Component Days (SPCD), International Symposium

15-18 October 2024

ESA/ESTEC, Noordwijk, The Netherlands

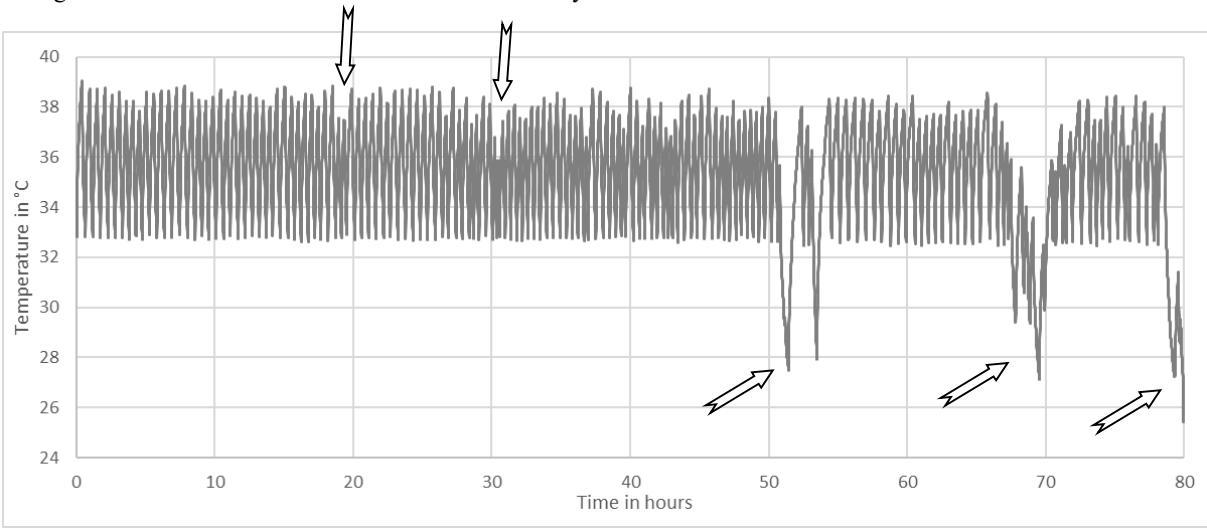
Figure 2: Partial Section of Telemetry data of heater temperature controlled by Thermostat TH47

The first few hundreds of cycles of the thermostat were nominal. Out of no apparent reason nor possible external factors however, the temperature oscillating profile started showing anomalous drops in the upper temperature as it can be seen on Figure 2 at around 20 and 30 hours of shown telemetry timeline.

The drop in temperature occurred stochastically and initially affecting only the functioning temperature (temperature at which the switch opens). Few cycles later, the restoring temperature started to be affected as well, as it can be seen from hour 50 onward. The temperature drop became so significant that the specific subsystem could not be operated reliably anymore and the switch to a redundant unit was deemed necessary.

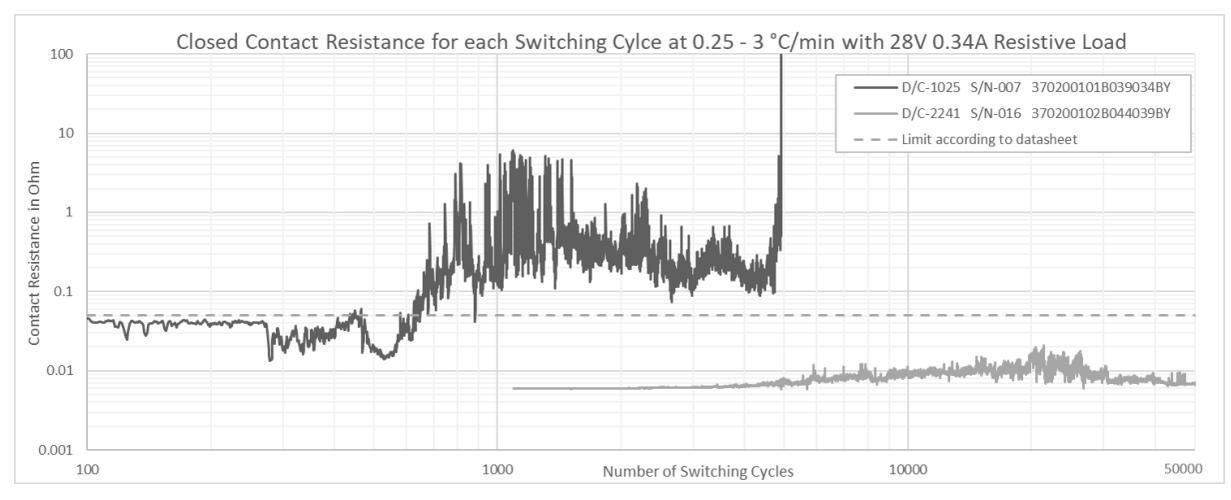
Figure 4: Contact Resistance Increase over Number of Switching Cycles

The TH47 manufacturer datasheet [3] specifies a limit of $50m\Omega$ for the contact resistance of closed contacts. The data plot in Figure 4, shows the calculated average closed contact resistance of the tested device up to 50 000 cycles. The tested thermostat S/N-007 started exceeding this value after about 400 cycles. The contact resistance showed a slight recovery before increasing significantly after 600cycles and showing a permanent open contact after approximately 5000 cycles, well below the 100 000 cycles expected lifetime for this thermostat, according to the relevant datasheet [3].

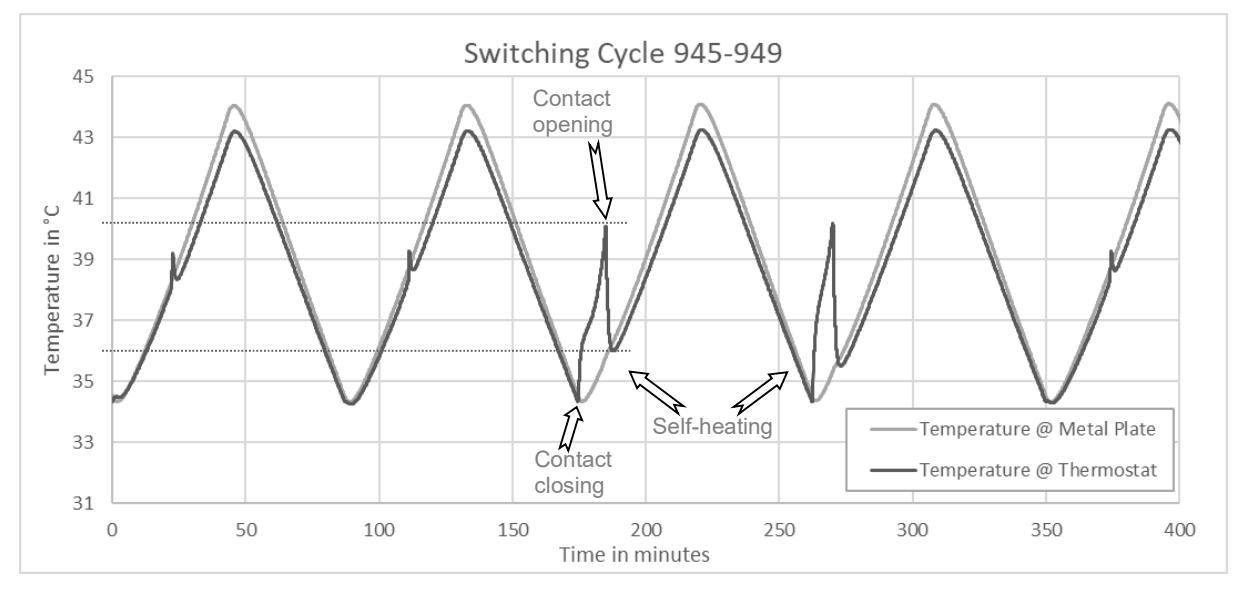
Figure 5: Self-Heating local Temperature increase on Thermostat

With the increase of closed contact resistance, the dissipated power at the contact increases following the well-known Joule heating relation $P=I^2$ ·R. Before the wear-out, on thermostat S/N 007 a contact resistance of up to 6 Ω was measured during the thermocycling. This resistance values at 0.34A led up to 600mW power dissipated at the thermostat contacts. In the temperature plots of Figure 5, showing the measured temperature of the supporting metal plate and the body temperature of the thermostat s/n 7, the effect of this 600mW power dissipated at contact level, caused the increase up to 4 Kelvin of the thermostat body with respect to the metal plate temperature, independently heated. This, so called self-heating effect, by reaching the bimetallic disc inside the thermostat, disrupt its nominal behaviour, leading to an opening of the contact well before the functioning temperature of 39°C is reached on the metal plate. The central cycles shown in Figure 5 for example, show the thermostat switching on at about 34°C and soon after, its body temperature increases sharply due to the joule heating at the internal contacts. The body temperature reached about 40°C while the plate temperature was still at about 36°C. With 40°C body temperature, the thermostat switched off and no more joule heating was produced at the contact, therefore the body temperature could quickly equalise to the plate temperature at 36°C.

The on-ground observed behaviour in Figure 5, mirrors the telemetry data in Figure 2 where first the functioning temperature starts to fluctuate before the restoring temperature drops as well.

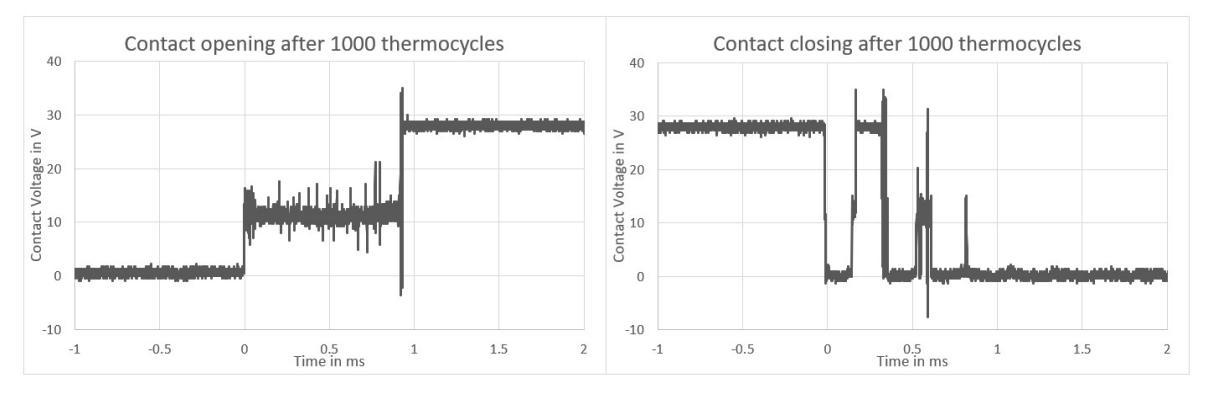
Figure 7: Switching Voltage Oscilloscope Plot after 1000 Thermocycles

Similar curves, taken after a significant amount of thermocycles, are shown in Figure 7. The voltage change from 0V to 28V at the contact opening, is not sharp anymore. Instead, the voltage sets to an intermediate potential level in the range of about 12V, showing random noise behaviour. This can be considered an indicator of electrical arcing between the switching contacts. This arcing event lasts over a duration of about 1ms. At the contact closing, similar arcing evidence can be observed with shorter duration.

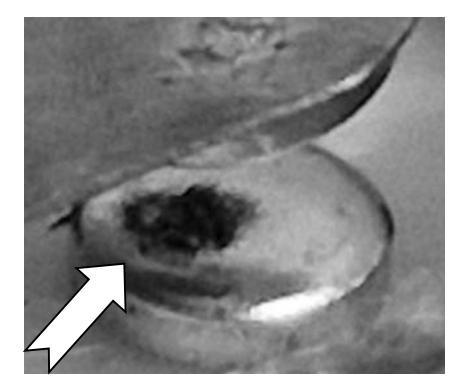
Figure 8: Thermostat S/N 007 with contaminated switching contact surface

Thermostat S/N 7 was opened to inspect the contact surfaces at the internal switching mechanism. A black spot in the middle of the contact surface is visible in Figure 8. This is most likely due to contaminants burnt-out during the electrical arcing between the contact surfaces.

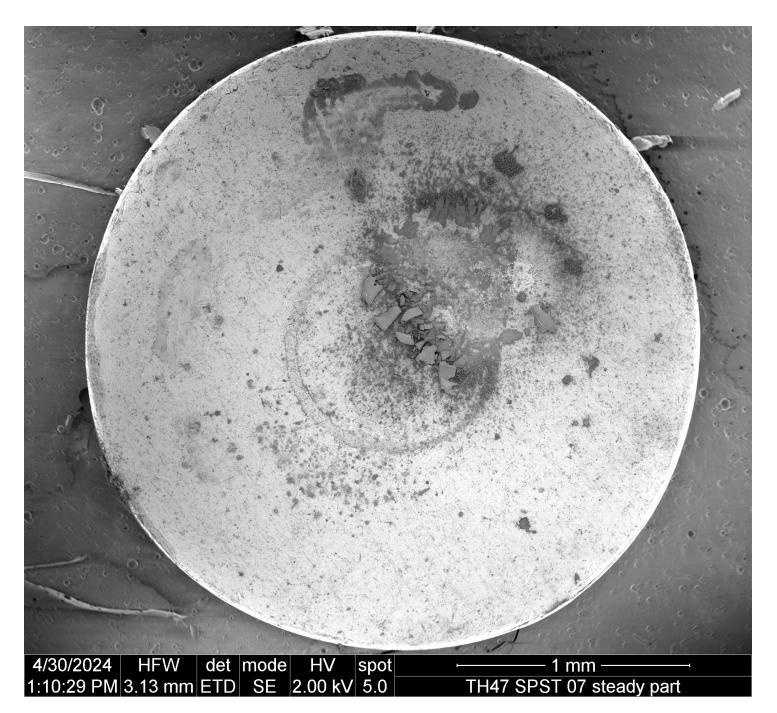
Figure 9: Scanning Electron Microscope Image of the contact surface

A more detailed investigation on the contact surface was performed to determine the nature of the contamination. Figure 9 shows a scanning electron microscope image of the bottom contact in Figure 8. Evidence of solid material deposited around the spot where the two contacts touch each other it is clearly visible. Due to the distribution and the morphology of the residual fragments, it is likely that the electrical arcing played a significant role in the formation and deposition of the foreign material at the contact interfaces.

Energy Dispersive X-Ray Analysis (EDX) was performed to investigate the elemental composition of the contaminants. The main elements detected were: Silicon, Oxygen, and Carbon. Worth to remember is that hydrogen cannot be detected via EDX analysis but, most likely, is still one of the elements in the chemical composition of the contaminants.
