Capacitors – Lessons from Industry

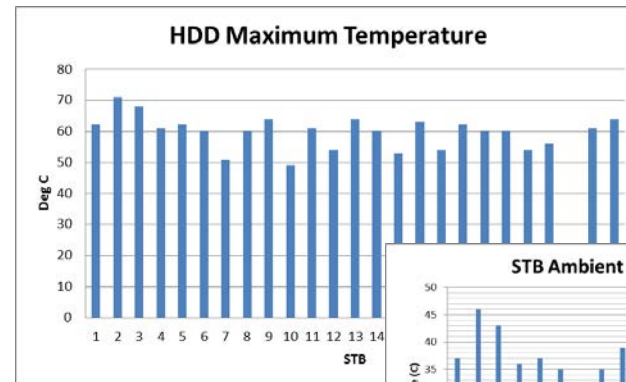
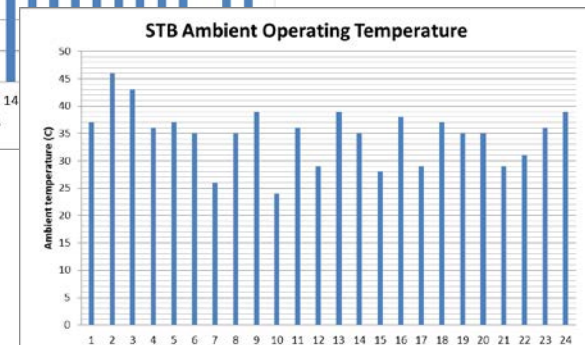
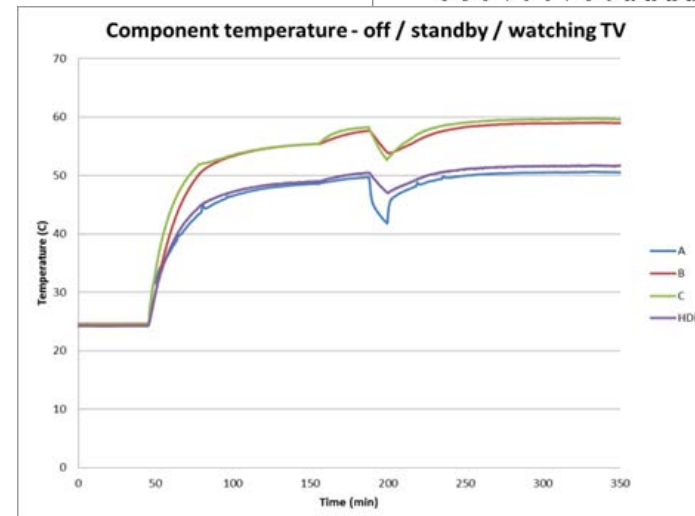
- STB manufacturer being sued by TV supplier – £50M~£100M
- STB power supply failure due to premature aluminium electrolytic capacitor degradation
- Circa 1M STB's claimed to be defective due to capacitors
- ERA acquired random sample of 1000
- Analysed circuit / measured electrical stress
- Extracted peak temp from HDD
- Correlated HDD logged temp with ambient temp
- Checked boxes
- Some capacitor batches were defective
- Overstated claim
- Majority of boxes operated outside manufacturers spec

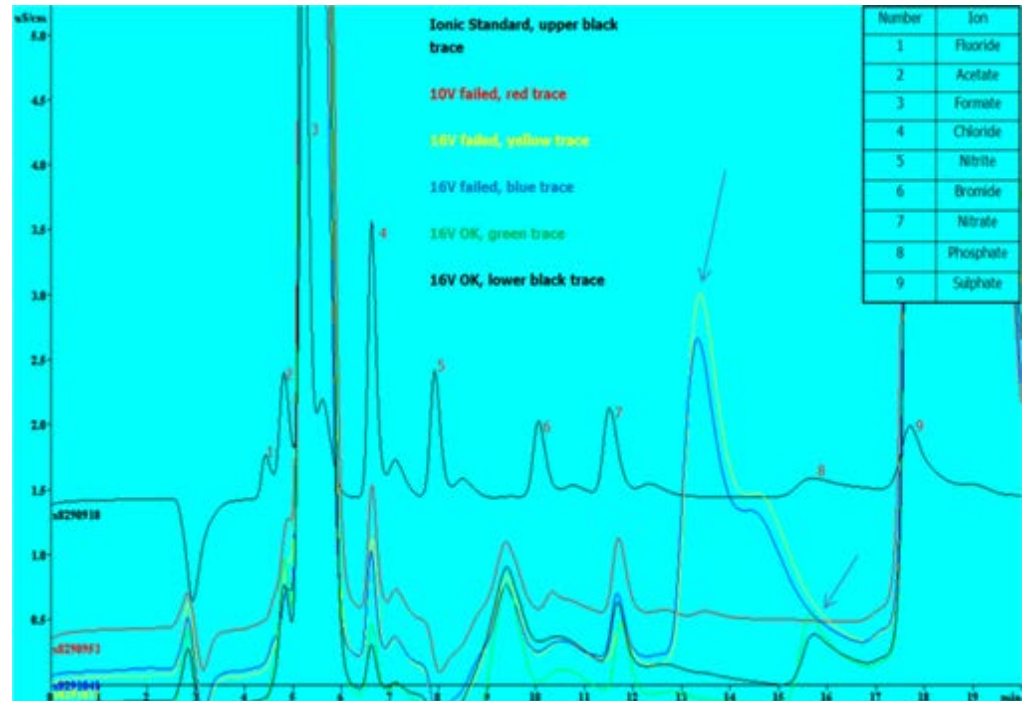
- Electrolyte analysis revealed differences in composition
- Unreliable batches – absence of phosphate
- SEM-EDX confirms alumina converted to aluminium hydroxide = ESR increase and venting

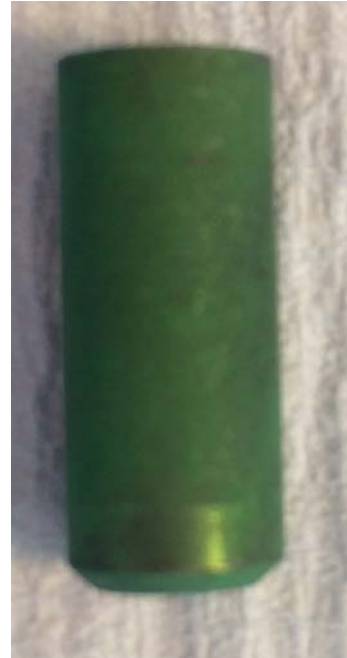
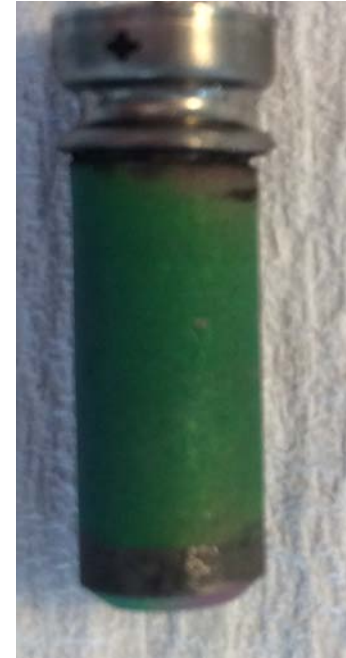
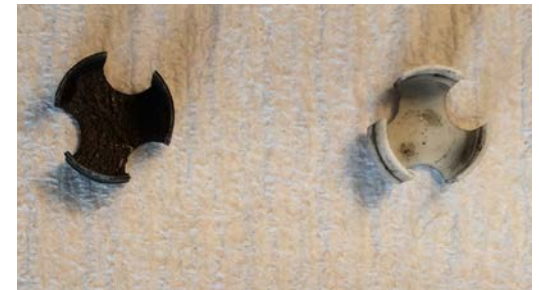
- Wet tantalum capacitors used in military application
- Failed after running in a high vibration environment
- Two failure modes
 - Abrasion against case contaminating electrolyte
 - Anode wire fracture
- Both failures related to mass of high density tantalum pellet / suspension on anode wire

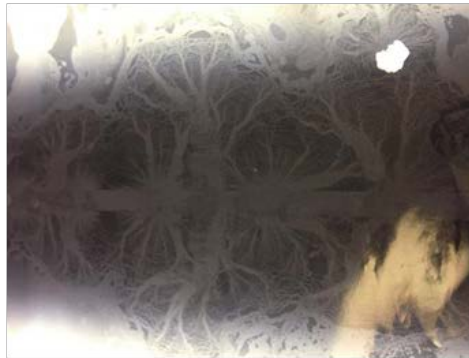
- Found a range of effects
- Primary concern - corrosion linked to fluorine, with spacing varying with diameter, linked to flux and lamination issue
- Recommended ongoing monitoring over life of asset.
- Recommended on site measure of electrical stress

- 5KV capacitors used in high power application
- Routine inspection revealed metal damage
- ERA asked to conduct independent investigation

- Application assessment
- Electrical testing
- Disassembly
- Materials analysis
- Trace contamination analysis

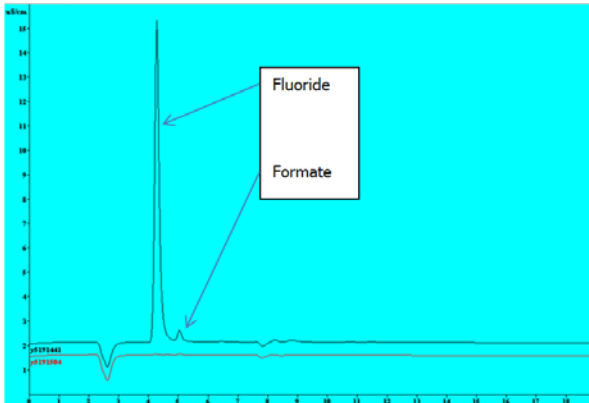
Electron Image 1

F Ka1_2

Spectrum	C	O	F	Al	Zn
1	88.3	3.6	1.5	2.6	3.9
2	83.5	5.5	2.2	3.2	5.7
3	70.5	14.9	3.4	3.6	7.6
4	92.5	2.2	1.5	1.6	2.2
5	86.5	7.8	3.4	2.4	0.0
6	84.4	5.9	3.6	2.1	3.9

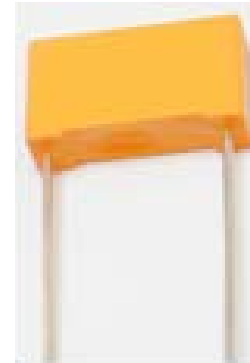
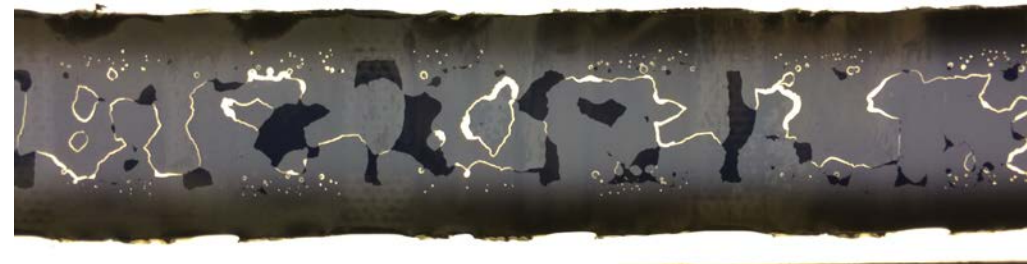
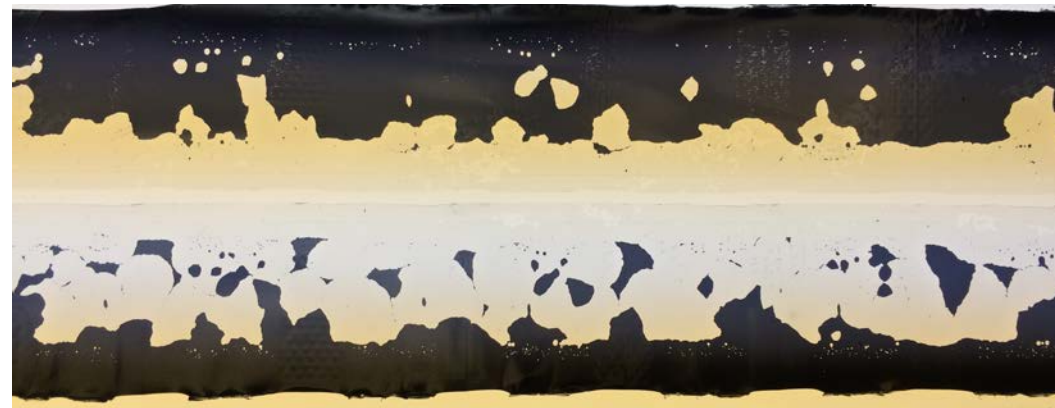
X2 Film Capacitor Failures

- Manufacturer of utility meters sued for large amount due to power supply failure
- X2 capacitors responsible

- Humidity affects the film
 - Miniaturisation allows moisture into package
 - Cost reduction of capacitors brings them into new applications
 - Effect takes time to become evident
 - Capacitor manufacturers didn't realise?
-
- ERA reported on manufacturers responsibility / due diligence / circuit design
 - Responsibility directed towards capacitor manufacturers
