# Passive components: 5 years failure analysis feedback From all markets

Eric ZAIA (Material Engineer)
Béatrice MOREAU (Passive components & PCB dpt. Manager)

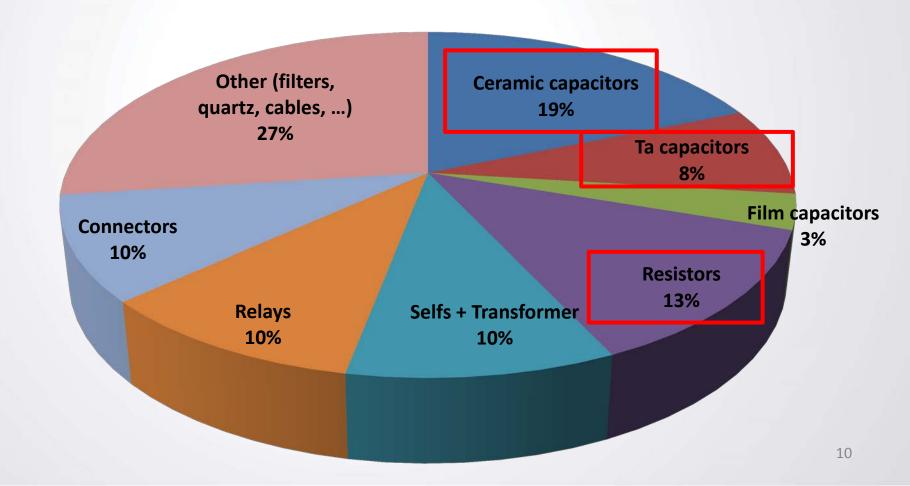
#### Type of component (by quantity)

• 2011 - 2015: 1 200 failure analyses on passive components

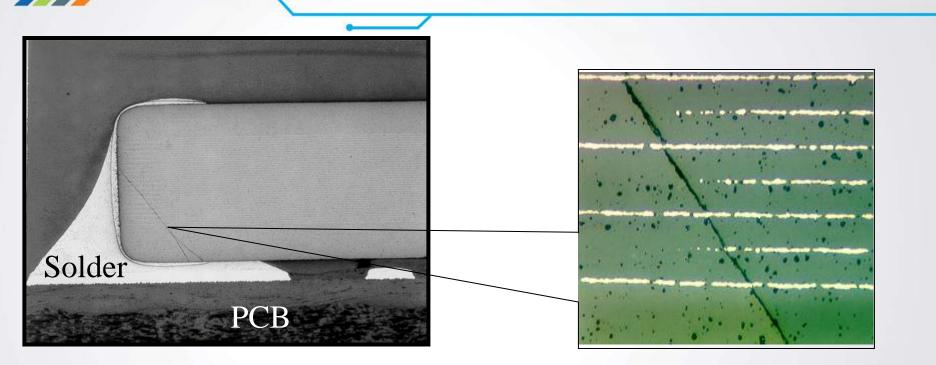
### Ceramic Capacitors Cracks

Diagonal cracks (@45°) due to Thermo and/or Mechanical stresses caused by soldering/testing/depanelization/handling...

→ Short circuit occurs when dielectric between opposite electrodes is cracked

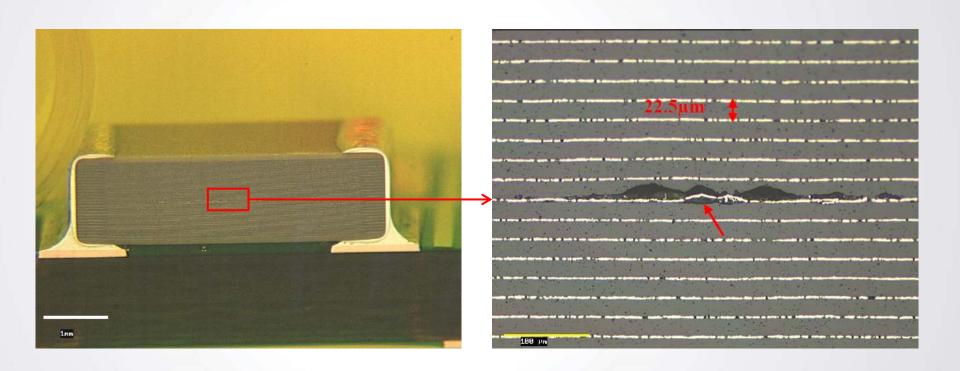
Delamination: Electrode/Ceramic

Delamination relative to the component process: Part lamination/sintering

→ Results in insulation reduction up to Short circuit

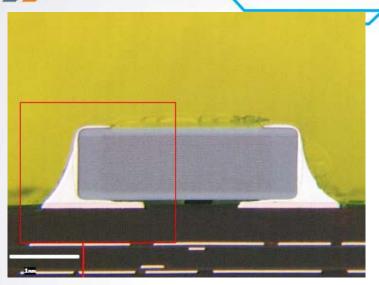
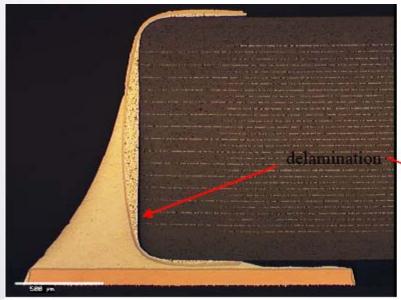
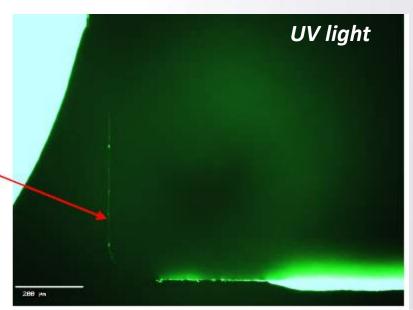
#### **Delamination Electrodes/Termination**

Soldering process + Component Weakness (at termination)

Revealed after ageing test

results in loss of capacitance up to Open circuit

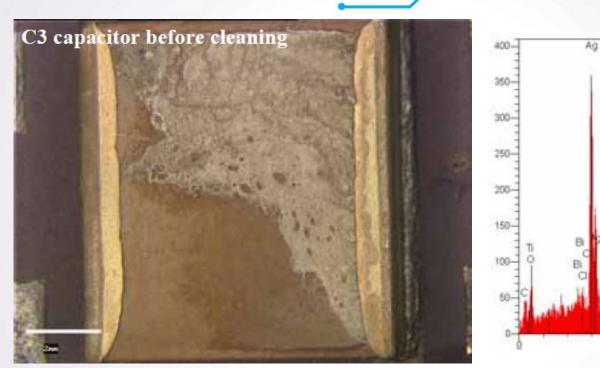
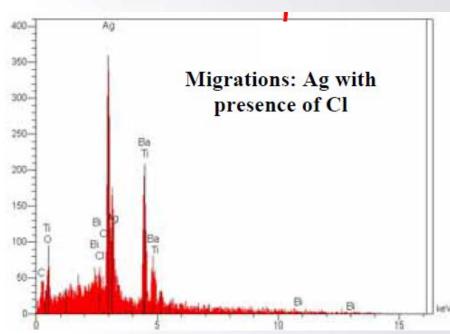
### Ceramic Capacitors Migration

Failure occurred during Environmental tests:

Moisture and contaminant (Cl,..) leading to Silver dendritic growth

→ Short circuit

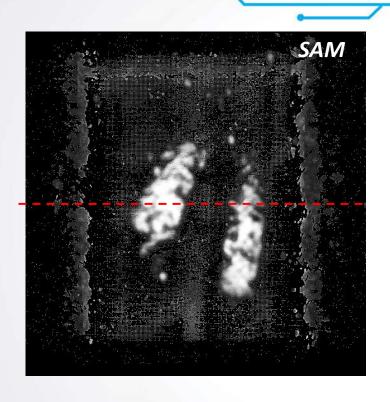
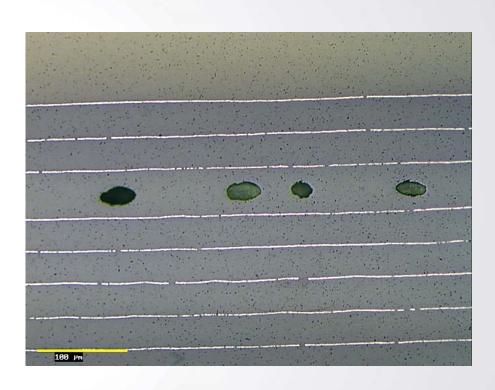
### Ceramic Capacitors Porosity

- Component quality
- Ceramic preparation issue or organic/inorganic contamination
- → Insulation reduction up to short circuit

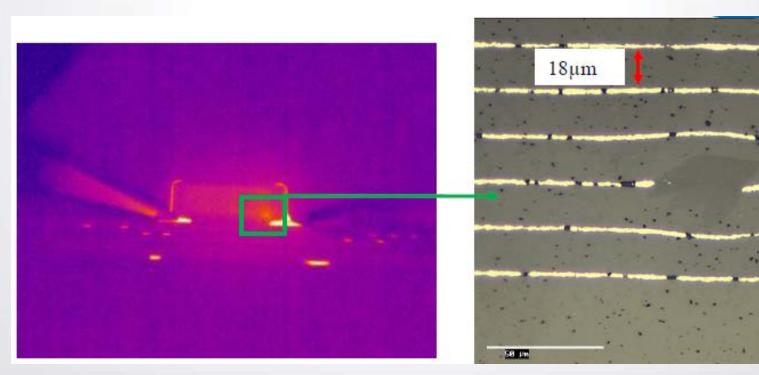
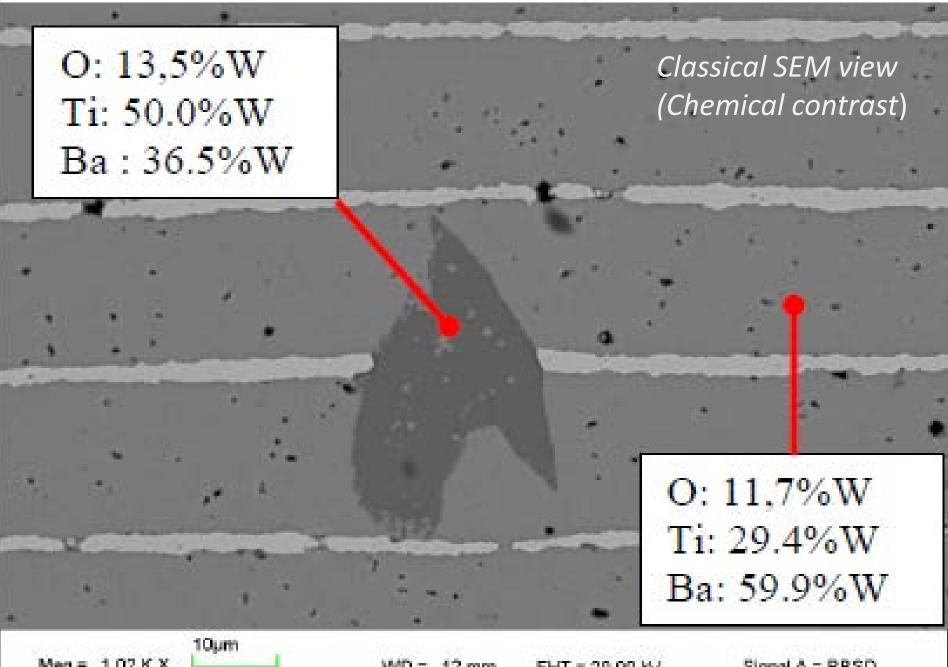
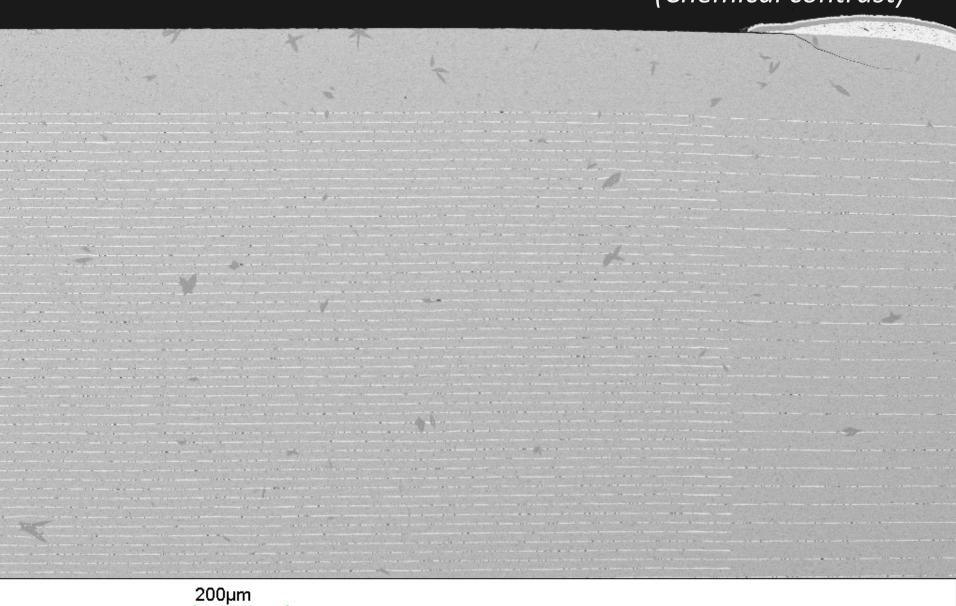
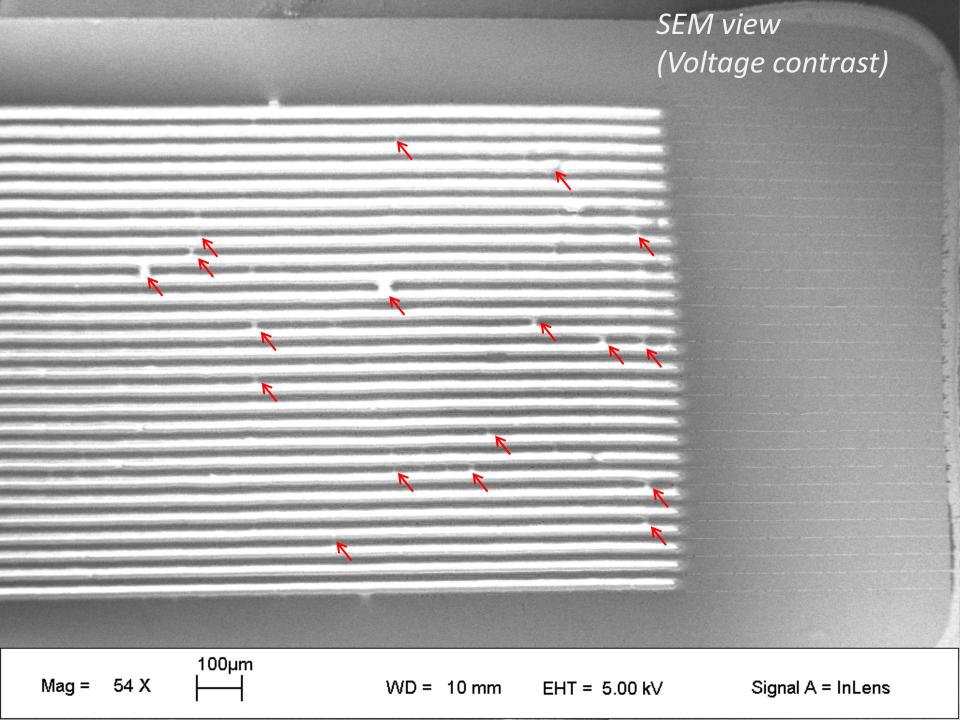
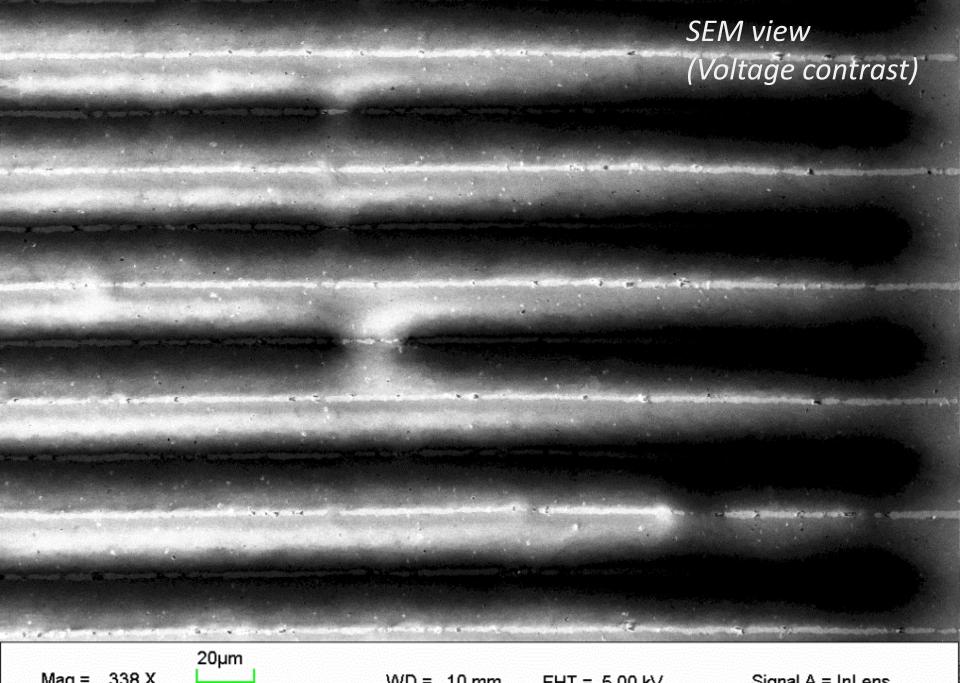
### Particular Technique Voltage contrast coupled SEM

- Presence of a short circuit on a ceramic capacitor,
- Infra red thermography confirmed the presence of the Short
- Cross section showed the presence of specific phases
- → Conductive or not?

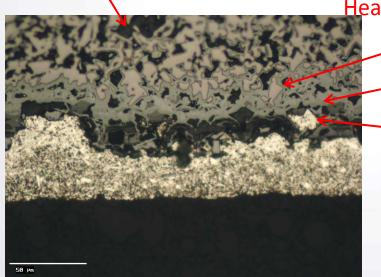
# Tantalum Capacitor MnO2 deposition

- Component quality
- MnO2 layer thin and inhomogeneous
- Ag penetration

- → Local ESR reduced
- → Overheating until short circuit

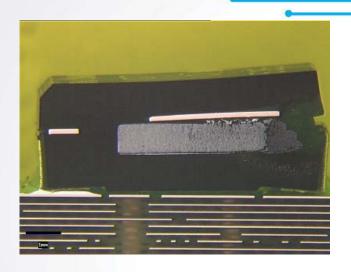
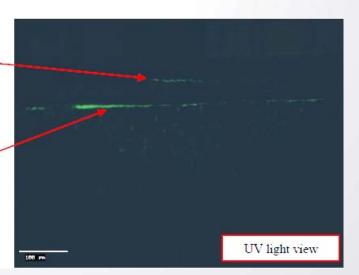
### **Tantalum Capacitors**Delamination

Delamination due to component quality or assembly process

# → ESR increase up to thermal runaway

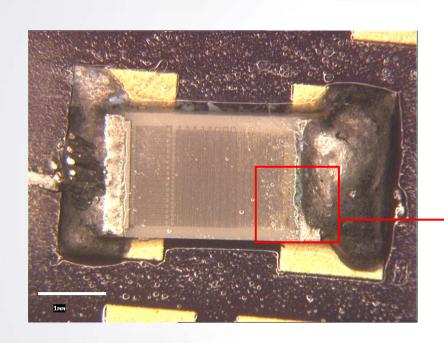
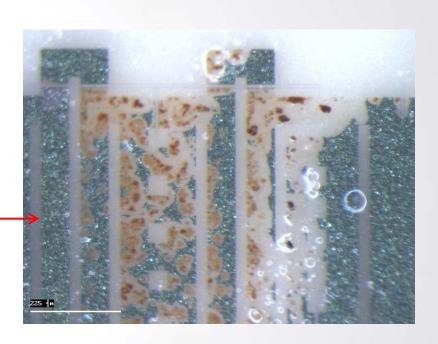
### SMT Resistors (Thin film) Corrosion

Oxidation of the resistive layer in presence of humidity

→ Resistance increases up to open circuit

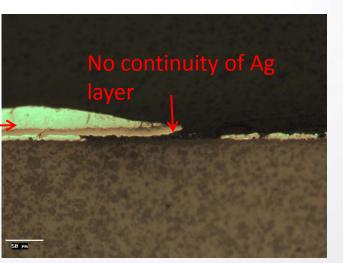
## SMT Resistors (Thick film) Corrosion (sulfuration)

Environment:
Sulfur attack of silver occurs at the interface of the glass passivation layer and the resistor termination

→ Open circuit
