Relays : Failures occurring & Lessons learnt

Dr. Denis Lacombe and Dr. Léo Farhat

ESA-ESTEC 10/10/2018

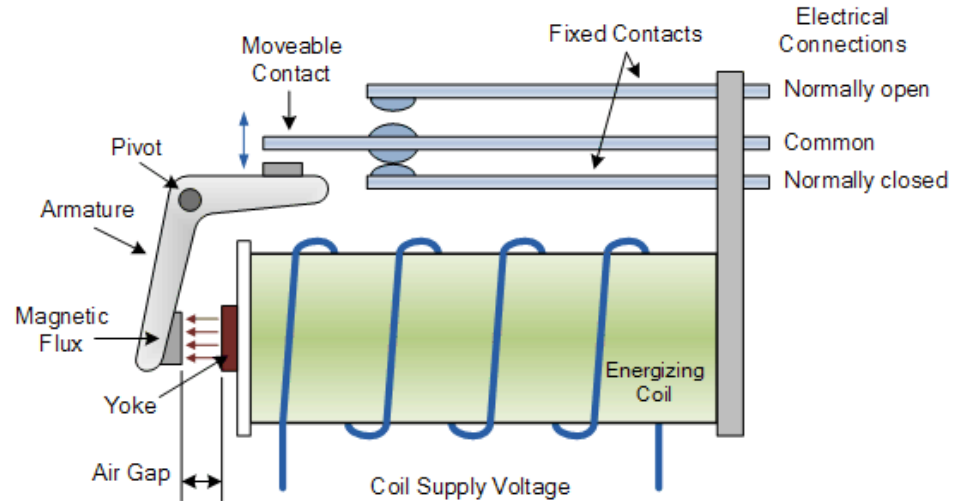
Control

The actuator or motor is based on magnetic circuit formed by coils with or without magnet that converts electric energy into electromagnetic force used to actuate the contact side.

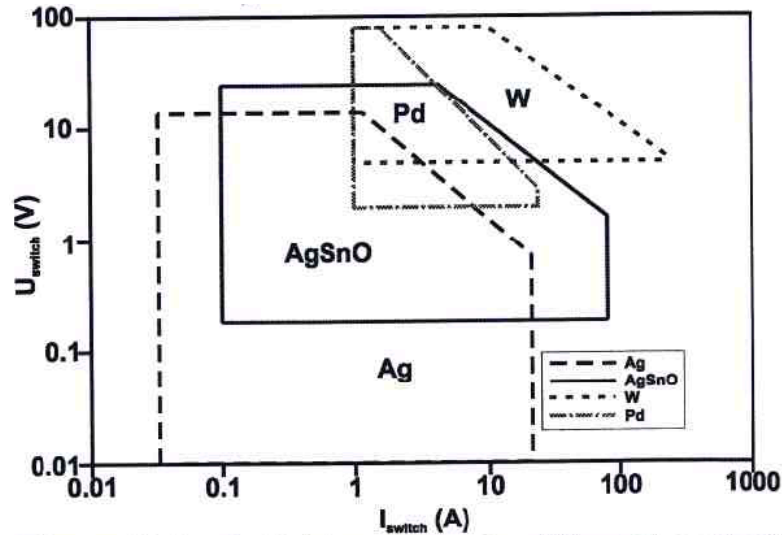
Contact

The choice of the contact material depends on the switching capability of the relays. In general, a trade off is made between low resistance material and abrasive resistance. In space application, contact are usually made with silver for low current, silver oxide for high current and tungsten for high voltage.

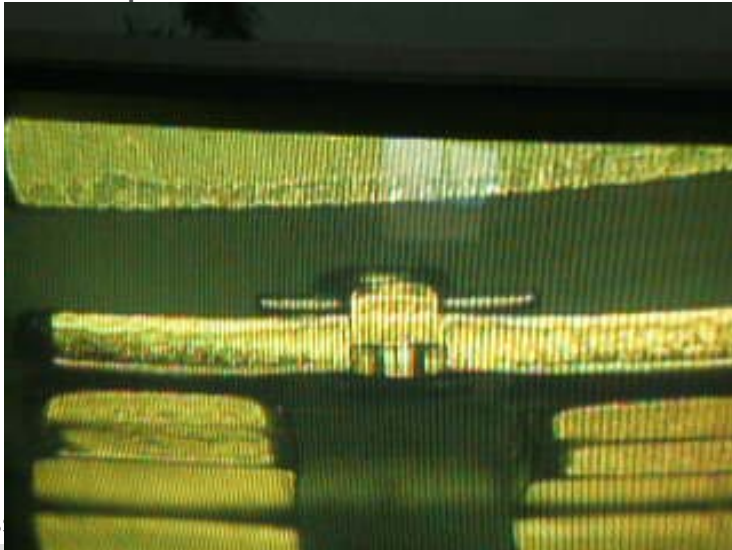
Tuning and arcing

The settings of the relays are based on the Holm curves and take into account several elements like the contact materials, the contacts gap, the internal gas inside the cavity, the pressure, etc.

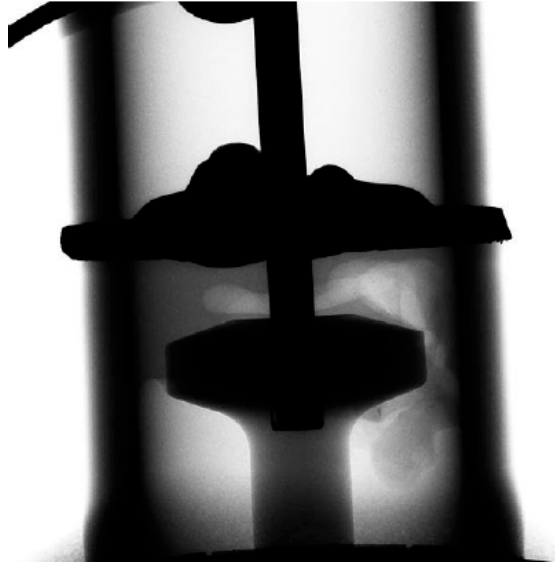
High voltage relay: increase of latch voltage

Actuator side not in hermetic package then vacuum may induce displacement but also cleaning process may cause damage to the gel.

- Methyl silicones were found on the actuator that showed anomalous behavior.
- The reference relays both likely cleaned with Dowclene PX-16S did not show methyl silicone absorptions.
- Analysis of the silicone gel with FTIR transmission spectroscopy indicated that the gel is composed of methyl silicone.
- Dowclene PX – 16S extracted significant amounts of methyl silicones from the dielectric gel
