A Screening Method Using Pulsed-Power Combined with Infrared Imaging to Detect Pattern Defects in Bulk Metal Foil or Thin Film Resistors

Jay Brusse⁽¹⁾, Lyudmyla Panashchenko⁽²⁾

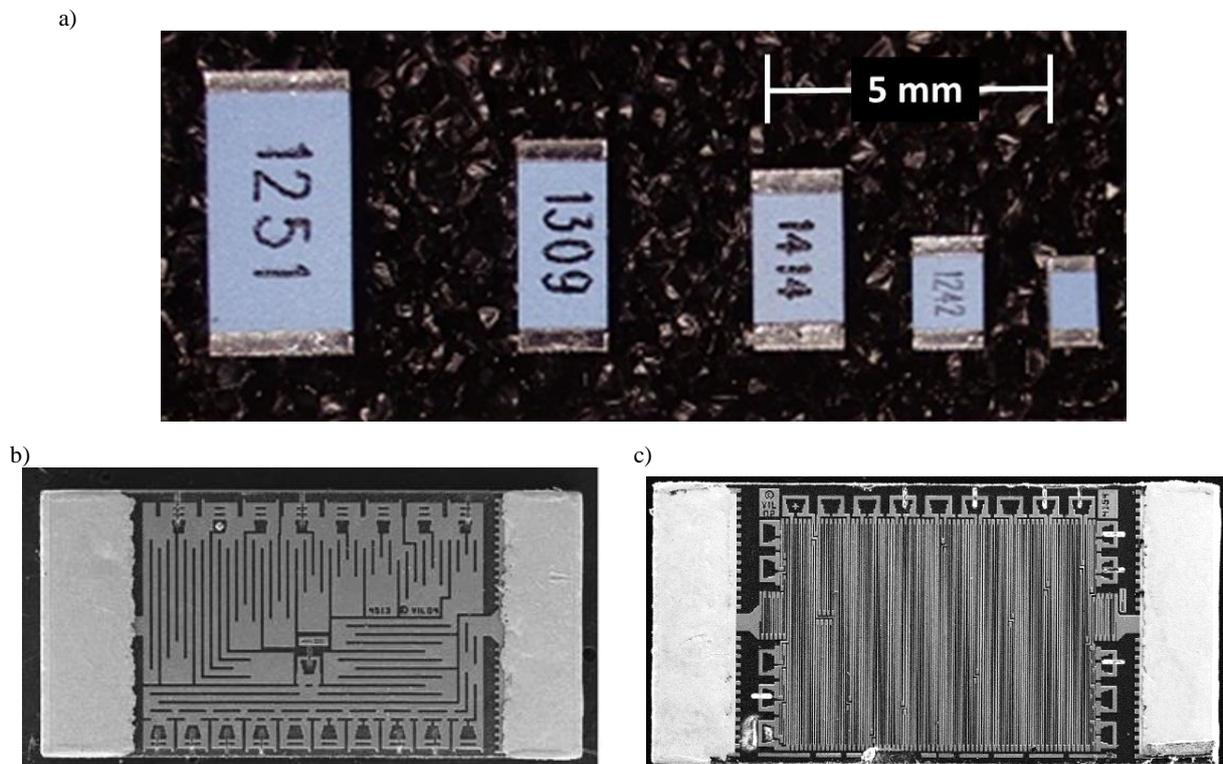
Fig. 1. a) Surface Mount Foil Resistors Sizes 2010 to 0603
Etched foil resistor pattern for size 1206 surface mount foil resistors b) 49.9Ω and c) $20,000 \Omega$

Surface mount foil resistors are commonly produced as two terminal devices with solderable wraparound terminations. They are available in a variety of standard footprints including sizes 0603 up to 2512 (see Fig. 1a). The basic construction of a bulk metal foil resistor is described in several patents [9, 10] and illustrated in Fig. 1 and Fig. 2 [7]. The typical surface mount foil resistor consists of a flat, rectangular, insulating substrate (e.g., alumina) on top of which the resistor element is bonded using adhesive materials (e.g., resins or polymers). The resistor element is made from proprietary nickel-chromium based alloy ingots that are precision-rolled into foil sheets having thicknesses in the range from $\sim 2 \mu\text{m}$ to $\sim 5 \mu\text{m}$. The foil sheets are then developed into serpentine resistor patterns using photolithography and electrochemical etching techniques. A wide assortment of resistor patterns may be produced with individual patterns having resistor lines (also called “gridlines”) having widths ranging from a few microns to many tens of microns depending on the resistance values to be achieved from that pattern. Fig. 1b and 1c provide examples of the serpentine resistor patterns for a low value (49.9Ω) vs. high value ($20,000 \Omega$) resistor each produced on a size 1206 alumina substrate.

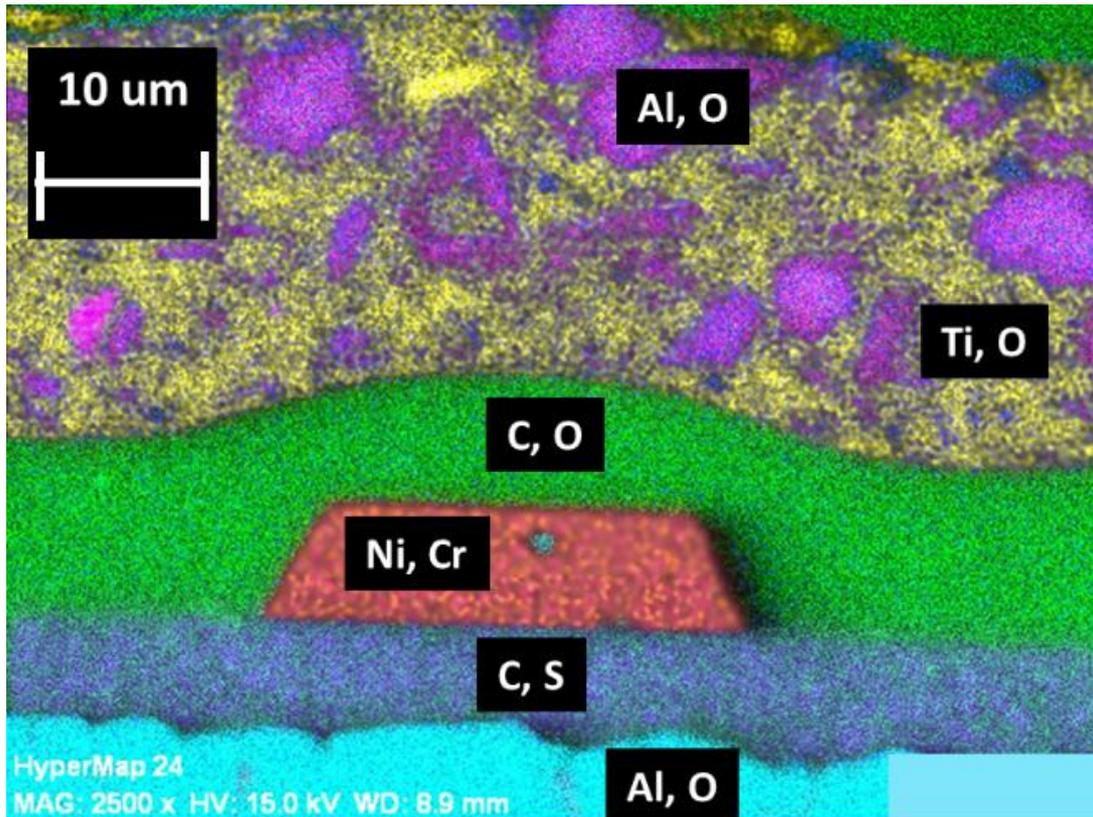
Fig. 2. Scanning Electron Microscopy (SEM) Image with Elemental Dot Map of a Cross Section of a Typical Surface Mount Foil Resistor

The resistor element is protected by a thin ($\sim 5 \mu\text{m}$ to $\sim 10 \mu\text{m}$), optically translucent polymeric coating followed by a thin ($\sim 25 \mu\text{m}$), optically opaque epoxy coating to protect the resistor element against handling damage and to allow for the printing of part markings (e.g., lot date code) onto the external surface of the component (see Fig. 2).

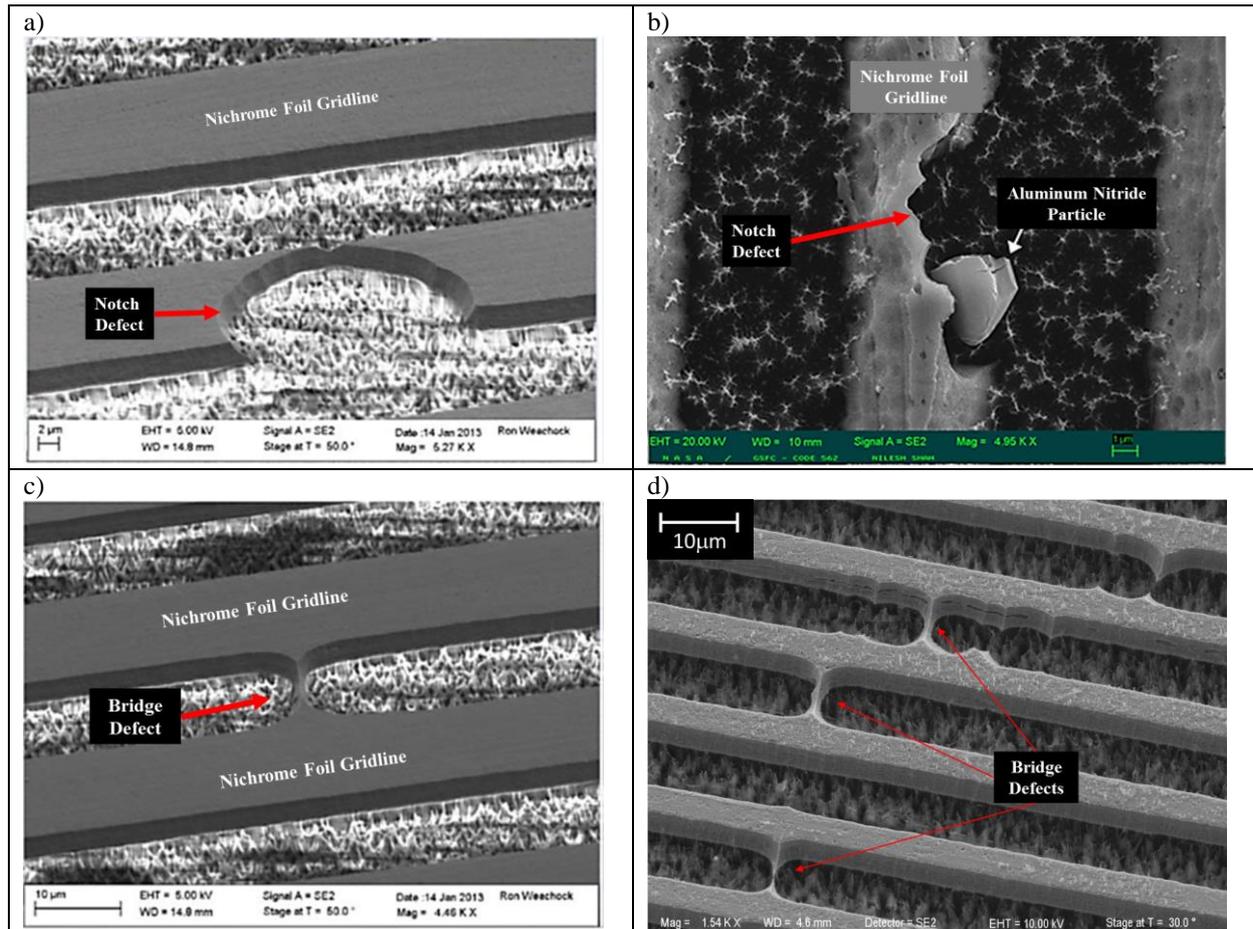
Fig 3. Destructive Physical Analysis (DPA) Examples of Constriction Defects in Foil Resistors
 a) Large Notch Defect in Gridline,
 b) Notch Defect Associated with an Aluminum Nitride Particle Embedded in the Foil,
 c) and d) Bridge Defects Between Adjacent Gridlines

Two main types of constriction defects may occur during the manufacturing of the foil resistor element: notches and bridges. Examples of each type of constriction defect are shown in Fig. 3 [4 - 8].

Notch defects are localized holes in the resistor gridline that reduce the gridline cross sectional area below the original design intent. Notches that take away >75% of the nominal resistor line width are considered to be unacceptable by some workmanship inspection criteria [3, 11] when the pattern is inspected at 30x magnification. The causes of notch defects include pre-existing pin holes in the foil sheet prior to etching, photolithography/etching-related anomalies and non-conductive particles (e.g., aluminum nitride) embedded in the foil [5]. If a notch defect breaks, then the electrical continuity of the gridline pattern is interrupted usually resulting in an open circuit failure mode. If the disrupted section of the resistor pattern has an associated parallel pathway, then a positive resistance shift occurs.

Bridge defects, as the name suggests, are sections of foil resistor material that interconnect two or more adjacent gridlines. Bridges whose narrowest width is <10% of the nominal resistor line width are considered to be unacceptable [3, 11]. The primary causes of bridge defects are related to photolithography/etching anomalies that result in a failure to completely remove foil material from the spaces between adjacent lines as intended. Bridges form unintentional parallel resistor pathways within the serpentine pattern. If during the trimming operation the manufacturer cuts a shorting tab associated with a section of the pattern containing bridge defects, then these bridges and the parallel resistance pathways they produce become essential features of the overall resistance value. Any disruption of the bridge would result in removal of the parallel path and an associated increase in resistance value.

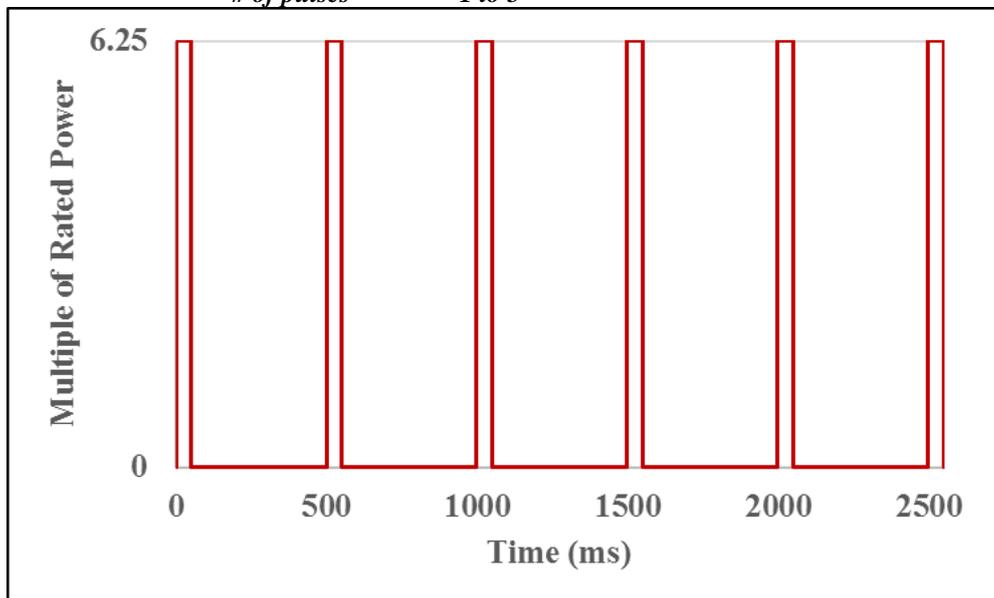
Power = 6.25x rated power
Pulse Width = 50 ms
Pulse Period = 500 ms (i.e., 10% duty cycle)
of pulses = 1 to 5

Fig 4. Pulsed-Power Parameters Used for Infrared Screening of Surface Mount Foil Resistors

The screening technique begins by selecting an appropriate set of power parameters to apply to the resistor under test. The objective is to produce Joule heating that is focused and confined primarily at the sites of localized constriction defects within the active region of the resistor pattern. The authors have found the pulsed-power square wave shown in Fig. 4 to be well-suited for this purpose. A Keysight model B2962A or similar low noise power source may be used. The choice of 6.25x rated power is based upon this same power level having already been established as the industry norm for the 5 second short time overload (STOL) screening test for both foil resistors and thin film resistors [1 – 3]. Obviously, if these resistors are specified to survive the 5 second 6.25x rated power STOL test with no damage, then it is reasonable to expect them to withstand the same power for 1/100th the time (i.e., 50 ms). The brevity of the pulse and 10% duty cycle confines the Joule heating of the localized constrictions to a small distance thereby allowing an infrared detector to provide more accurate location of the hot spot. In practice, only a single pulse is necessary to perform the test, but the authors have found using from 1 to 5 pulses enables a human operator to more easily review and interpret the infrared video captured for the resistor under test. Future improvements of this test may employ software automated interpretation of the infrared images instead of human interpretation.

A total of 280 resistors identified in Table 3 were screened prior to life test using the aforementioned pulsed-power infrared inspection technique in Fig. 4. A serialization scheme was used to maintain traceability. The results of this screening inspection are presented in Figs. 10a and 10b. Hot spot severity was qualitatively assigned as either 'significant' or 'less significant' based on how readily discernable they were by human operator review of the infrared images. Fig. 10a shows that within each 40 piece sample from the 7 lots tested there was at least 1 resistor and up to 6 resistors with a 'significant' hot spot. A total of 29 out of 280 resistors were judged to have 'significant' hot spots with an additional 25 resistors having 'less significant' hot spots. Neither the type of foil used (i.e., Type A = with particles vs. Types B & C = "particle-free") nor the level of STOL screening (i.e., Types A & B = 1 STOL vs. Type C = 2 STOL exposures) appears to have produced a significant difference among the 7 lots tested in terms of number of resistors with hot spots remaining in the 40 piece samples.

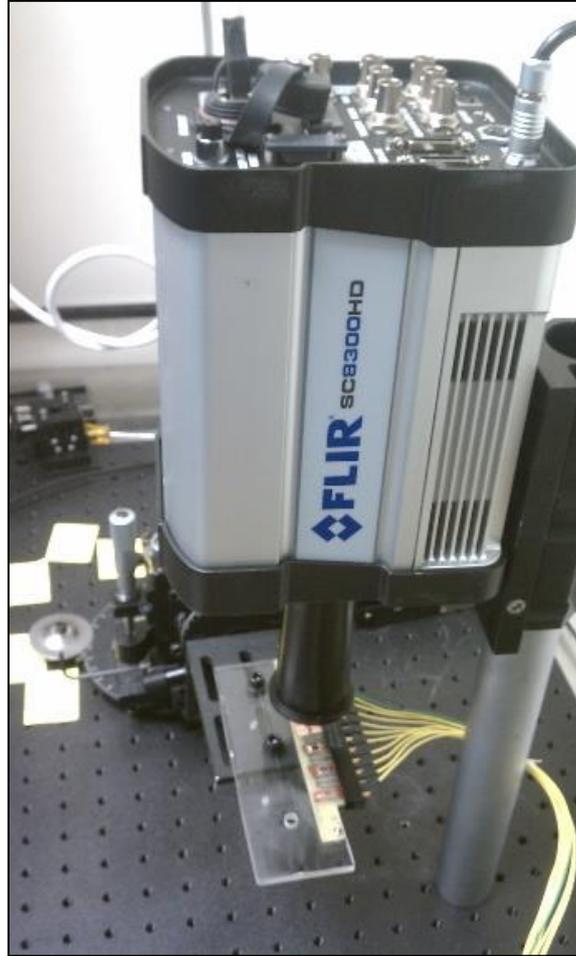
Fig 5. FLIR SC8300 Series Infrared Camera with 4x Lens

The key feature of this new screening method is the use of the FLIR SC8300 series high-speed, high-resolution infrared camera combined with a 4x magnifying lens (see Fig. 5) to capture infrared video (i.e., sequence of images) of the resistor pattern while applying the pulsed-power signal of Fig. 4. Relevant specification parameters for this camera and lens configuration are listed in Table 2 and described in [13]. The field of view of ~4.6mm x ~5.6mm enables inspection of resistors up to size 2010 in a single inspection. Larger footprint resistors require 2 or more inspections with repositioning of the sample between inspections in order to examine the entire active area. The detector has over 1 million pixels that can readily detect feature sizes down to ~5 μm which is sufficient to identify hot spots associated with constriction defects found in the etched resistor pattern geometries in production today.

Parameter	Specification
Detector	InSb
Spectral Range	1.5 μm to 5 μm
Measurement Temperature Range	-20°C to +350°C
Field of View	~4.6mm x 5.6mm (> 1 million pixels)
Resolution of Feature Sizes	~ 5 μm per pixel
Working Distance at Focal Plane	~25mm
Frame Capture Rate	>100 frames per second (fps)

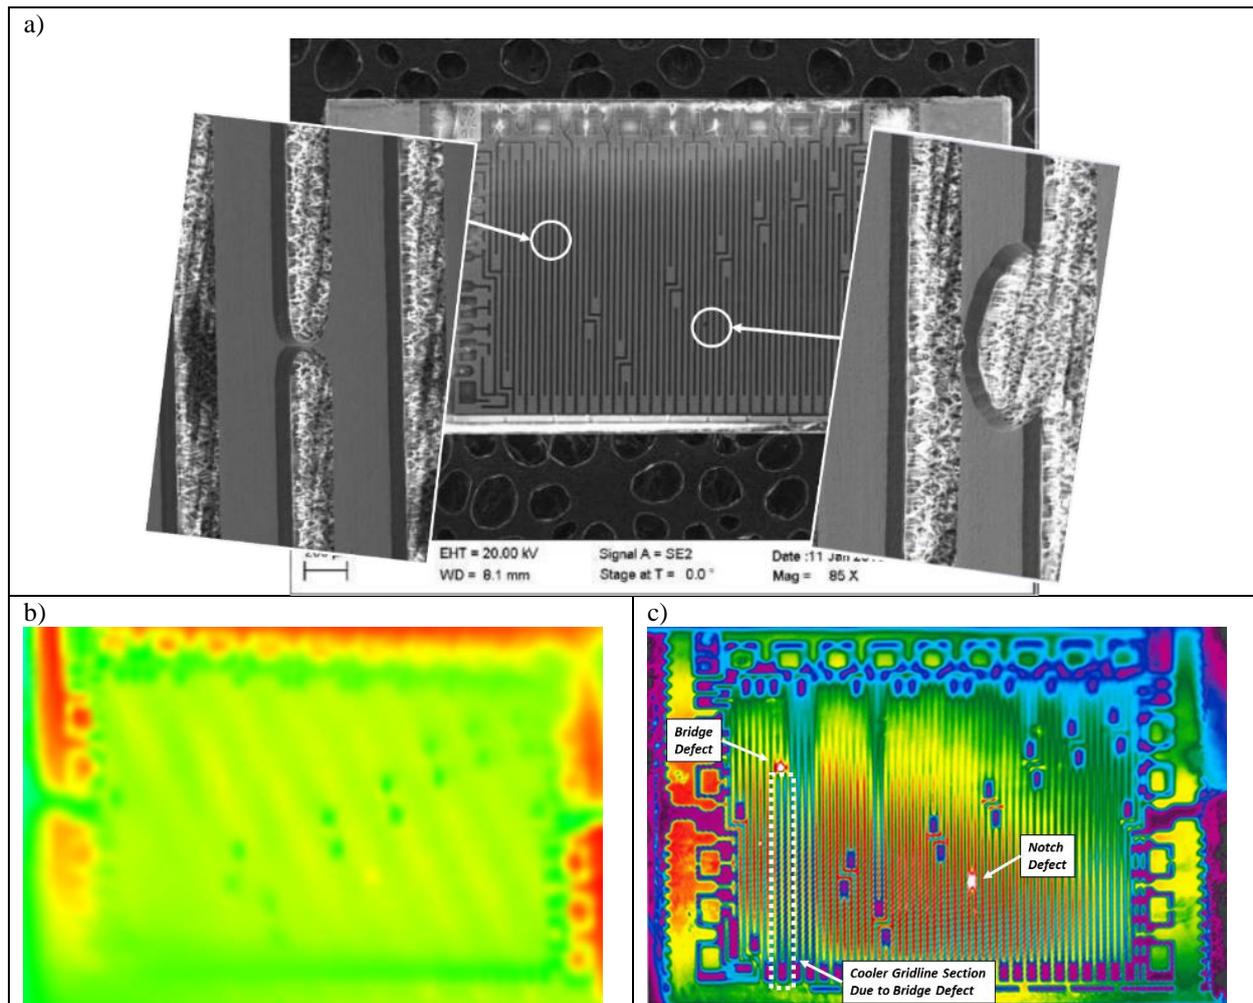
Fig 6. Inspection of a Single DPA Sample Foil Resistor Having 1 Notch and 1 Bridge Defect
a) SEM Images, b) Low Resolution Infrared FLIR SC660, and c) High Resolution Infrared FLIR SC8300

The first pulsed-power infrared inspection for this resistor DPA sample was performed using a FLIR SC660 infrared camera with ~25 μm resolution after which the same resistor was re-examined using the FLIR SC8300 high resolution infrared camera (see Fig. 6).

The difference in resolution of the images acquired by the two infrared cameras was remarkable. Hot spots associated with both the notch and bridge defects (seen as white in this color palette) were readily identified by the FLIR SC8300 whereas the same defects were not discernable with the SC660. Even without a-priori knowledge from high-magnification SEM inspection, the high-resolution infrared image can be used to identify the constriction defect type. For example, the notch defect shown in Fig. 6 is revealed as a hot spot contained within a single gridline run. The notch is also identifiable by noting that the temperatures of the gridline runs entering and exiting the notch are approximately the same magnitude since the current flowing in each is the same and therefore, so too is the Joule heating. The bridge defect in Fig. 6 appears as a hot spot between two adjacent gridlines. The bridge can also be recognized by the much cooler temperature of the gridline section beyond the bridge defect where less current is flowing due to the bypass provided by the bridge. These initial results provided the motivation to pursue the use of the FLIR SC8300 as a non-destructive, post-procurement screening inspection tool.

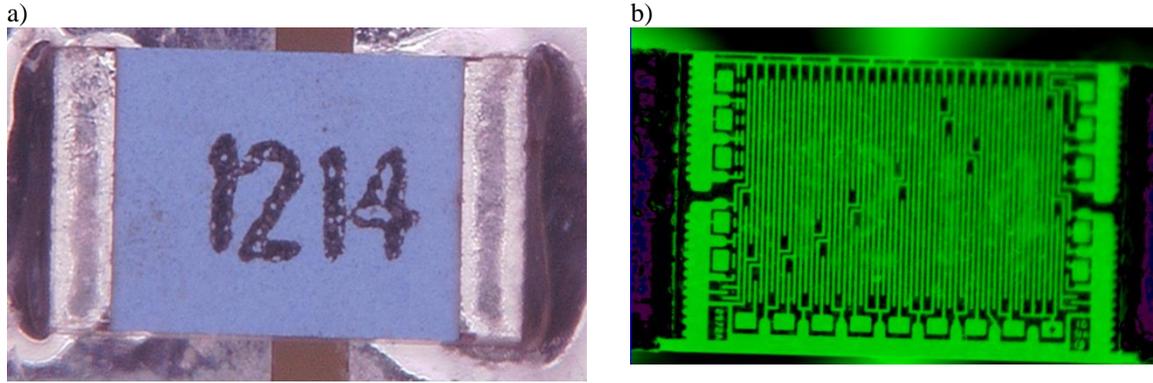
Fig 7. a) Optical Microscopy Image of a Foil Resistor and
 b) FLIR SC8300 Infrared Image of Resistor in a) without Removing Protective Coating and Without Power Applied

To assess this potential the authors examined several surface mount foil resistors and thin film resistors from more than one source with all of the protective coatings still intact. To our surprise, even with no power applied to the resistor and with the protective polymer and epoxy coatings still present, the FLIR SC8300 camera was able to produce a detailed image of the resistor pattern beneath the coatings almost as if the coatings were not present (see Fig. 7). The SC660 camera could not identify pattern features with the coatings present. Such detail was possible with the SC8300 due to the highly transmissive attributes of these specific protective coatings in the spectral range (~1.5 μm to ~5 μm) used by this infrared detector. Notice in Fig. 7b, however, that the black marking ink used to label the resistor with lot date code information is more opaque in this infrared spectral range. Nevertheless, even with this hindrance, the ability to see through the coatings is highly advantageous for this screening technique.

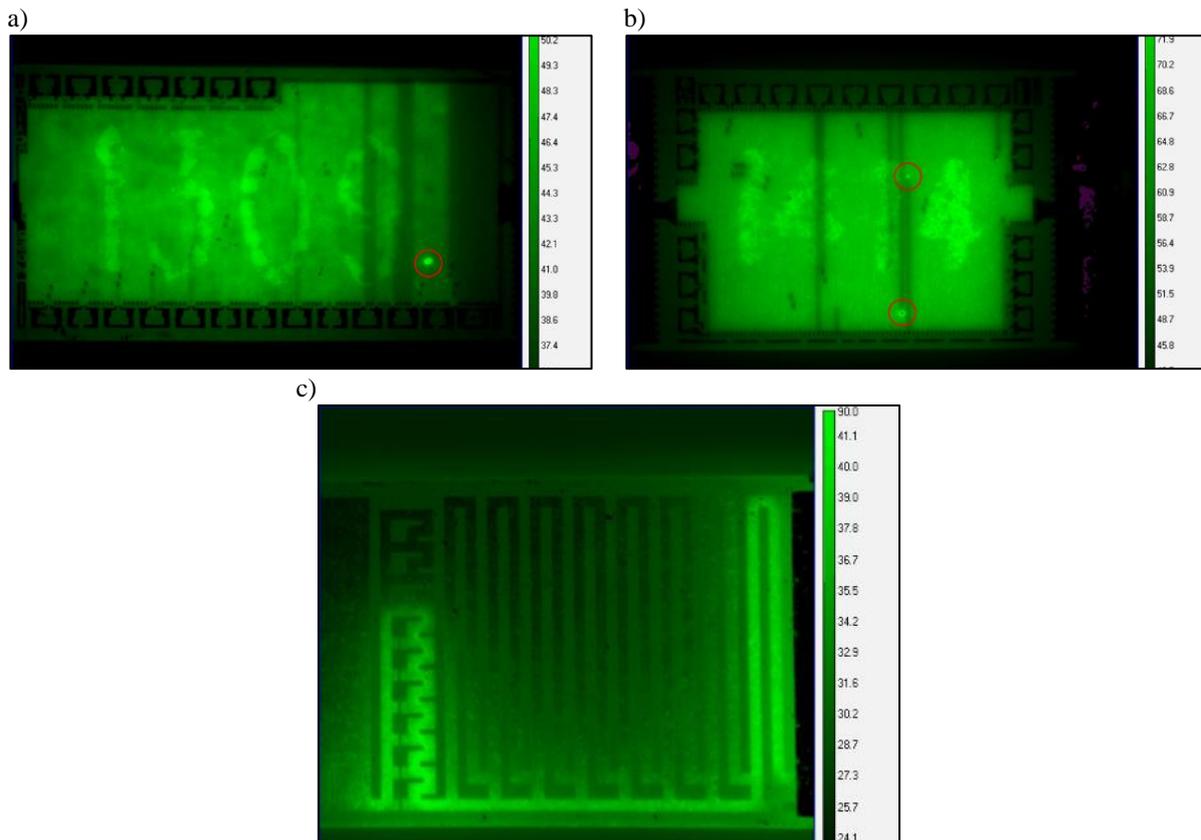
Fig. 8 – Examples of Pulsed-Power Infrared Images of
 a) Foil Resistor with a Notch Type Defect, b) Foil Resistor with 2 Bridge Type Defects and
 c) Thin Film Resistor with No Defects

Next, infrared inspection was performed on several surface mount foil resistors and some surface mount thin film resistors while applying brief power pulses as described in Fig. 4. Fig. 8 provides a few examples of the kinds of pulsed-power infrared images obtained at this stage of development. The infrared camera's software allows selection of a variety of color palettes to represent different temperatures within the field of view. For these images the green palette was chosen where darker colors are cooler and lighter colors are hotter. Note: Due to differences in the emissivity of the marking ink compared to the other materials, the part markings give a false impression of hotter temperatures at their location.

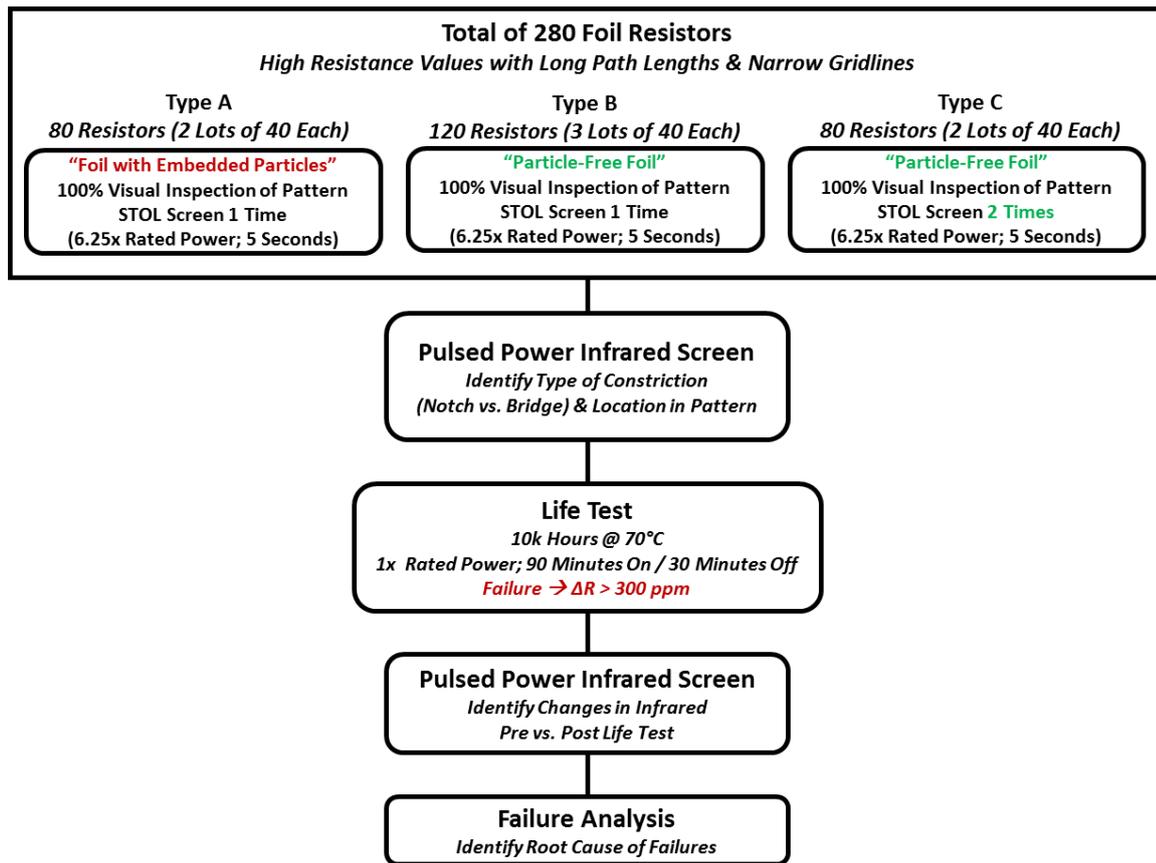
Fig. 9. Evaluation Test Flow Used to Assess Effectiveness of Pulsed-Power Infrared Screening Method

Having established the feasibility of the pulsed-power infrared screening method described above, an evaluation was performed to determine its effectiveness to non-destructively identify foil resistors having localized constriction defects and furthermore, to assess what, if any, effect such defects have on long-term reliability. The evaluation flow is shown in Fig. 9.

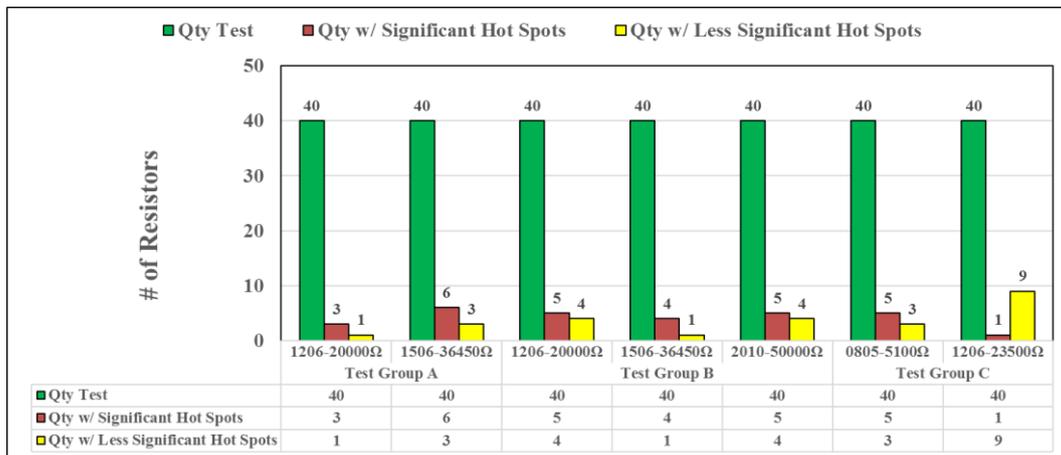
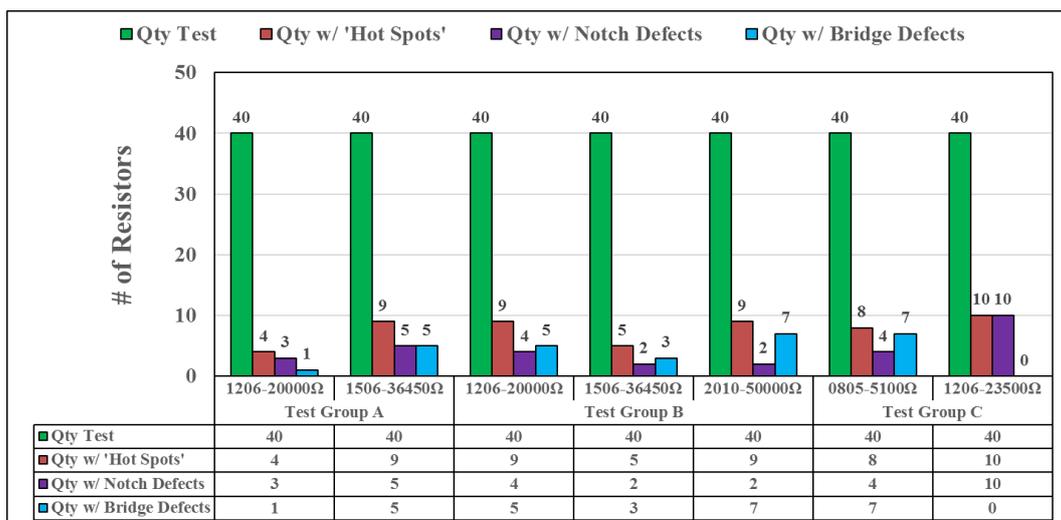
Fig. 10 – Pre-Life Test Pulsed-Power Infrared Inspection Test Results by
a) Severity of Hot Spots and
b) Type of Hot Spots (Notches vs. Bridges)

Fig. 10b presents the same pre-life test pulsed-power infrared inspection results in terms of the total number of resistors with hot spots (total = 'significant' plus 'less significant') and then identifies them by the type of constriction defect (notch vs. bridge). Several resistors had more than one hot spot within the resistor pattern including some resistors having both notch and bridge type defects. For this reason the total number of resistors with hot spots does not always equal the sum of resistors with notches plus resistors with bridges.

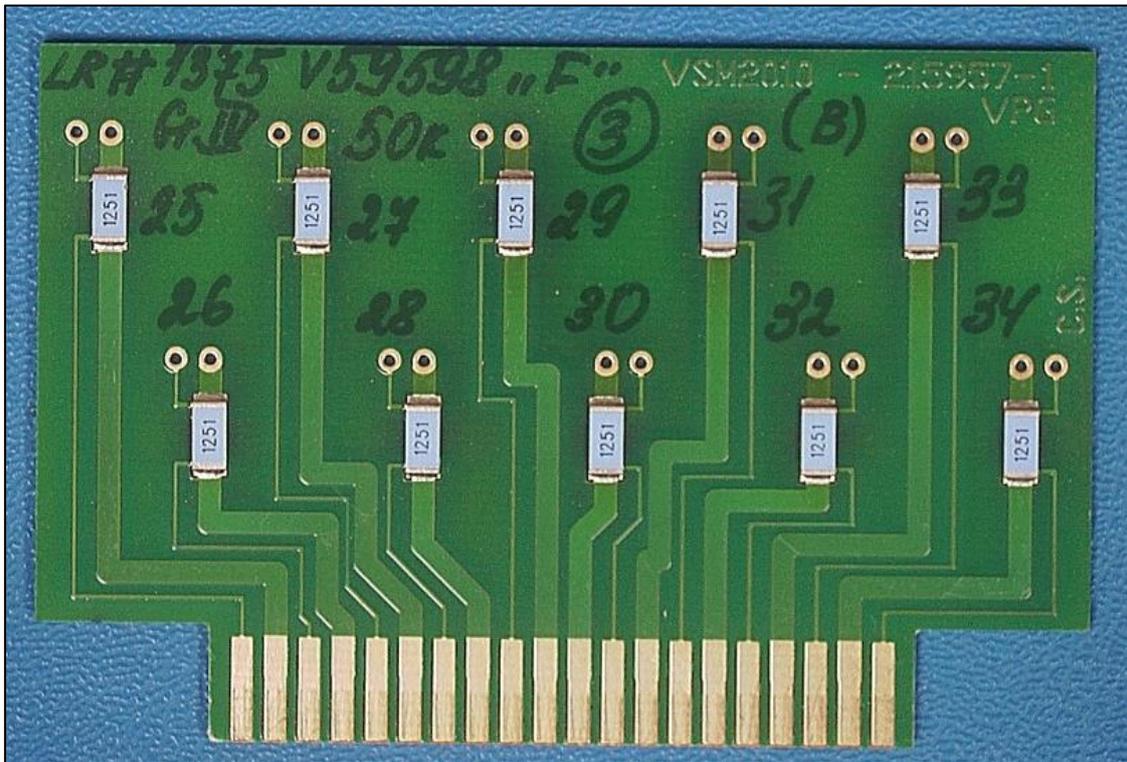
Fig. 11 – Example of Life Test PWB Used in this Evaluation (size 2010 resistors shown)

After screening per the above infrared technique, all 280 resistors, including those with hot spots, were returned to the manufacturer for long-term life test. The resistors were assembled by the manufacturer onto printed wiring boards (PWBs) as shown in Fig. 11 using recommended practices (e.g., appropriate reflow profile, SnPb solder). Initial resistance was measured after PWB assembly to verify all resistors were initially within the expected tolerances shown in Table 3. All interim resistance measurements during the course of life test were made using a 4-wire Kelvin technique to ensure accuracy of measurements for these precision tolerance resistors.

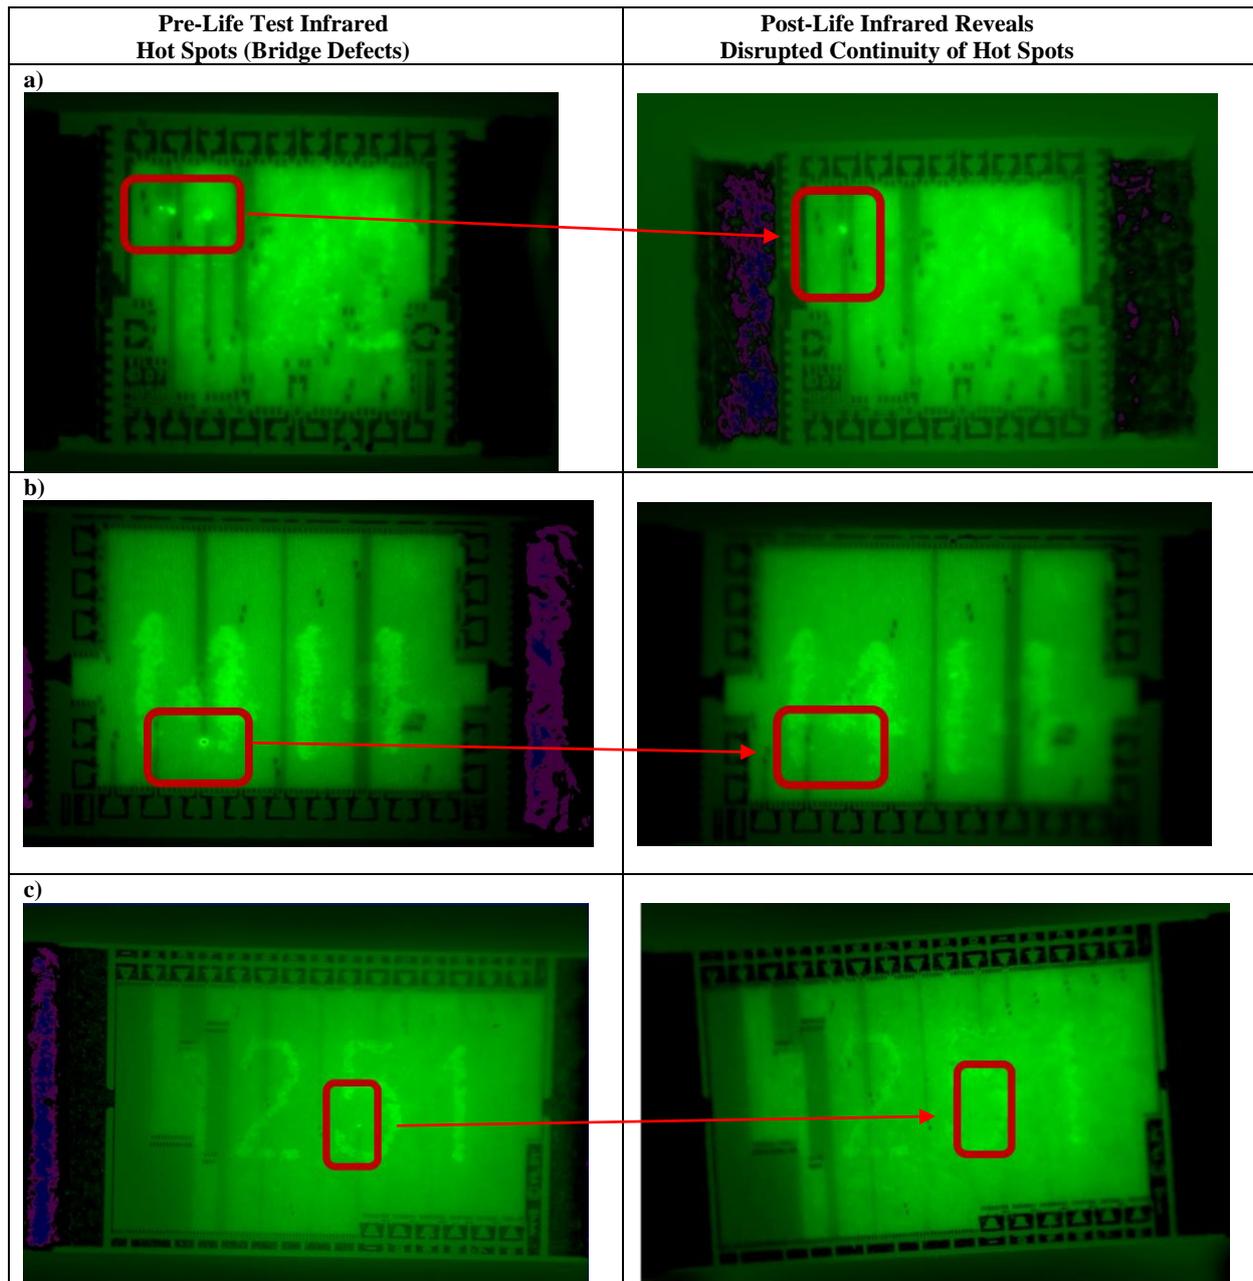
Fig. 12. Pre-Life Test and Post-Life Test Infrared Comparison Images of the Three Life Test Failures

- a) Size 0805, 5.1k Ω , S/N12, Type C,
- b) Size 1206, 20k Ω , S/N 28, Type A,
- c) Size 2010, 50k Ω , S/N 48, Type B

The pre-life test and post-life test infrared images for each of the three life test failures are shown in Fig. 12. These comparison images show that each of these three resistors had ‘significant’ hot spots identified prior to life test and by the conclusion of life test either 1 or 2 bridge defects per resistor had lost electrical conductivity as evidenced by the disappearance of the hot spots in the post-life test infrared images.

Since S/N 12 (0805 - 5.1k Ω) exhibited two distinct and large positive resistance shifts (see Table 5), it is a good example to discuss the correlation between the resistance shifts and the infrared signature changes during life test. Fig. 12a shows that prior to life test S/N 12 contained 4 distinct hot spots each consisting of a bridge defect between adjacent gridlines. After life test, only 2 of the original 4 hot spots remained indicating that the other 2 bridge defects had become electrically open (i.e., non-conducting) during life test. As described earlier, the disruption of a bridge defect results in a positive resistance shift due to the removal of the parallel resistance pathway created by the bridge.

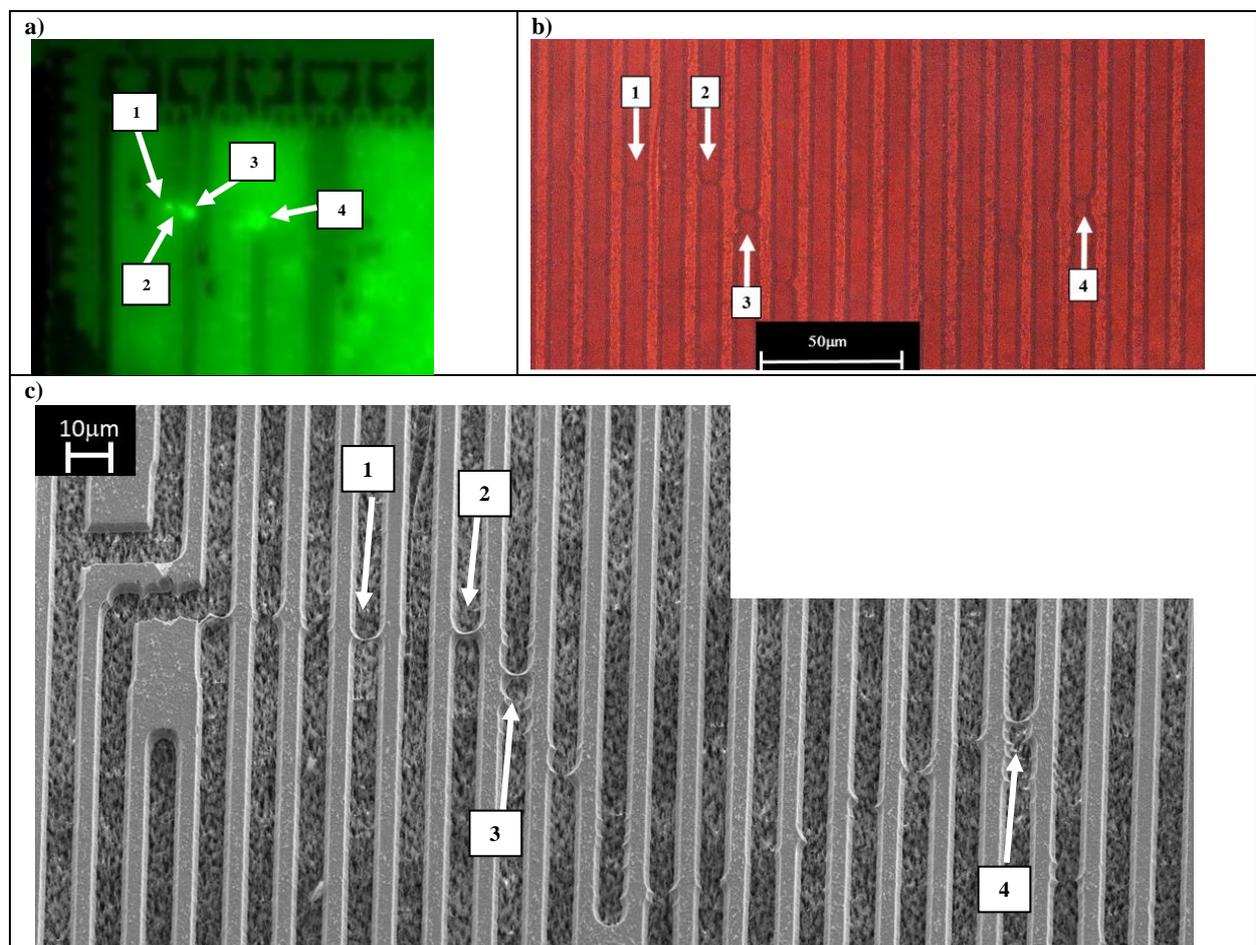
Fig 13. Failure Analysis Size 0805, 5.1k Ω , S/N 12

- a) Infrared Image Showing 4 Hot Spots Associated with Bridge Defects
- b) Transmitted Light Microscopy Montage Image Highlighting Bridge Defects in a),
- c) SEM Image of Region Shown in b)

The results of these inspections are shown in Figs. 13 and 14. Fig. 13a shows the pre-life test infrared image of a resistor that had 4 significant hot spots each associated with a bridge defect. Fig. 13b is an optical microscopy image of the same resistor after removal of the opaque epoxy coating. Optical inspection through the translucent polymer coating that protects the resistor element shows certain aspects of these 4 bridge defects. However, especially at higher magnifications, factors such as focal range and optical reflections from the complicated shapes of the constrictions make it exceedingly difficult to quantify the dimensions of such defects. Fig. 13c shows a SEM view of the same region from Fig. 13b after complete removal of the polymer coating. The SEM, with its superior focal depth and magnification capabilities, reveals enhanced details of constriction defects not possible with optical microscopy.

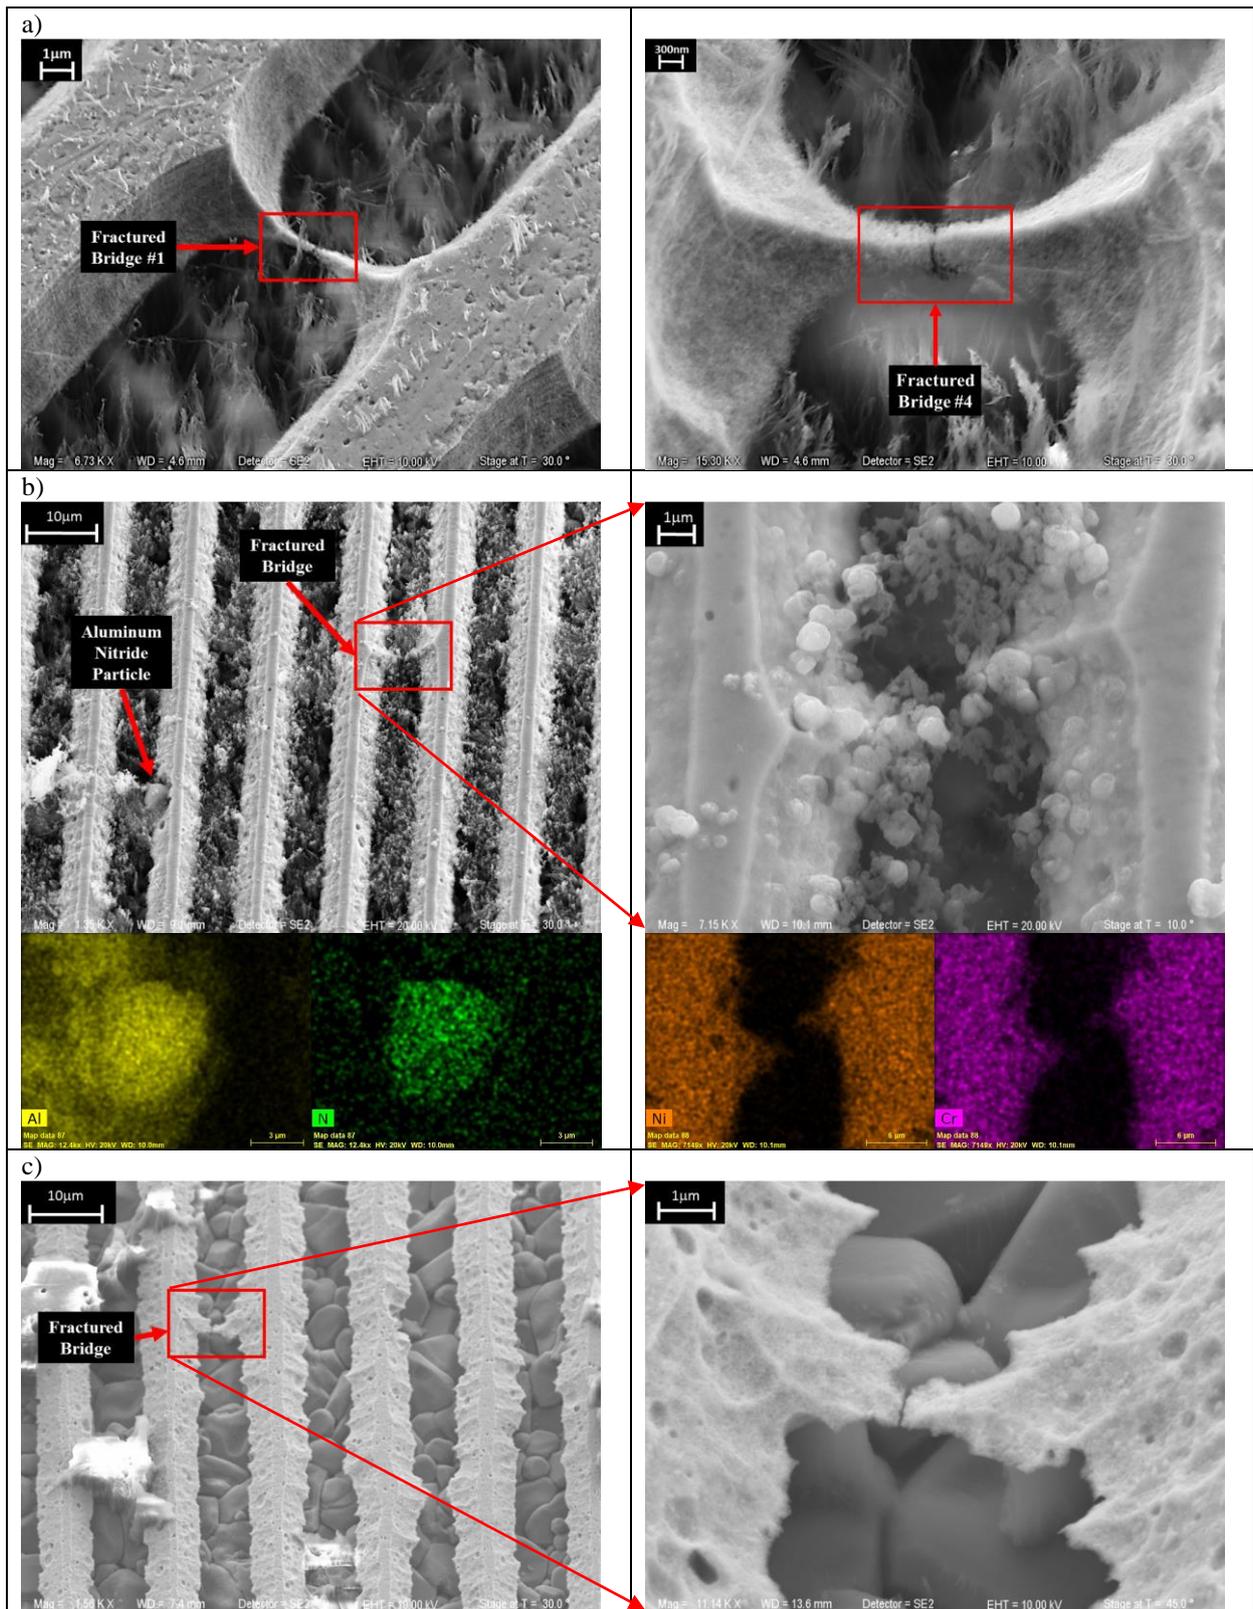
Fig. 14 – SEM and EDS Images of Once-Conducting Bridge Defects that Fractured During Life Test

- a) Size 0805, 5.1kΩ, S/N12, Type C, Showing the Fractured Bridges Labeled “1” and “4” in Fig. 13,
- b) Size 1206, 20kΩ, S/N 28, Type A Fractured Bridge and EDS of an Embedded Aluminum Nitride Particle
- c) Size 2010, 50kΩ, S/N 48, Type B, Fractured Bridge Defect

Fig. 14 shows that the failure sites for all 3 life test failures were identified and confirmed to be fractured bridge defects consistent with the locations of the pre-life test hot spots that had disappeared at discrete time intervals during life test. Each of these previously-conducting bridge defects fractured at the approximate mid-point in their span producing an open circuit condition in the bridge. The fractured bridges resulted in the removal of parallel resistance pathways in each resistor pattern thus producing the observed positive resistance shift failure modes. Detailed inspection of the fractured bridges shows no evidence of melting nor tensile stretch-to-break failure. Instead, the fractures are all consistent with cyclical fatigue fracture. The source of cycling was thermomechanically-induced by the on/off power cycling that resulted in hot spot expansion and contraction during the life test.

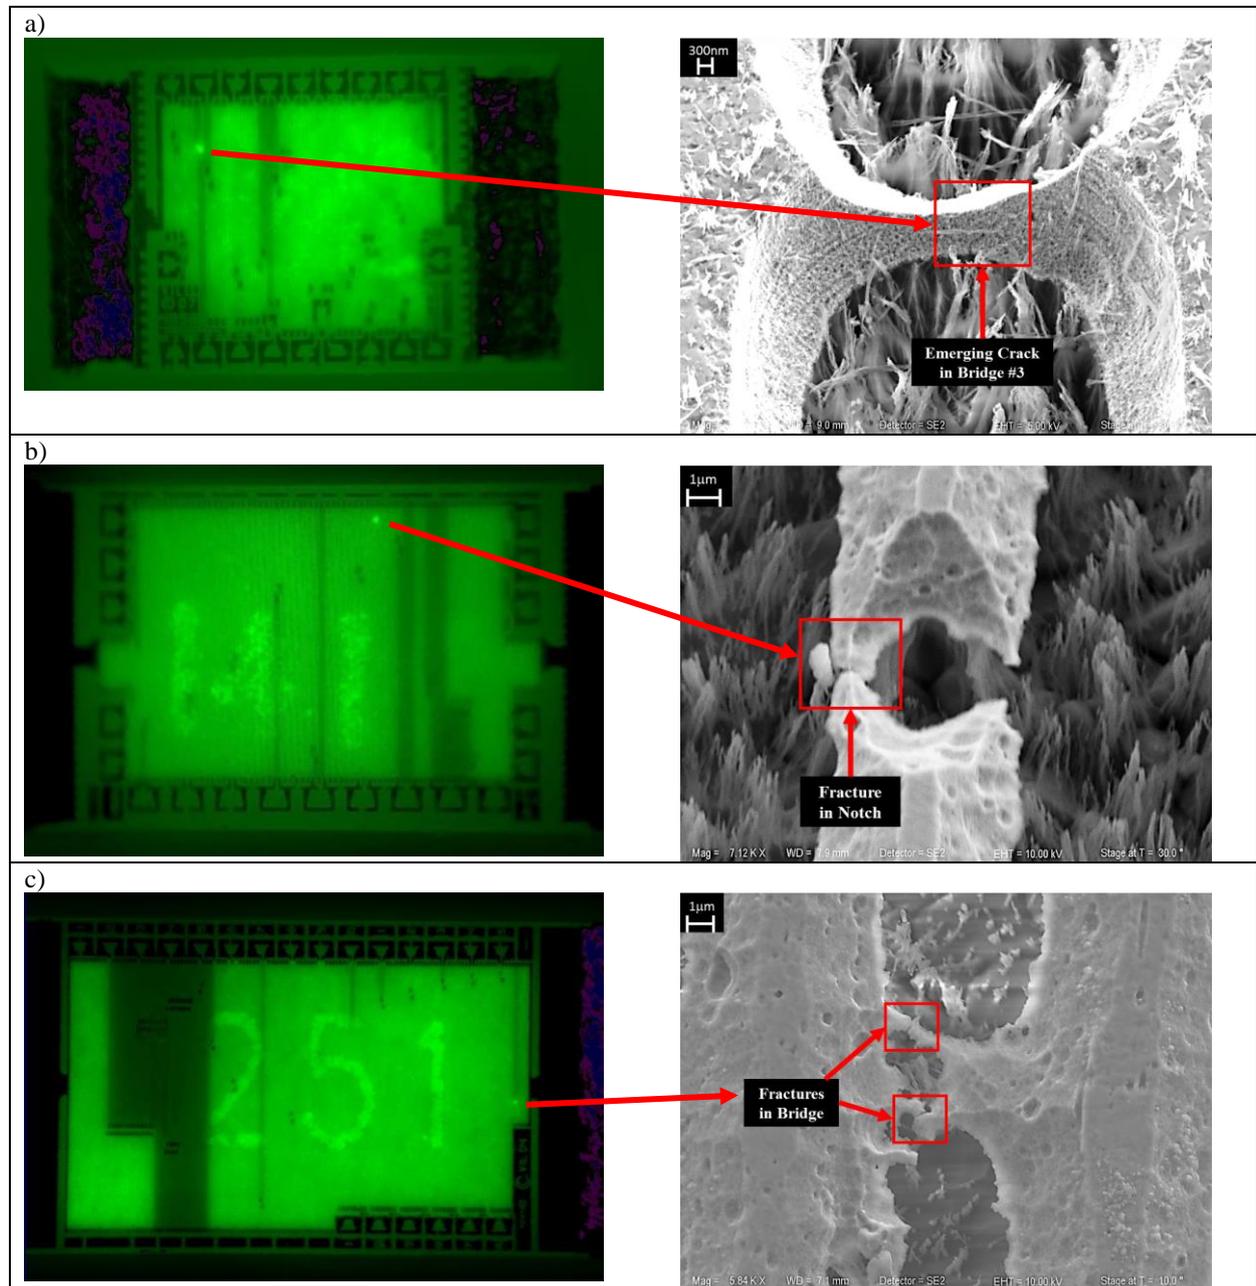
Fig. 15. Infrared and Corresponding SEM Images of Constriction Defects that Remained Intact Through Life Test
a) Size 0805, 5.1kΩ, S/N12, Type C, Bridge Defect (see Fig. 13 bridge #3) with Emerging Fracture
b) Size 1206, 20kΩ, S/N 25, Type A, Notch Defect with Near-Complete Fracture
c) Size 2010, 50kΩ, S/N 33, Type B, Bridge Defect with Two Near-Complete Fractures

Three resistors with significant hot spots that persisted after life test were also deprocessed as described above to enable detailed SEM inspection (see fig. 15). High magnification SEM inspection of these three resistors showed evidence of emerging (fig. 15a) and/or near-complete fracture of the constrictions associated with these hot spots. In particular figs. 15b and 15c show evidence of near-complete fracture of the constriction. It is possible resistors in this condition will exhibit intermittent resistance changes caused by small displacements of the fractured ends that make and break pressure contact between the ends of the constriction. Such displacements may be produced by changes in ambient temperature leading to expansion and contraction of the resistor materials. Intermittent behavior like this would be very difficult to detect during life test since continuous resistance monitoring is not used.
