# Feedback From 10 years of Failure Analysis on connectors – all electronic sectors

# SUMMARY

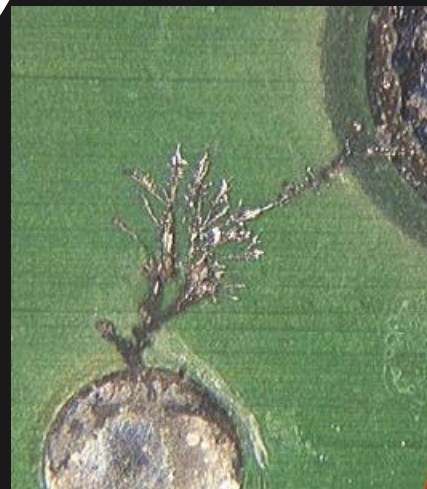
Movement of metal ions between metallic conductors to form dendrites → Leading to current leak, insulation breakdown

Few water is needed (condensation, relative humidity).

- Observed on copper, gold, tin, nickel, lead, palladium, solder.
- Not with metals that form protective oxide films (chromium, aluminum or tungsten)

Change the conductivity of the water and attract water on to the insulating surface between the conductors (flux).

Low potential difference needed depending the distance between the conductors.

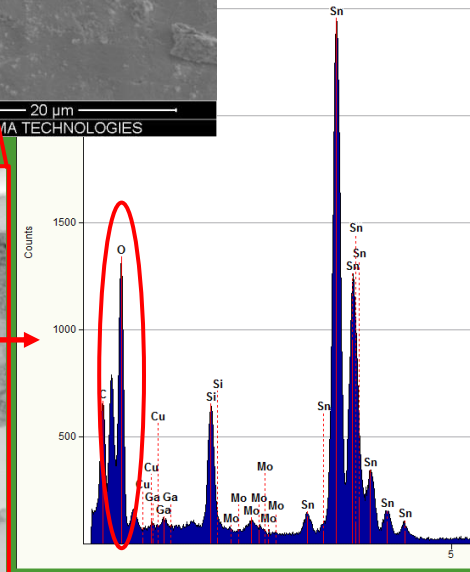
Fretting wear is generated by small-amplitude movement (few  $\mu\text{m}$  -  $100\mu\text{m}$ ) leading to the formation of small debris particles

- Wear : **no detection of oxygen** element
- Fretting corrosion: **clear presence of oxygen**

► **Failure mechanism:** degradation of mating layer, increase the electrical contact resistance, hot spot, thermal runaway → intermittent or contact loss.

► **Main causes:** Process/environment  
Vibrations and/or changing temperature due to differences in thermal expansion coefficients of the mating materials.

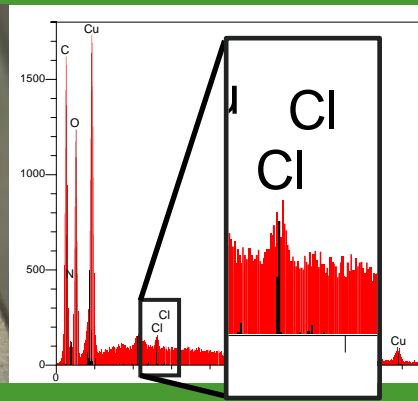
Pollution make a direct insulating layer leading to an increase of the contact resistance.

Pollution could mainly come from assembly process, or with external environment

In presence of  $\text{Cl}_2$ ,  $\text{H}_2\text{S}$ ,  $\text{NO}_2$  and  $\text{SO}_2$  complex compound can appears

For example NaCl salts at the interface of contacts is conductive in water and insulating in its crystalline form.

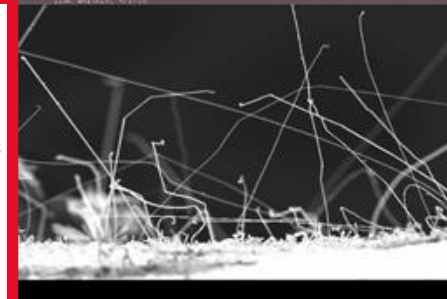
Whiskers grow across circuit connection up to  $> 200\mu\text{m}$  leading to sudden failure and intermittent short circuit.

Main energy for growth may comes from microstrains or from externally applied pressure.

→ Tin alloy with a minimum of 3% of Lead

→ « reflow »: tin heated to a  $T^{\circ}\text{C}$  above tin melting point
