# PLATINUM SENSORS EMBEDDED IN ESCC-4006/014 MODIFIED CONSTRUCTION:

## A TURBULENT TALE ABOUT THE COEXISTENCE OF DISSIMILAR MATERIALS

B. CAMPILLO IGLESIAS (OHB), M. BRODA (OHB), P. BRUNO (OHB), P. JANÍK (ESA), J. JIMÉNEZ CARREIRA (ESA), S. MASSETTI (ESA), G. MILASSIN (ESA), P. MORAN (TE), K. WASTIAN (OHB)

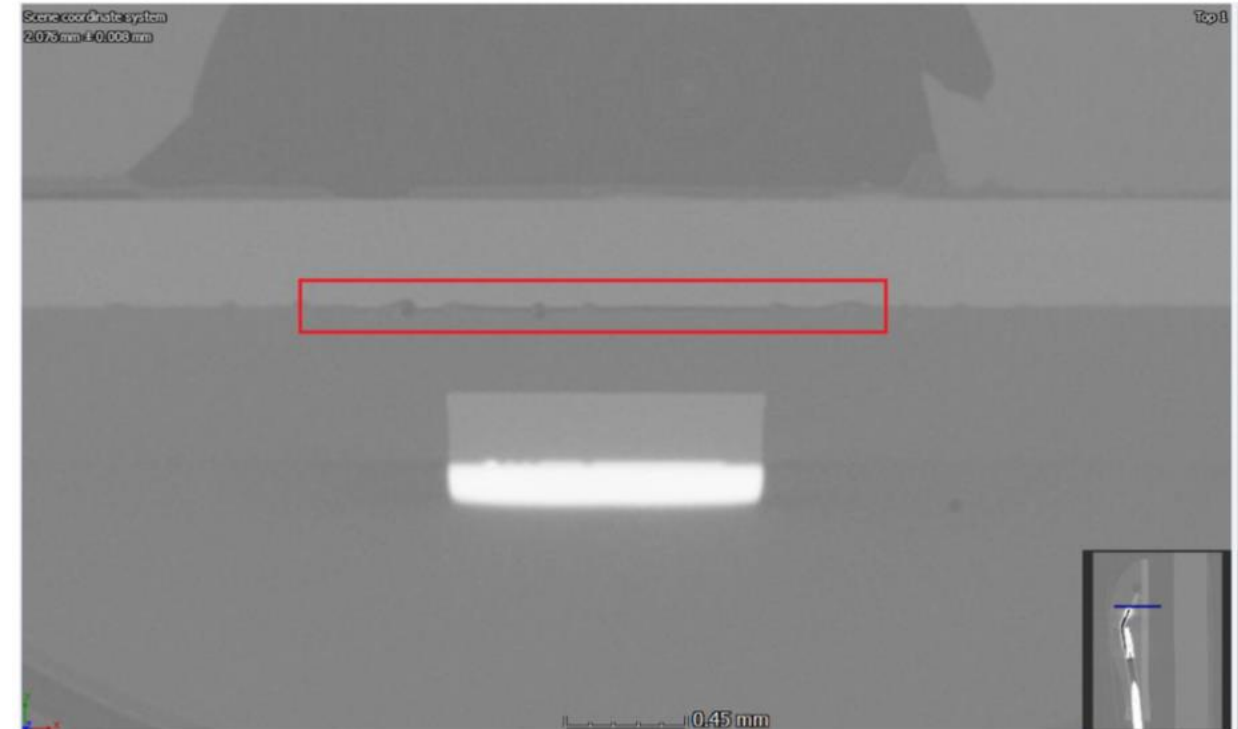
- Sensors not affected by external delaminations, presented internal delaminations and a swarm of bubbles associated with the central area of the baseplates, made rougher by punching to increase the contact area. These features degrade the effective adhesion strength.

- The centre rougher area was removed from the baseplates, as correlated with internal delaminations and voids.
- Prior to the epoxy application, the baseplates were prepared following the best process based on the Socomore products and the primer. A “water droplet” test was introduced on two samples in order to check the suitable surface energy of the baseplates.

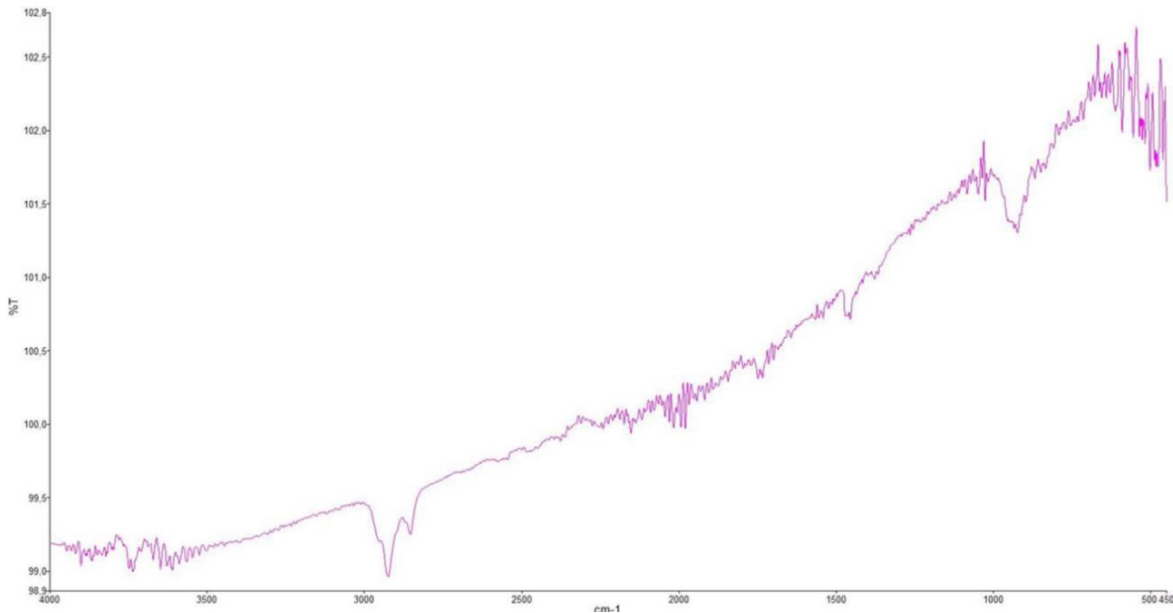
- ATR-FTIR spectroscopy on the baseplates, both as received and as cleaned, shows an absorption peak near  $3000\text{cm}^{-1}$ , associated with absorption frequencies of C-H bonds. Hence, organic contamination was present.
- Water droplet test results show contact angles near  $90^\circ$ , with indicated a far from optimal wettability of the bonding surface, hence low surface energy/bonding affinity.

- As per these results, the likely ultimate root cause of the poor adhesion strength was an insufficient surface preparation of the baseplates before the application of the epoxy. In order to validate this hypothesis, three main changes were proposed for the surface preparation:
  - Improving the cleaning of the bonding surface, using solutions of non-polar solvents (hexane and Isopropyl alcohol), polar solvents (acetone) and proprietary alkaline cleaner Sococlean type, from Socomore. To enhance the cleaning actions, usage of elevated temperature and US (Ultra-Sonic) energy.
  - De-oxidizing the bonding surface, through mechanical abrasion, fine grit abrasives, and chemical etching, using REACH compatible proprietary acidic etchant Socosurf type, from Socomore.
  - Using primer EC-3901 to enhance the adhesion strength and its robustness against the environmental aging.
