New generation of wafer-scalable, hermetically sealed chip fuse for space

4th Space Passive Component Days (SPCD), International Symposium, 11-14 October 2022

Bruno Zemp, Advanced Engineering, SCHURTER AG

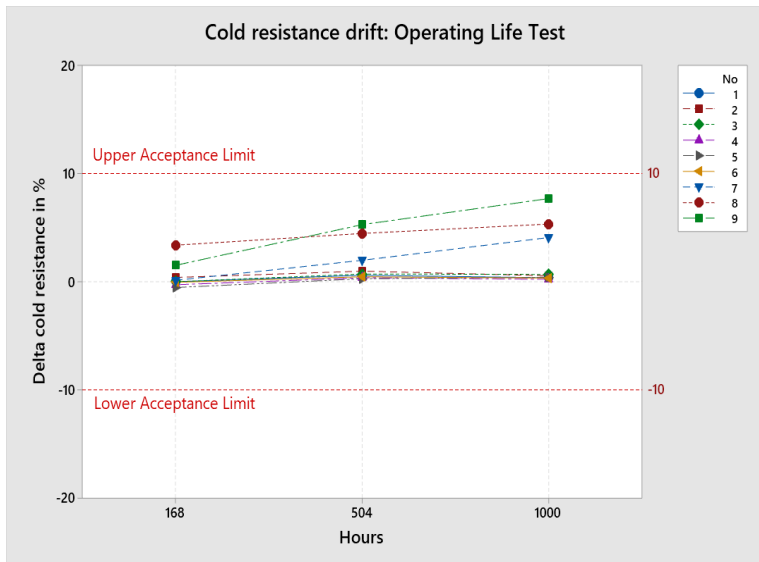
- > Sample size: 9
- > Samples are powered with 90% of IR
- > 125 °C for 2'000 h

Intermediate RESULTS:
