A Screening Method Using Pulsed-Power Combined with Infrared Imaging to Detect Pattern Defects in Bulk Metal Foil or Thin Film Resistors

Jay Brusse

ASRC AS&D at NASA Goddard Space Flight Center

NASA Goddard Space Flight Center

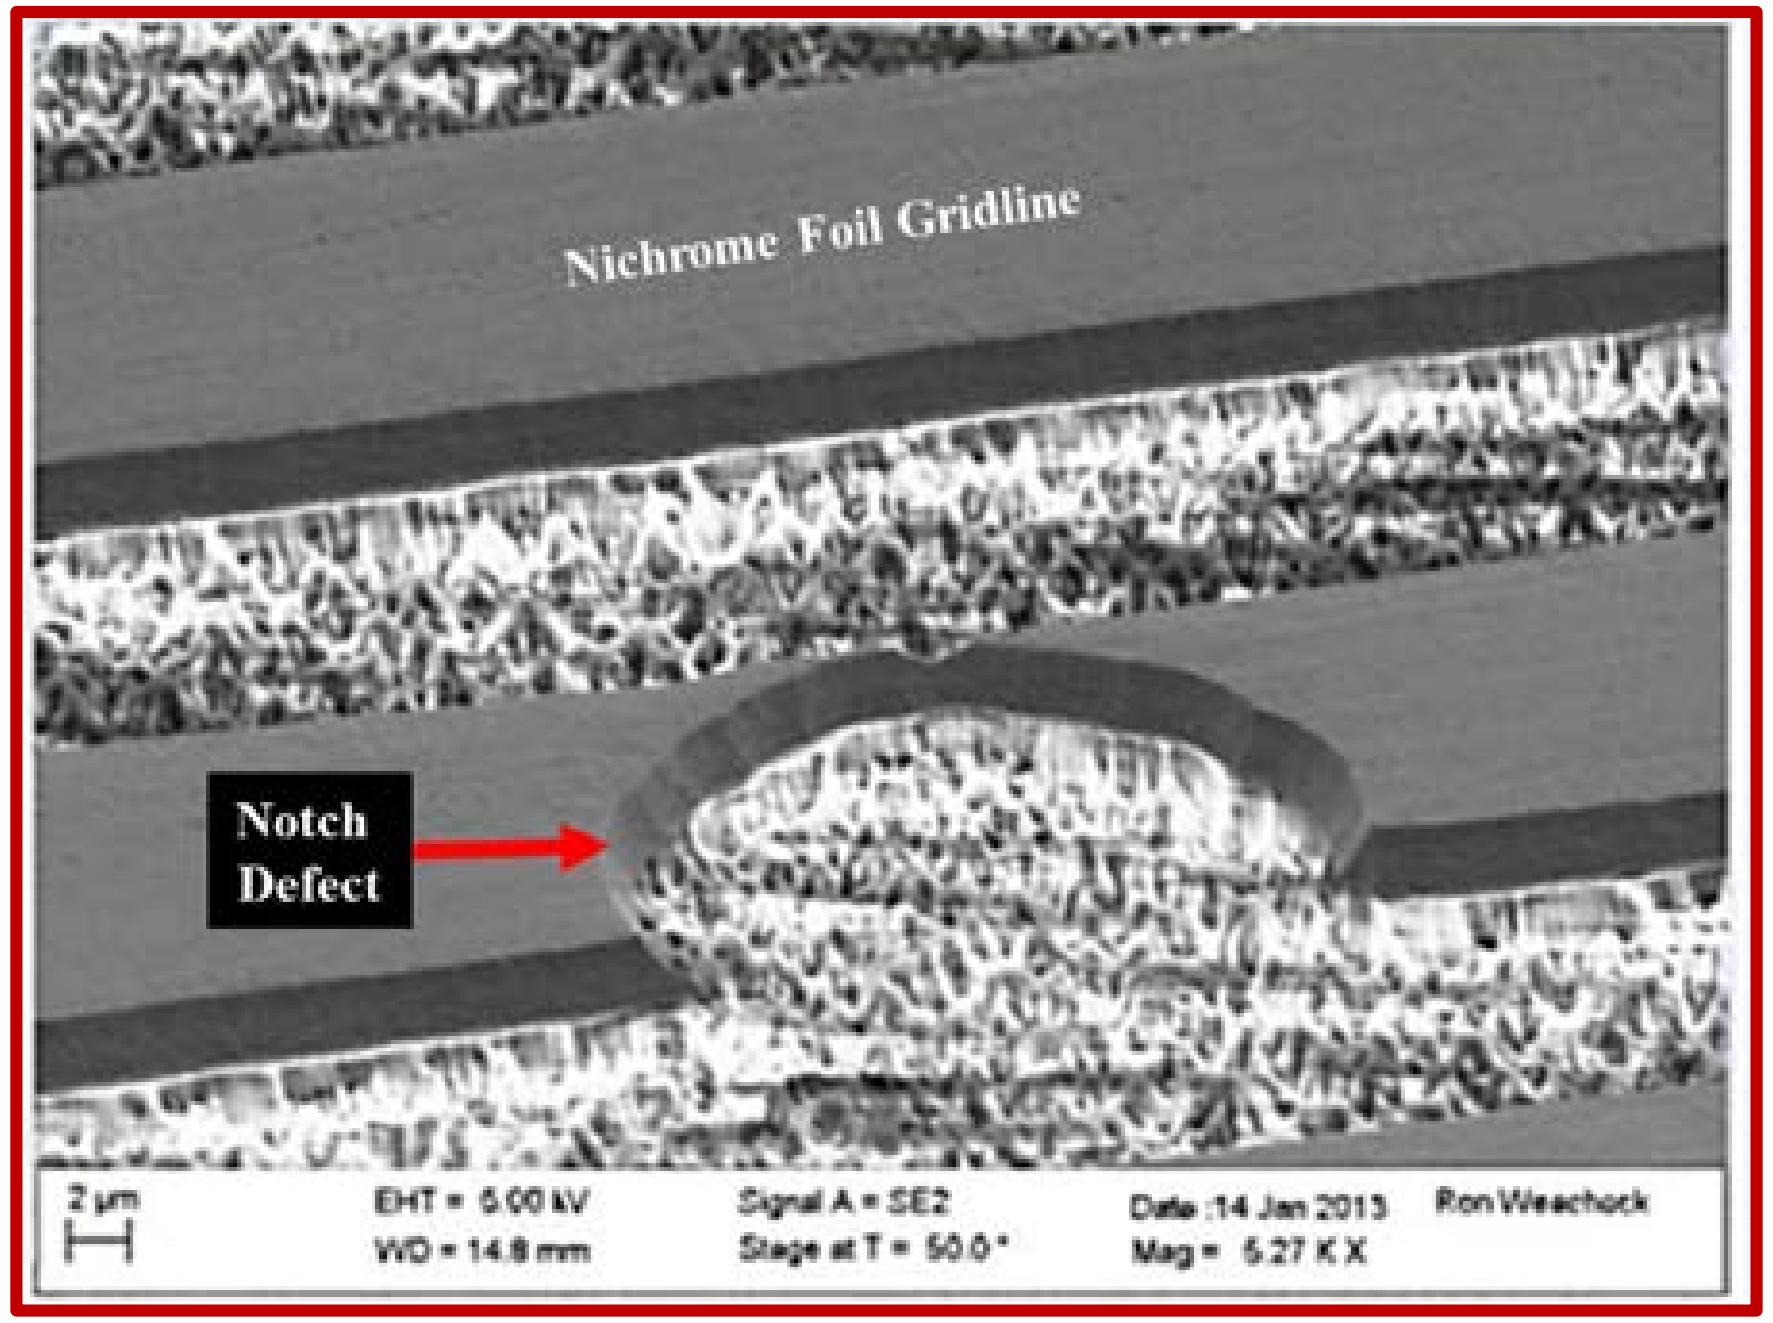
Notches

1. Constriction defects contribute directly to the final resistance value (e.g., bridges provide parallel resistor pathway).
2. Constriction defects are at risk of breaking due to thermomechanical fatigue fracture <u>especially during power cycling</u>
    1. Constrictions carry higher current density and develop localized 'hot spots' due to Joule heating
    2. Hot spots produce locally greater expansion of the NiCr foil
3. ***If a constriction defect fractures, then a positive resistance shift, including open circuit, will occur.***

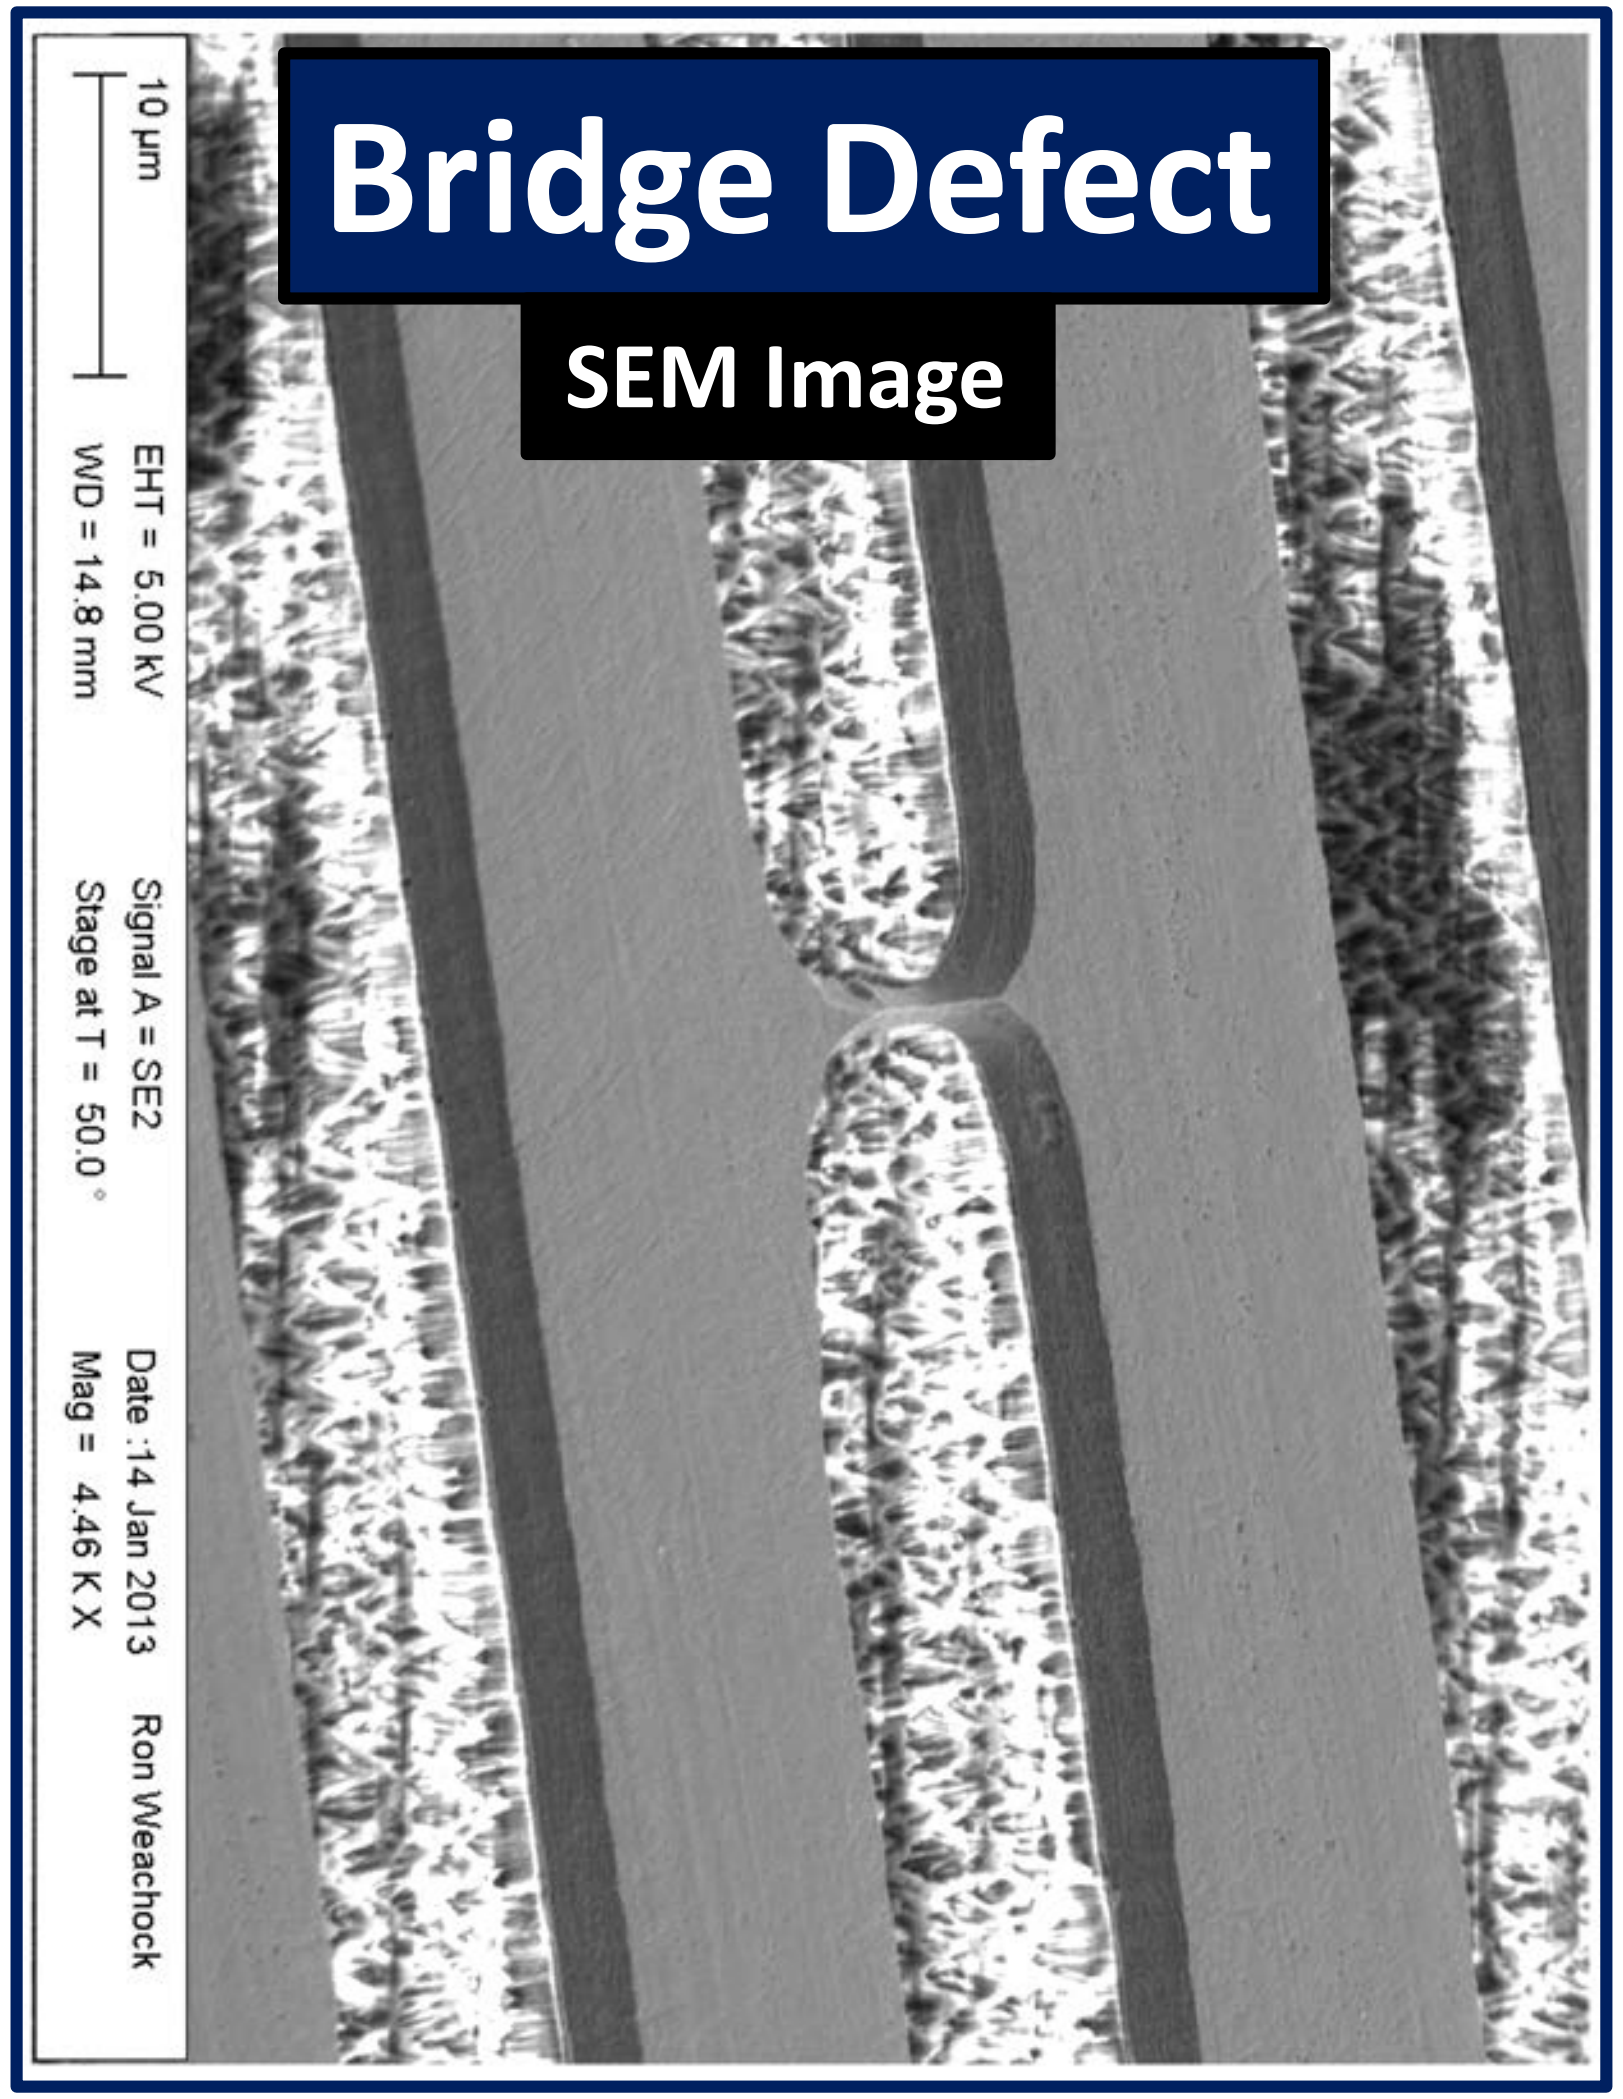
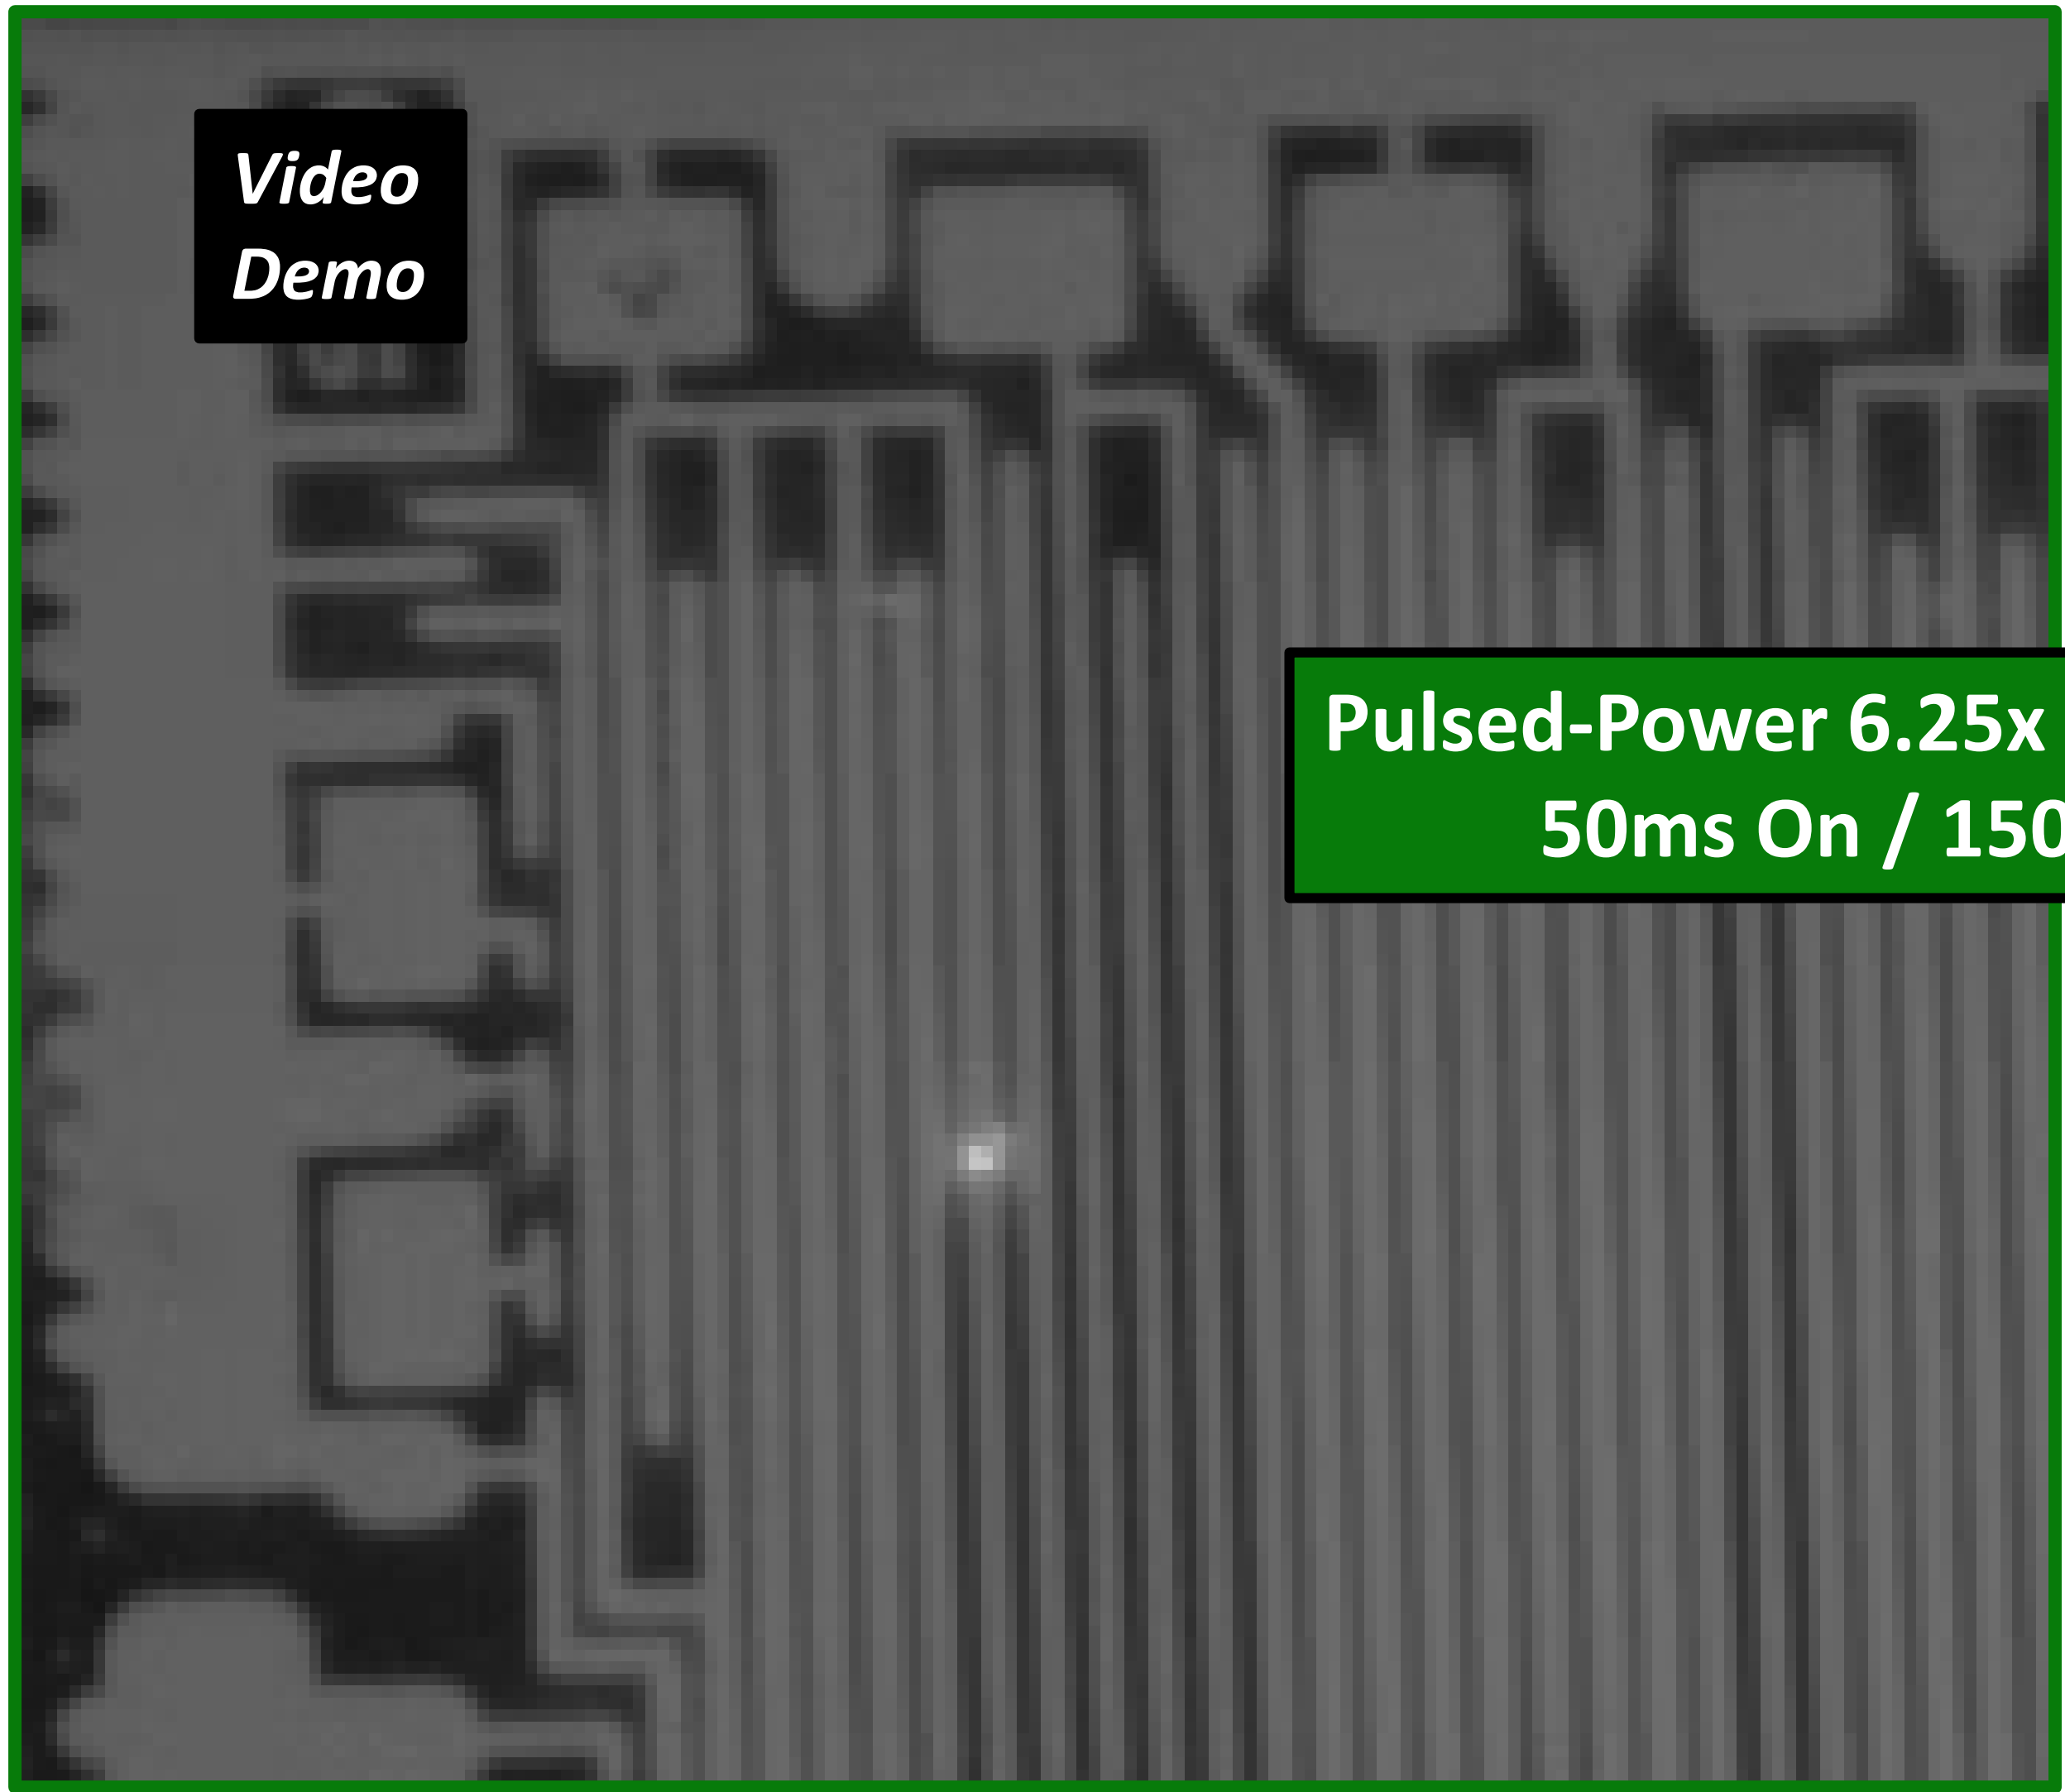
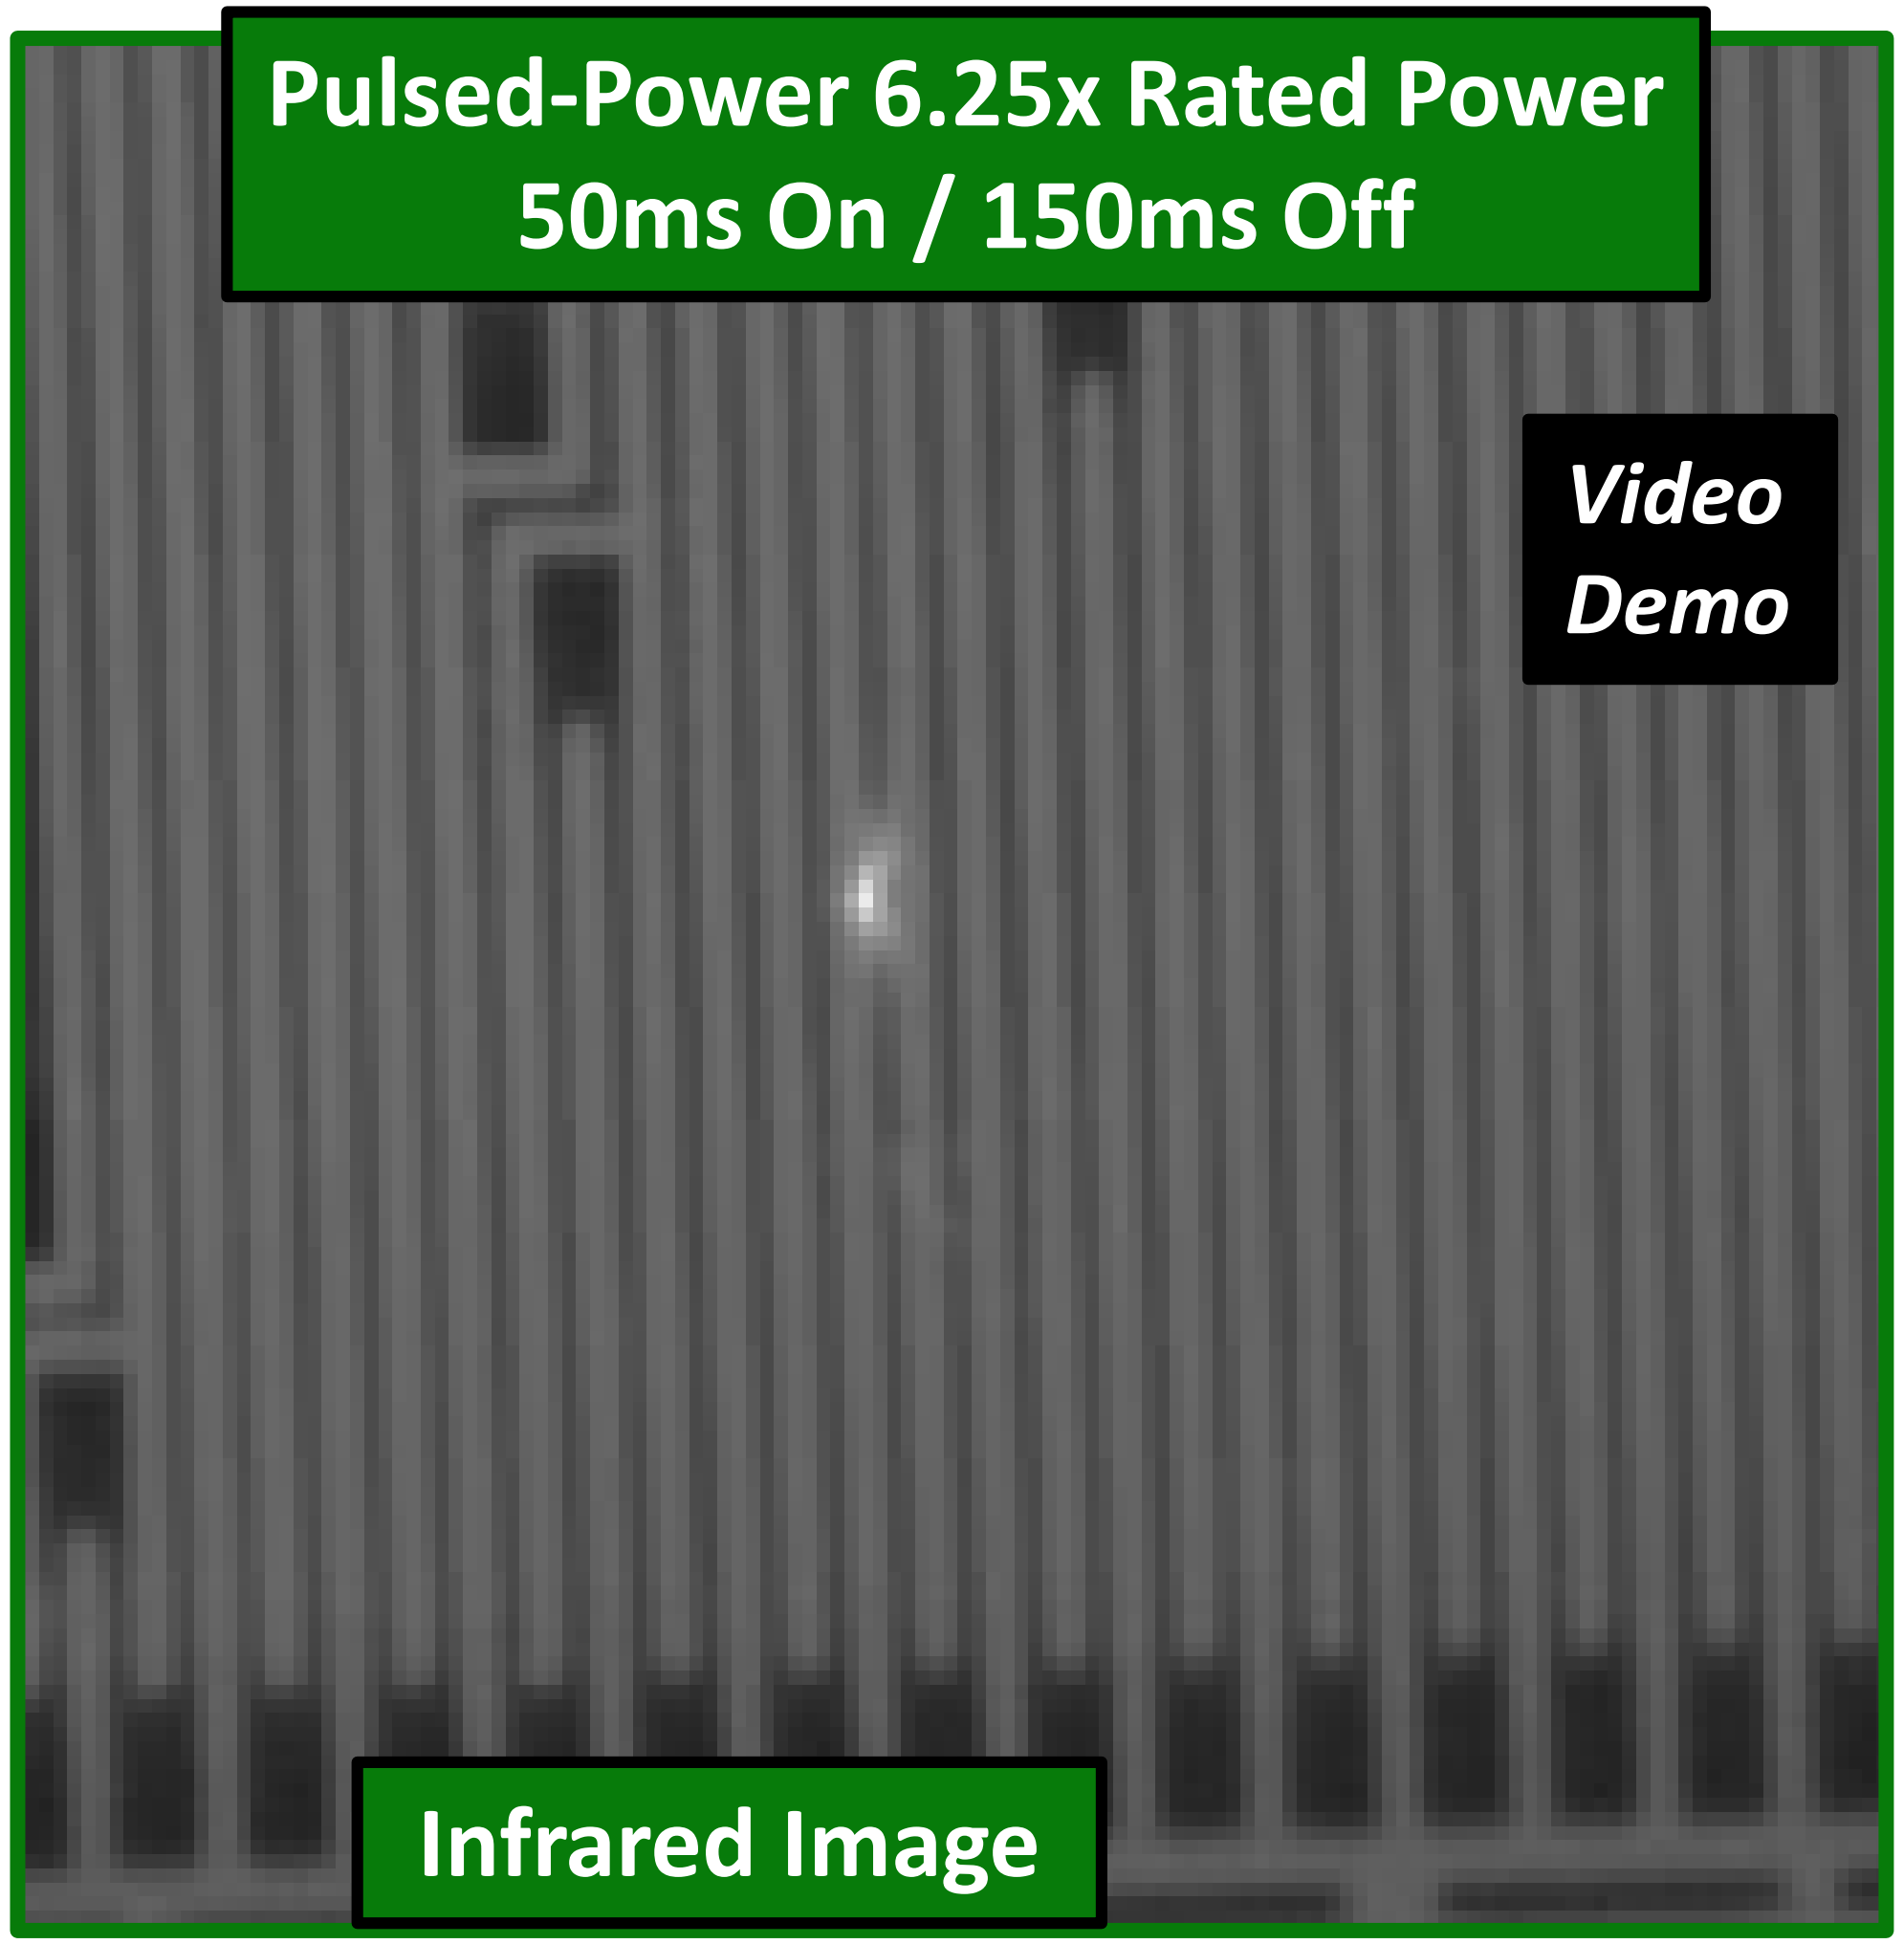
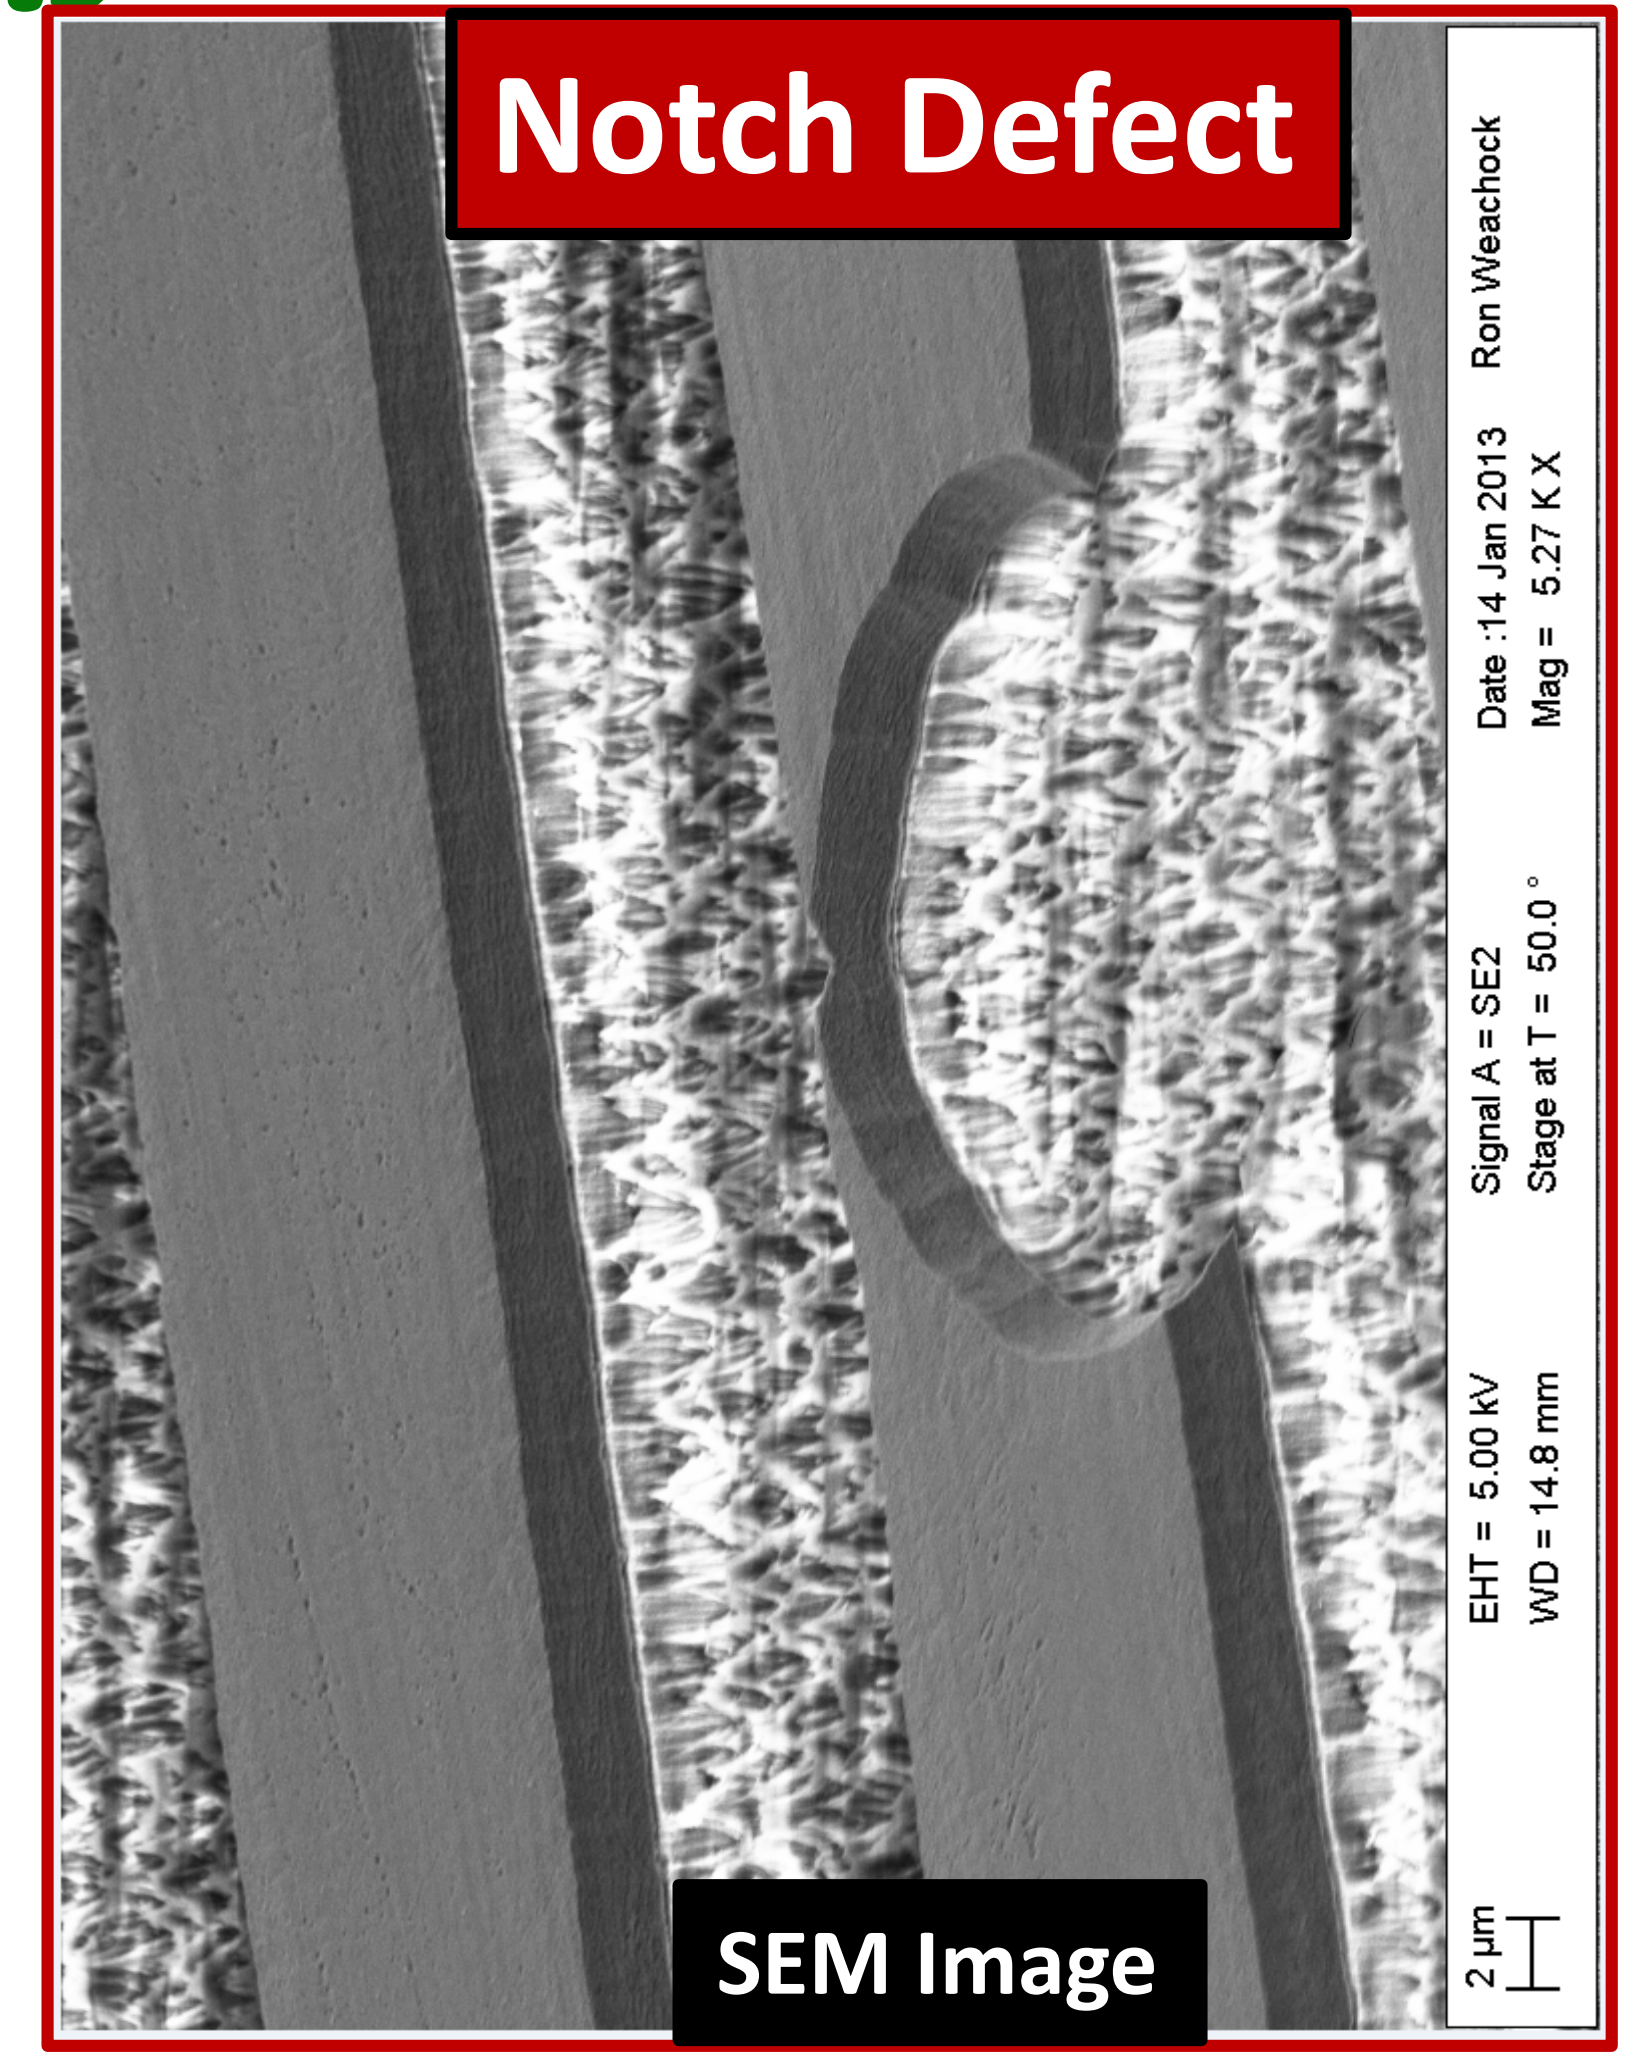
Demonstration of New Screening Method

Using DPA Sample with Bridge and Notch Defects

Pulsed-Power 6.25x Rated Power
50ms On / 150ms Off

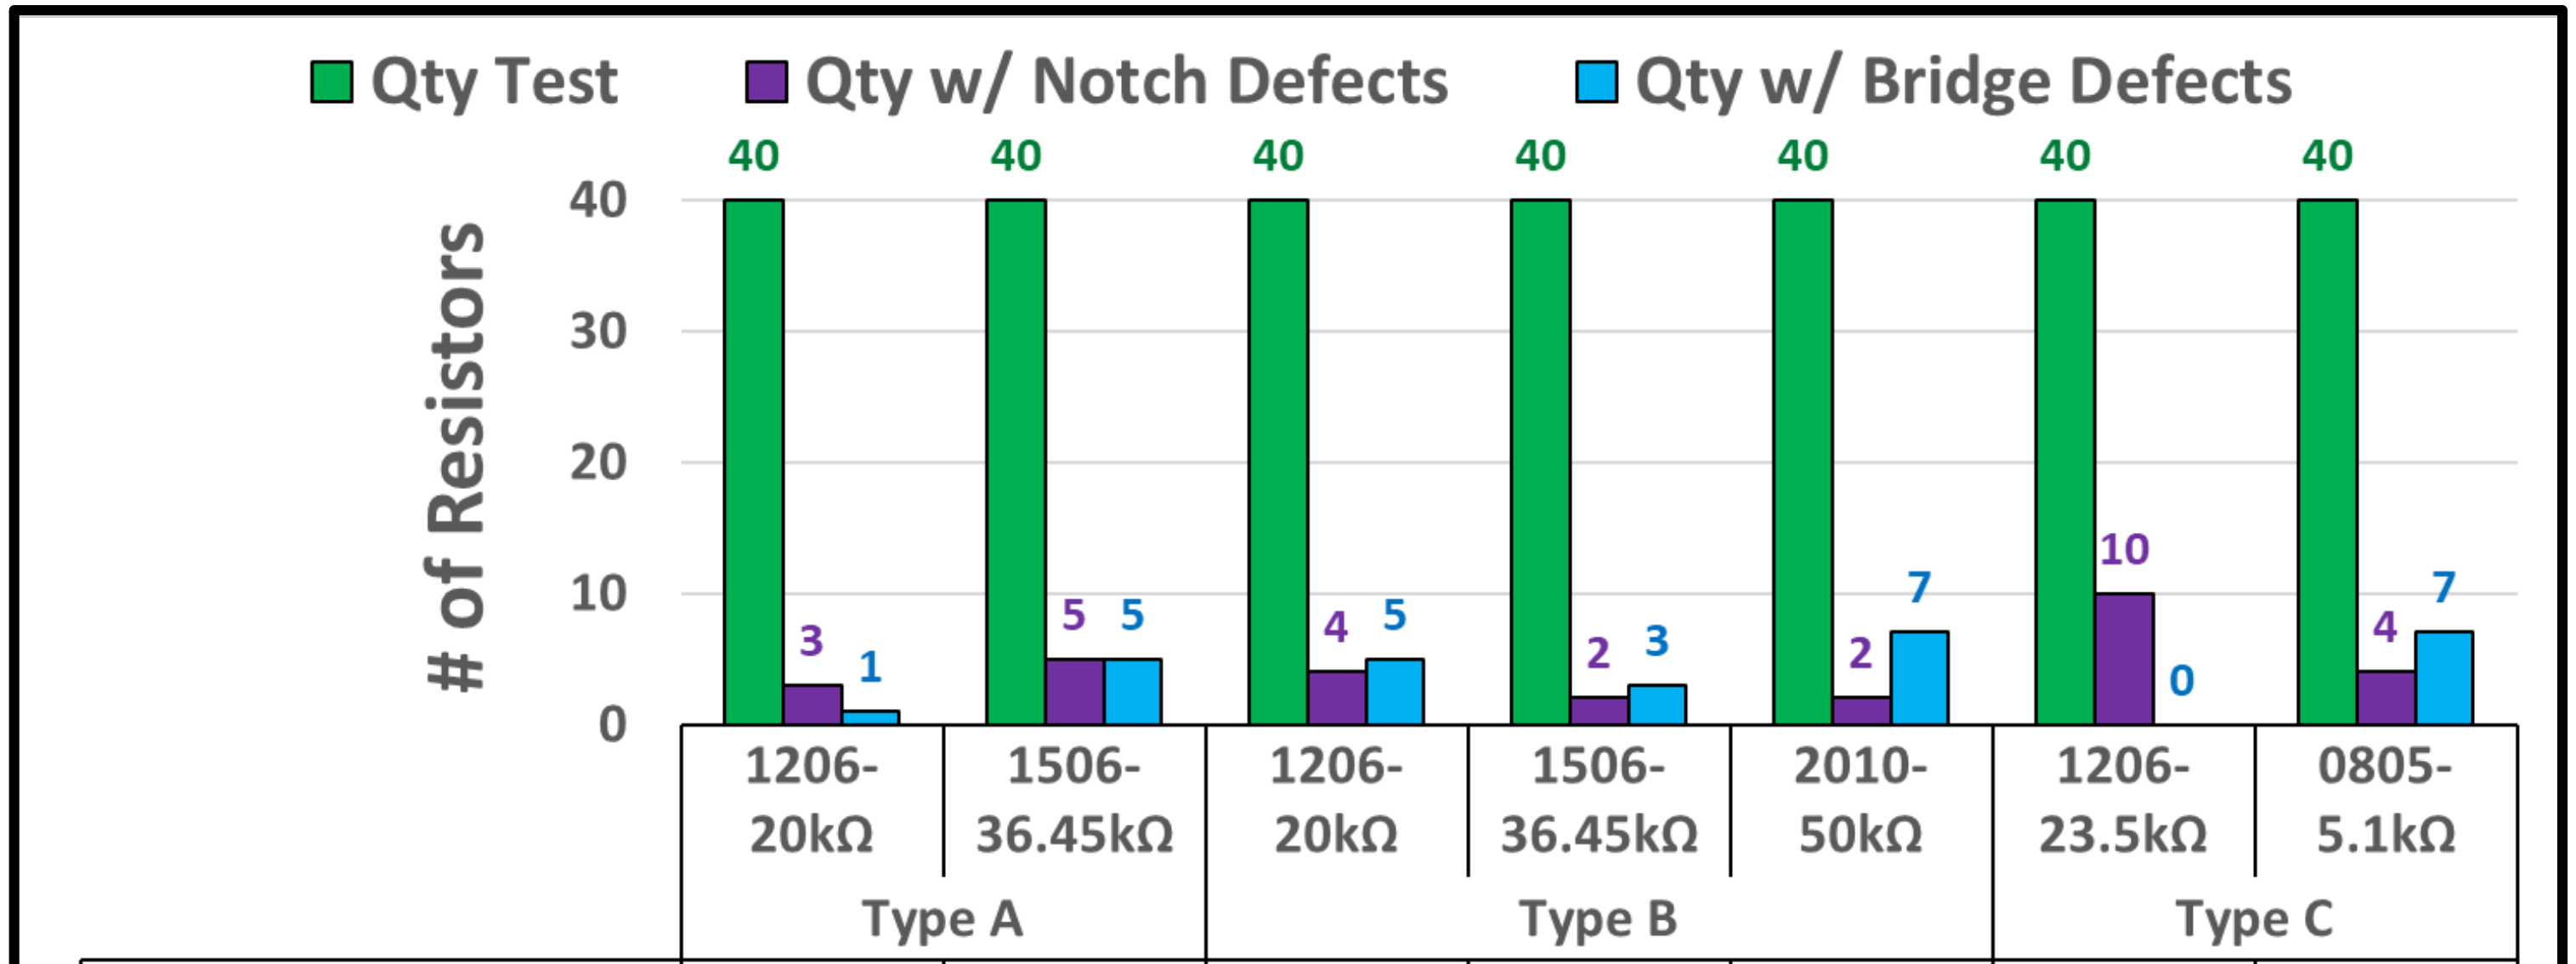
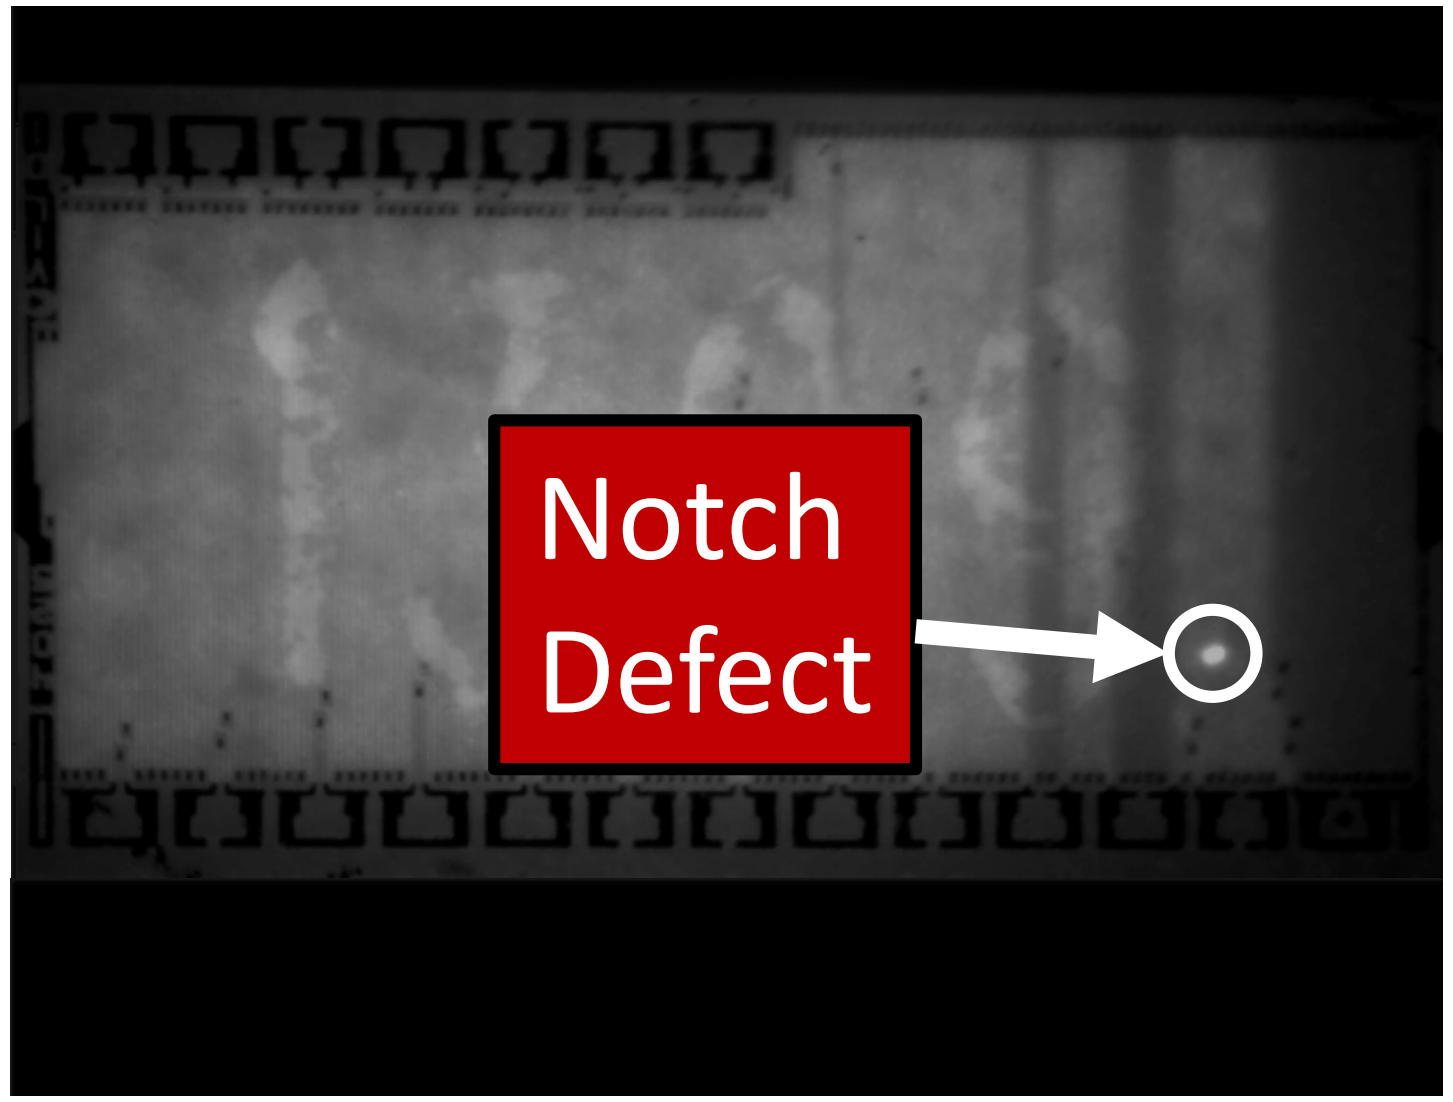
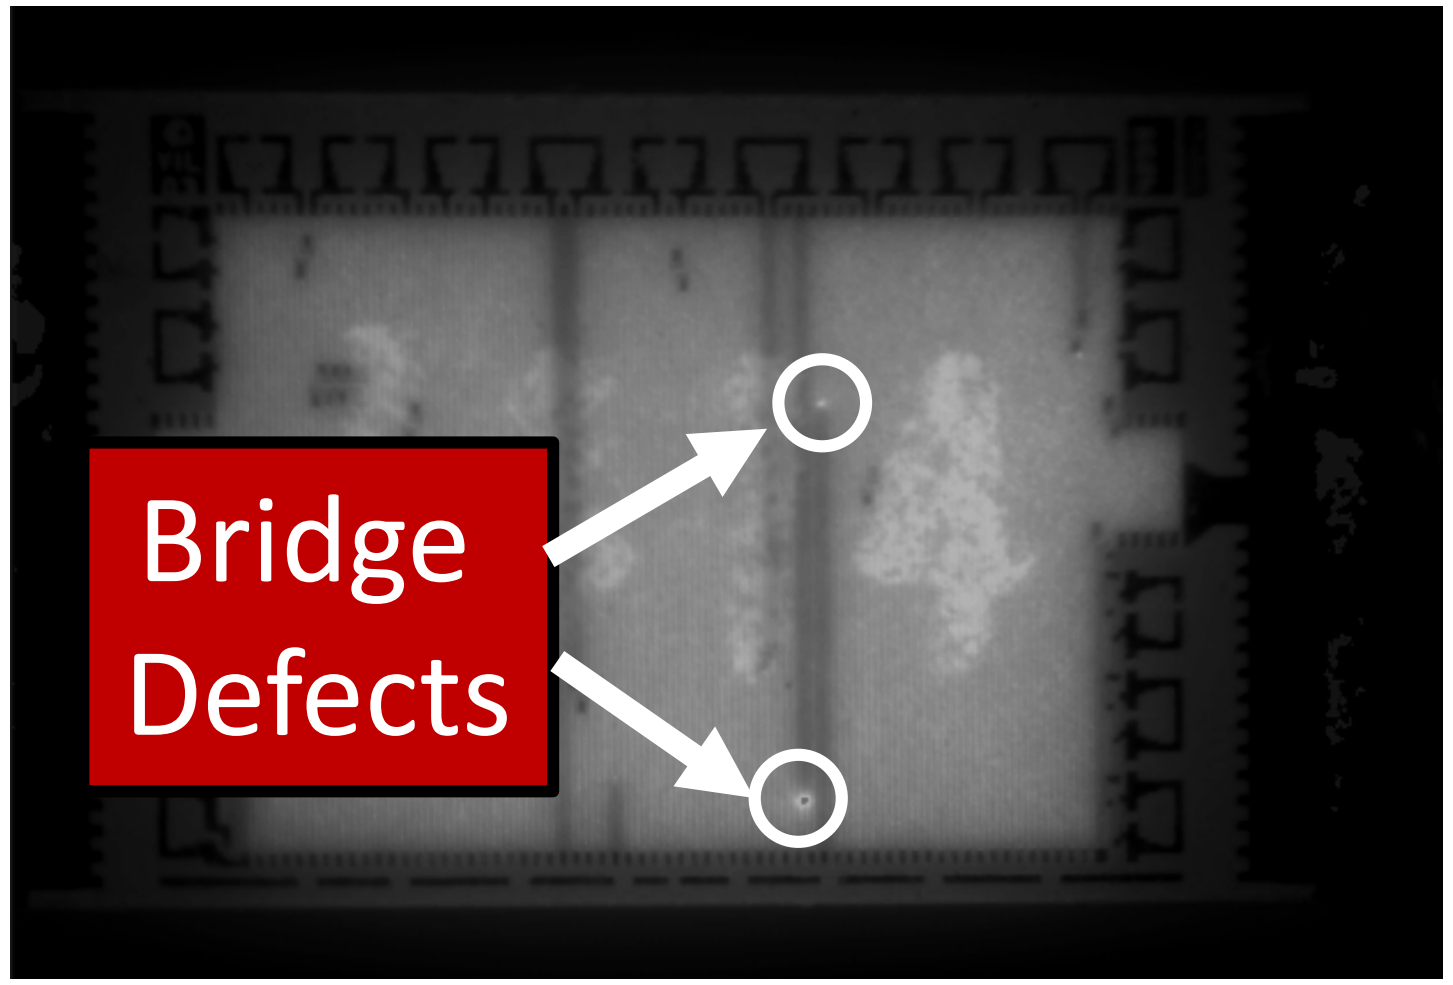
Results: Pre-Life Test Pulsed-Power Infrared Screening

~10% to 25% of Resistors Per Lot Tested Had Constriction Defects

Type A		Type B			Type C	
	1206-20kΩ	1506-36.45kΩ	1206-20kΩ	1506-36.45kΩ	2010-50kΩ	1206-23.5kΩ	0805-5.1kΩ
Qty Test	40	40	40	40	40	40	40
Qty w/ Notch Defects	3	5	4	2	2	10	4
Qty w/ Bridge Defects	1	5	5	3	7	0	7

Totals
280 Tested
30 with Notch Defects
28 with Bridge Defects
