A Screening Method Using Pulsed-Power Combined with Infrared Imaging to Detect Pattern Defects in Bulk Metal Foil or Thin Film Resistors

Jay Brusse

ASRC AS&D at NASA Goddard Space Flight Center

NASA Goddard Space Flight Center

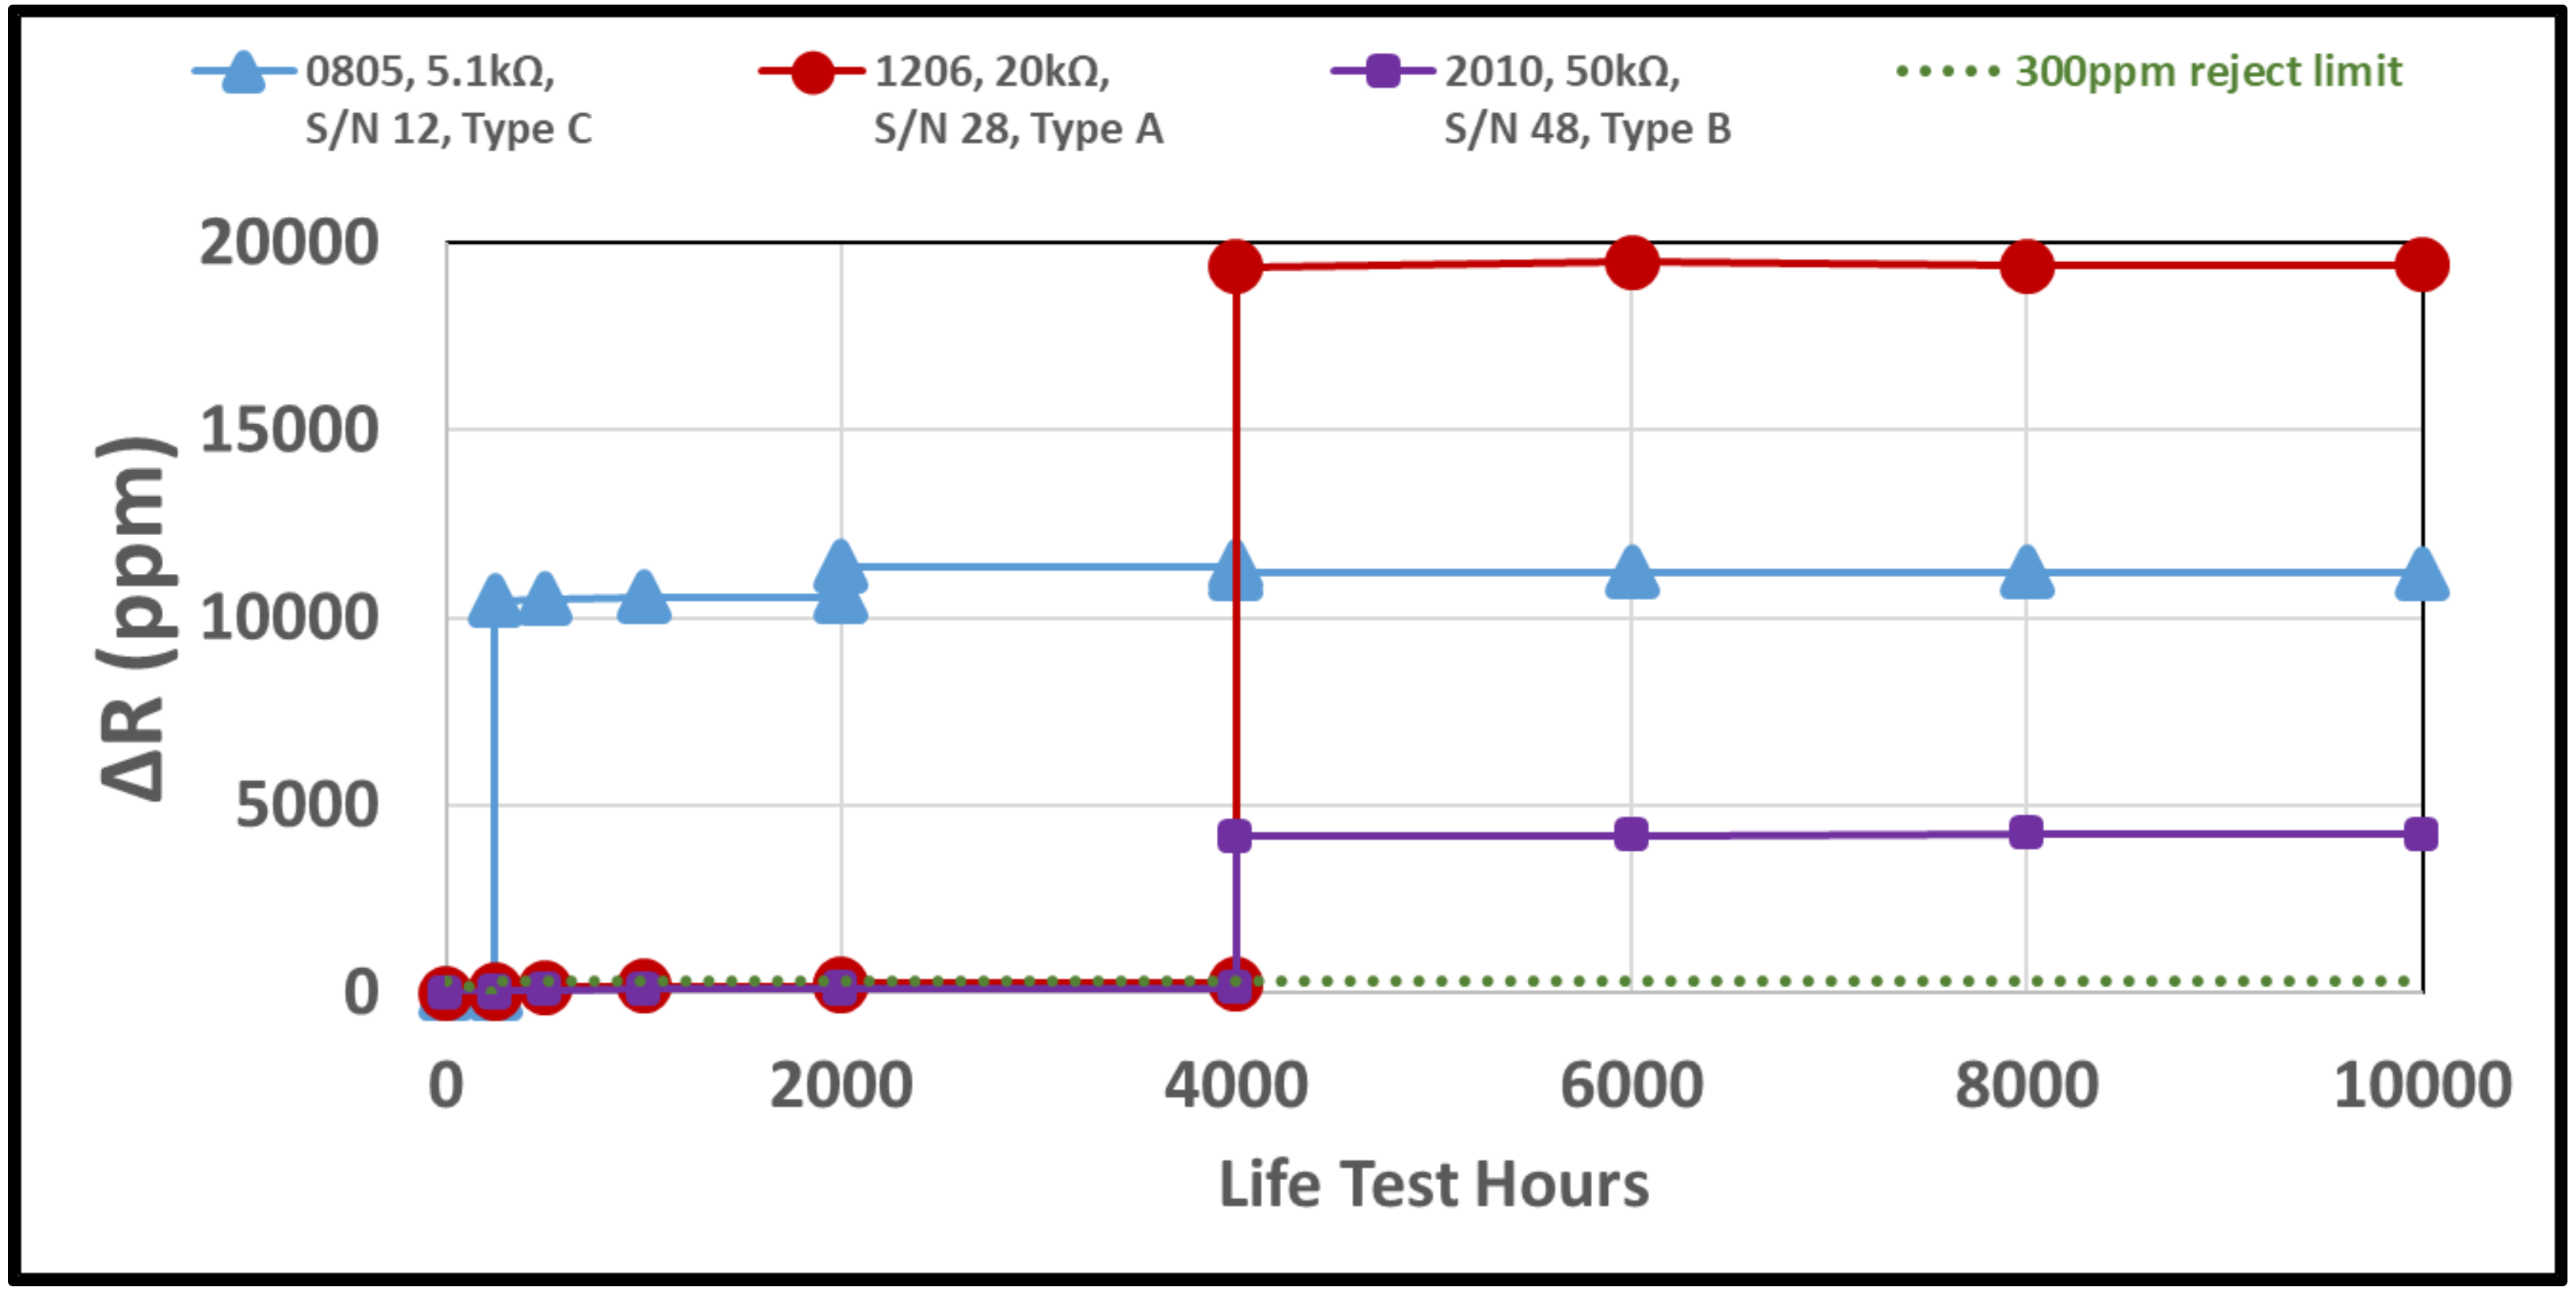
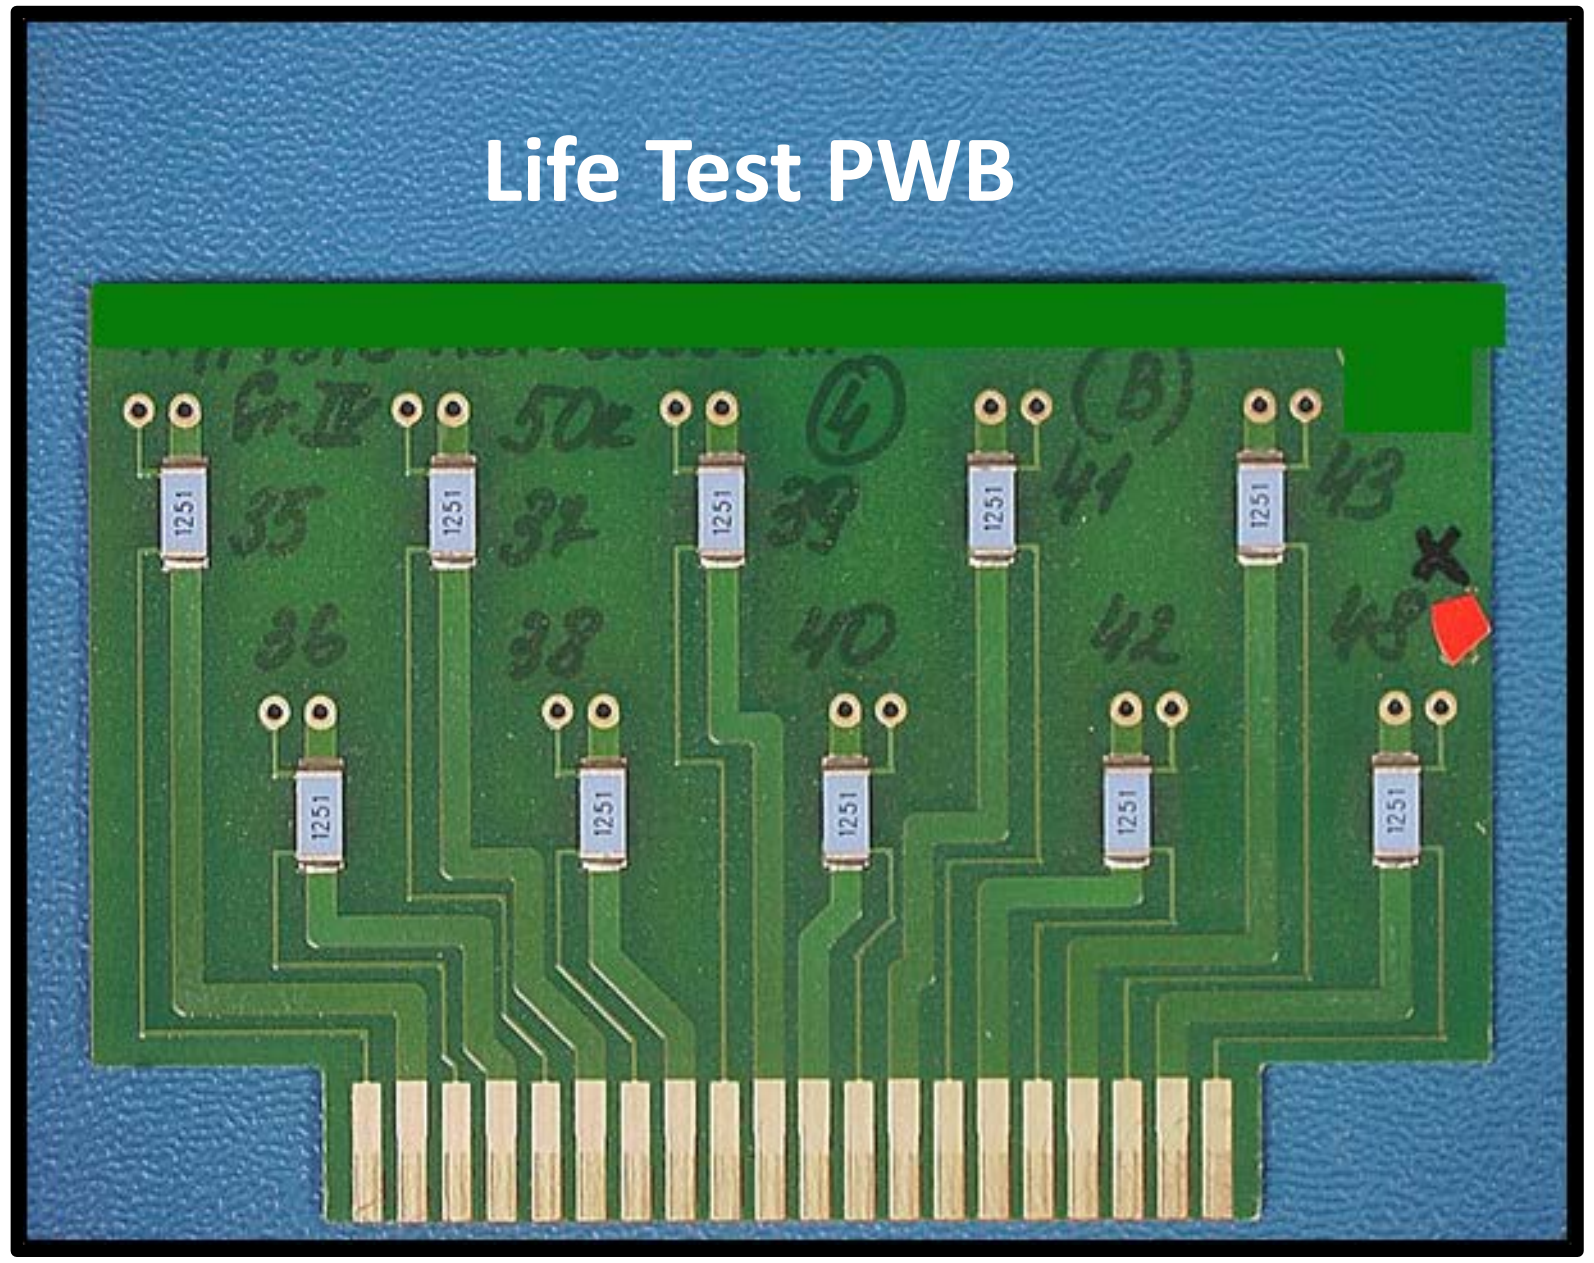
Results: 3 Life Test Failures (280 Resistors Tested)

Abrupt Positive Resistance Shift Failure Modes

** S/N 12 exhibits 2 distinct positive shifts during life test*

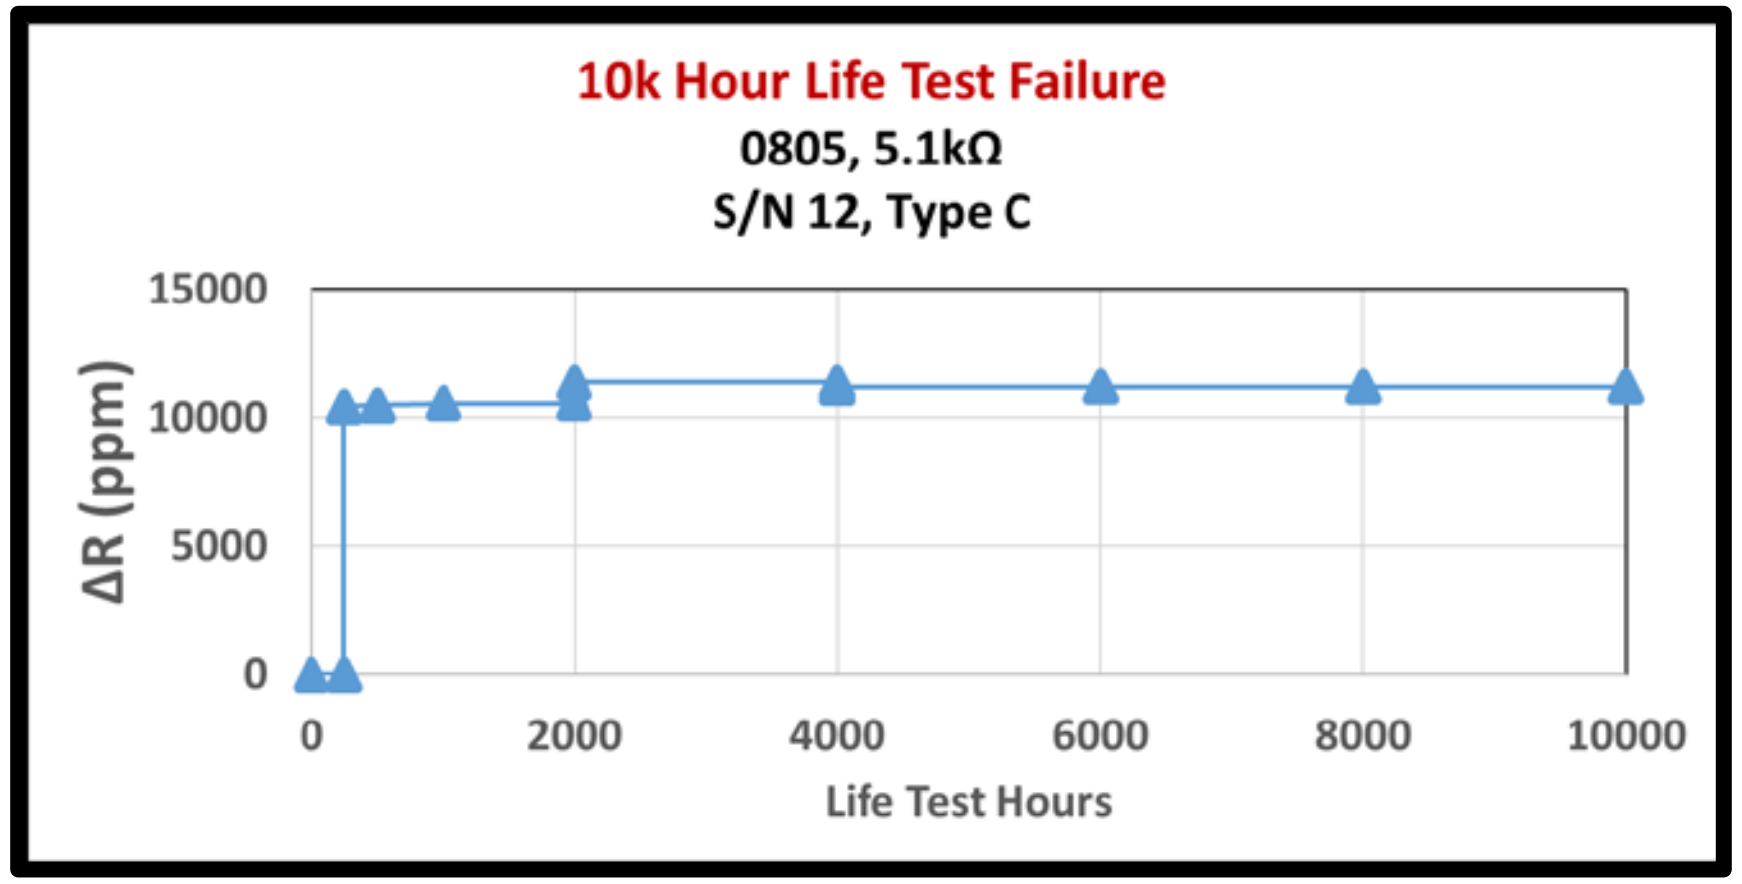
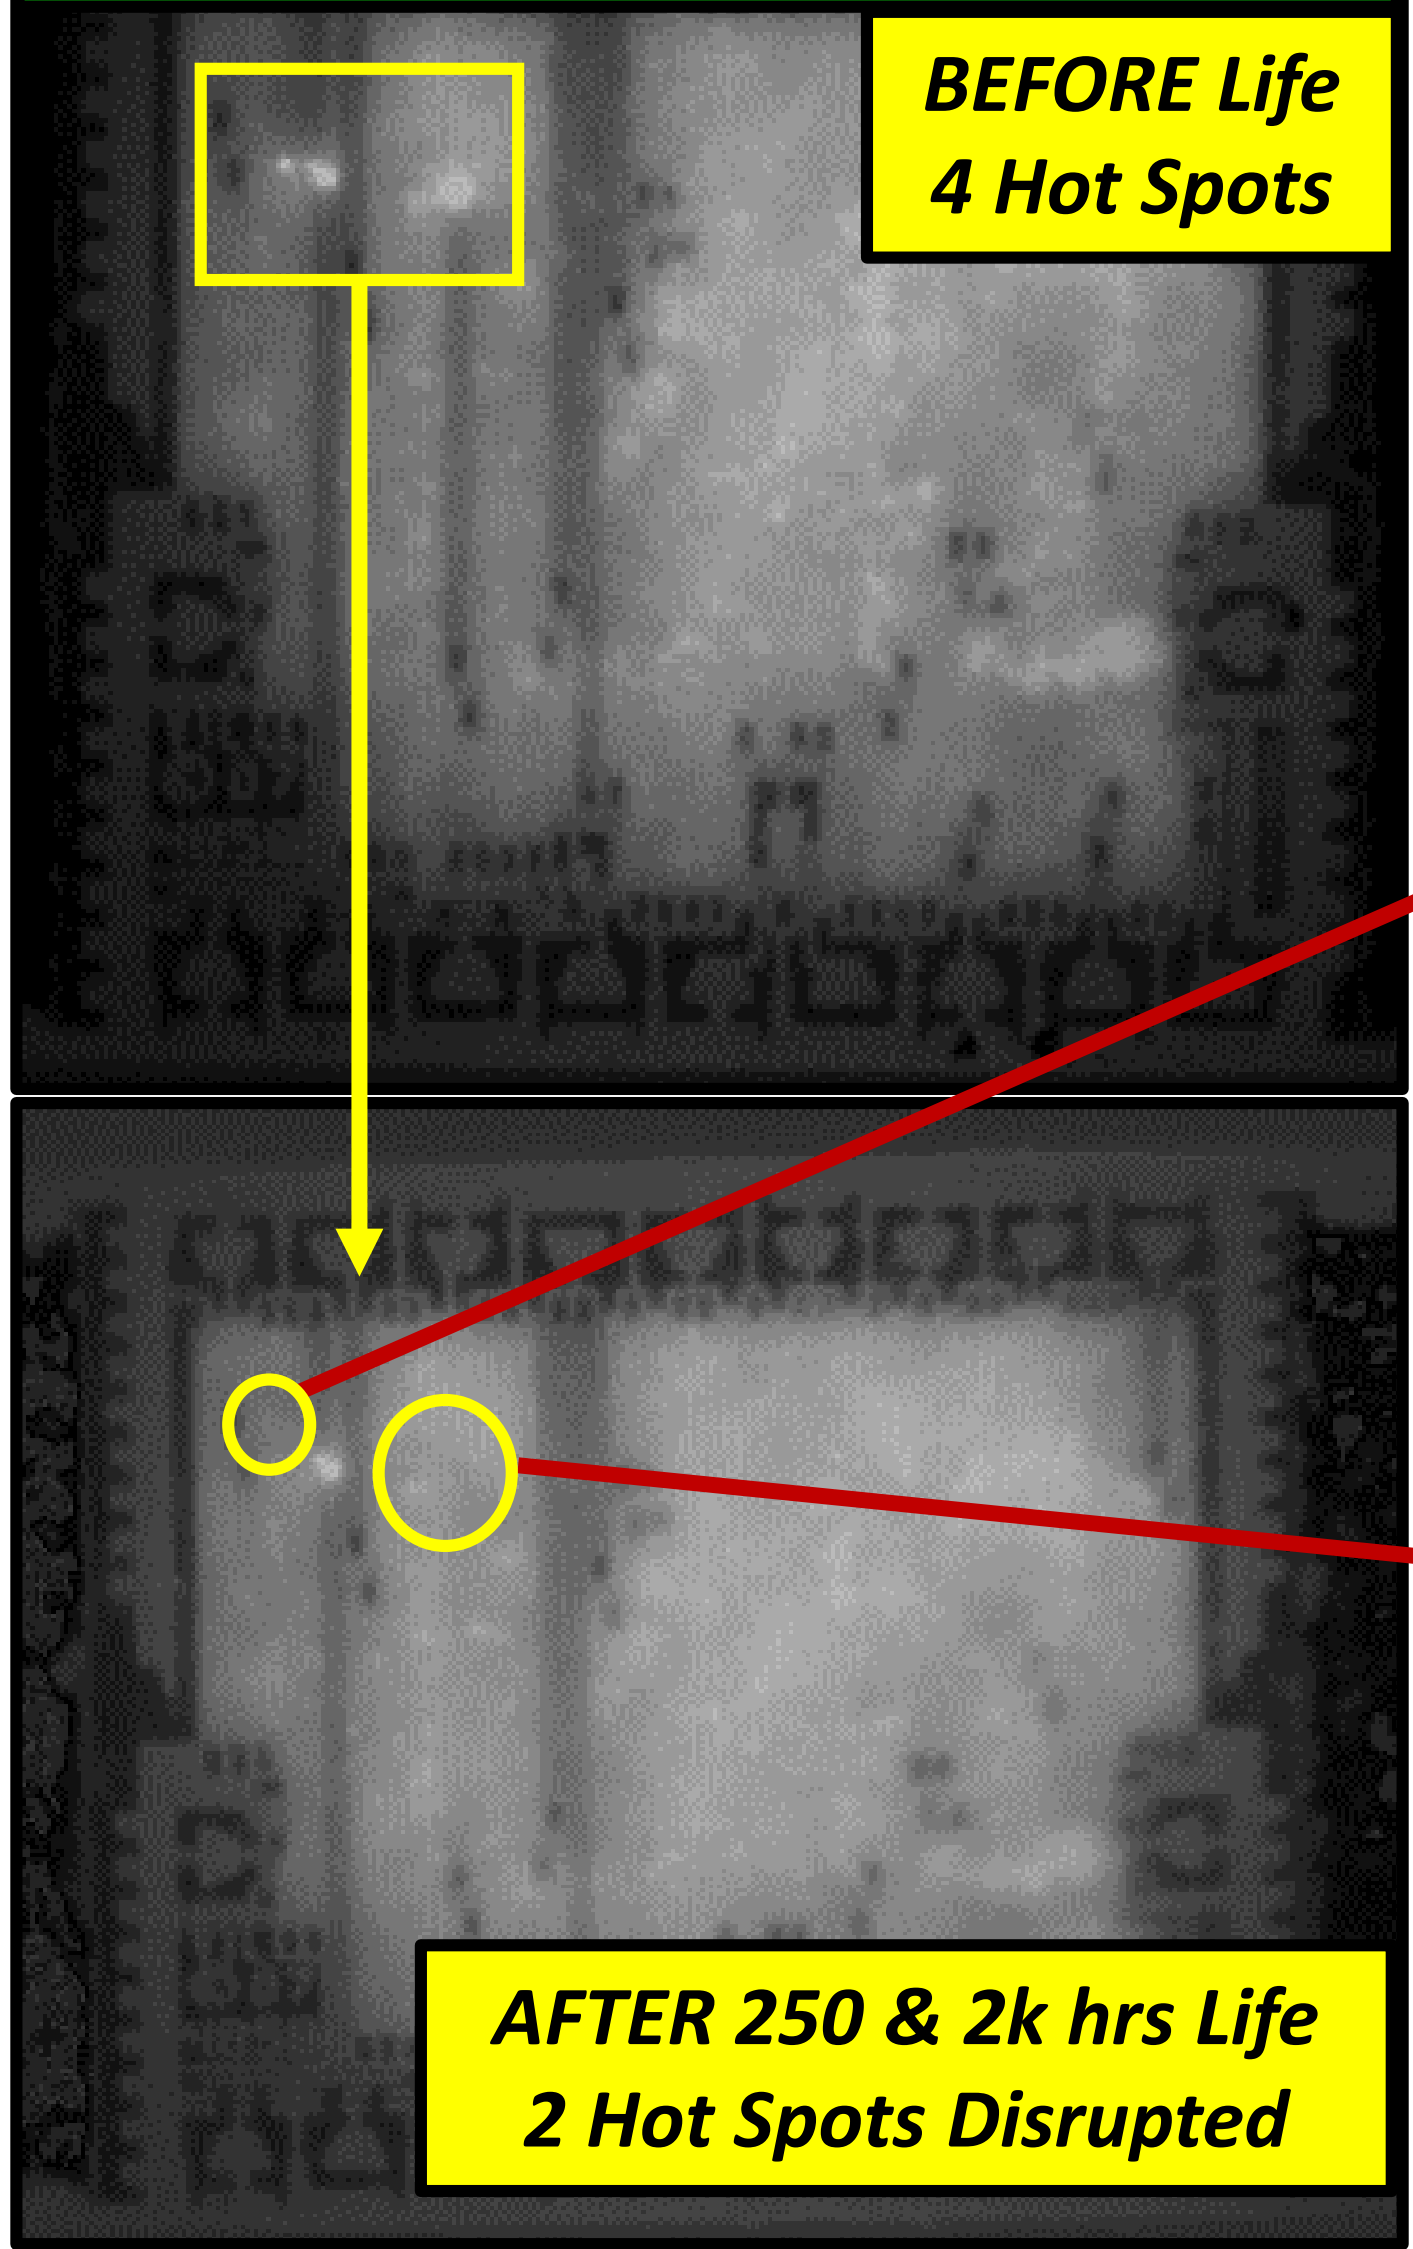
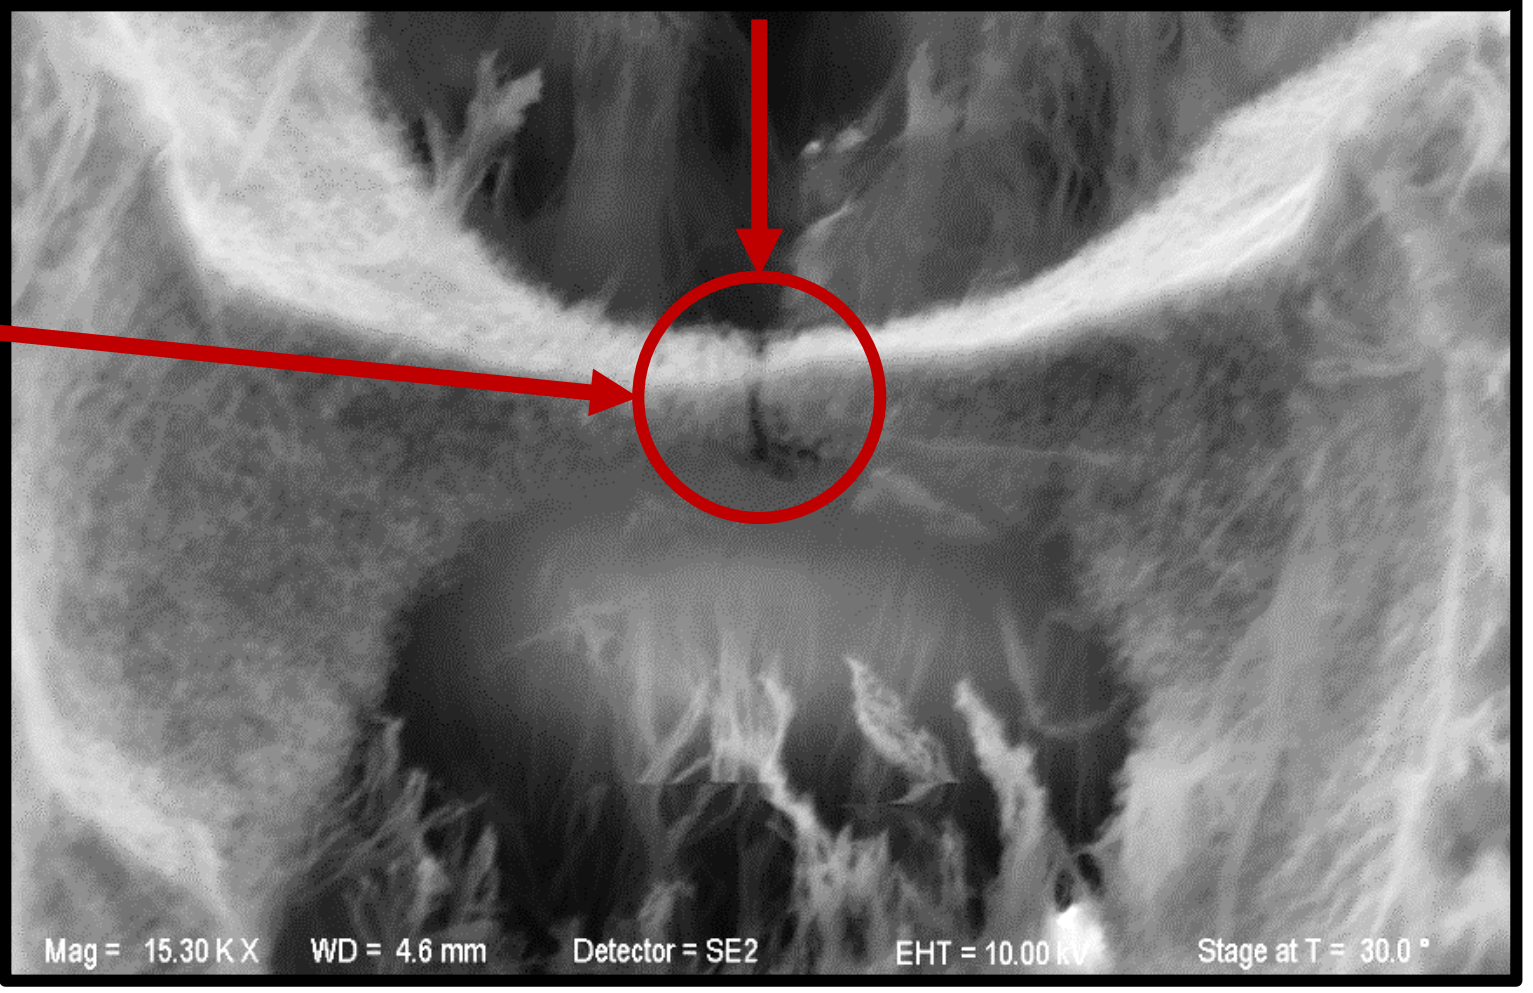
0805, 5.1kΩ, S/N 12, Type "C"

***Two* bridge defects fractured** during life test causing total ΔR ~11000 ppm

Pulsed-Power Infrared Screen detected both bridge defects as 'hot spots' BEFORE Life Test

Fractured Bridge #1

Fractured Bridge #2

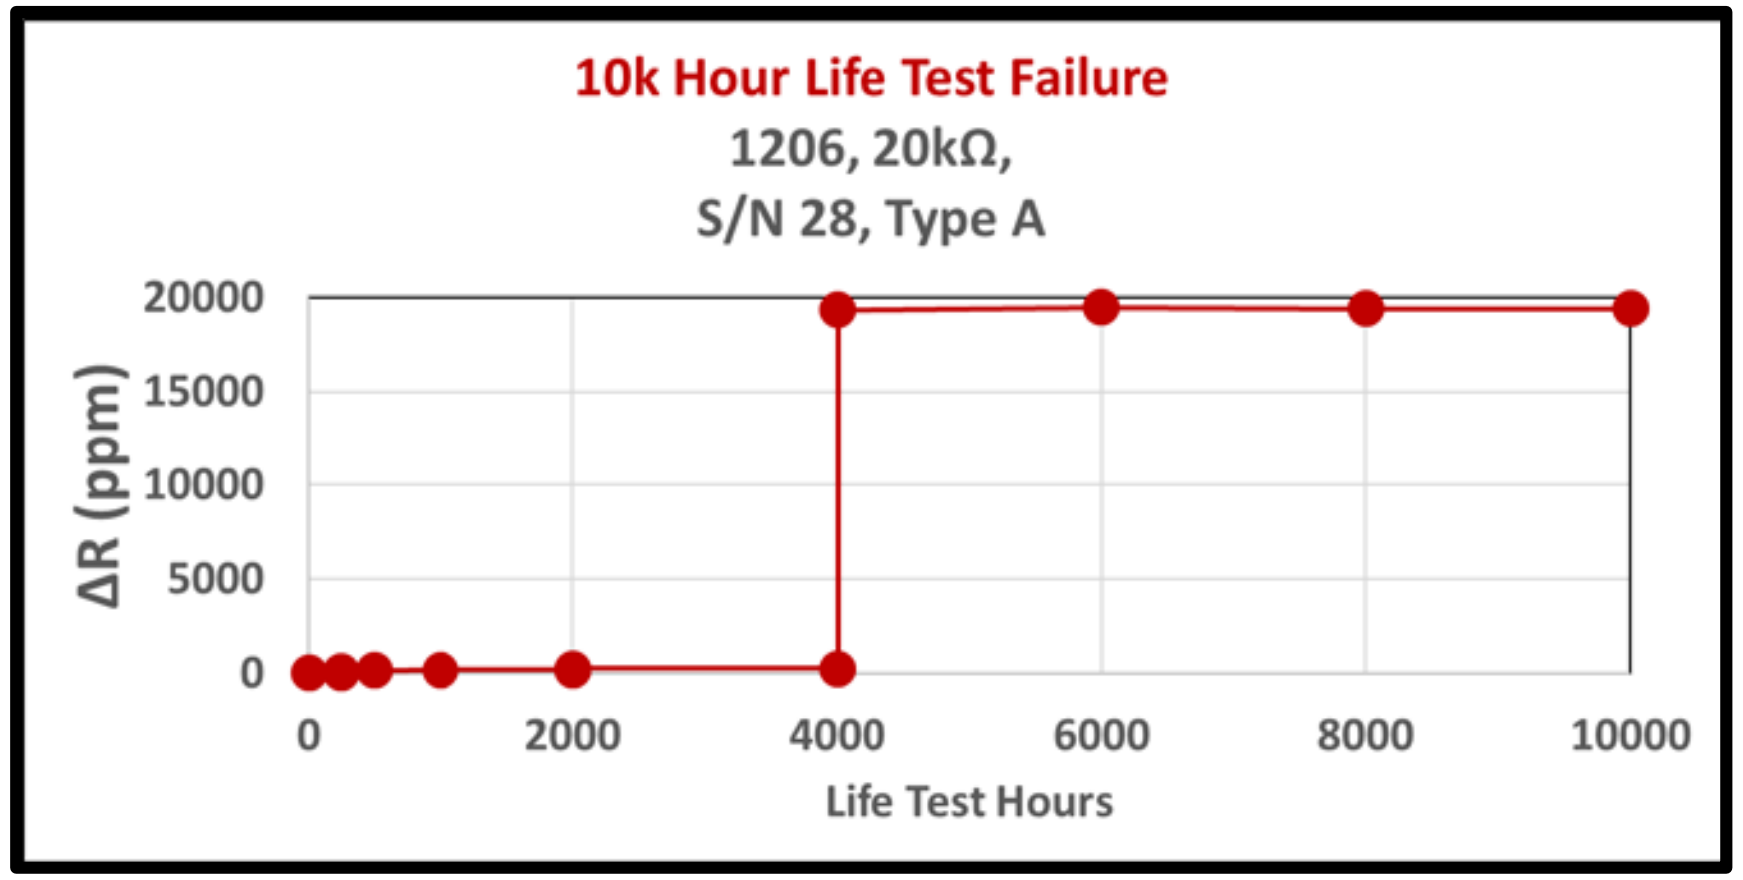
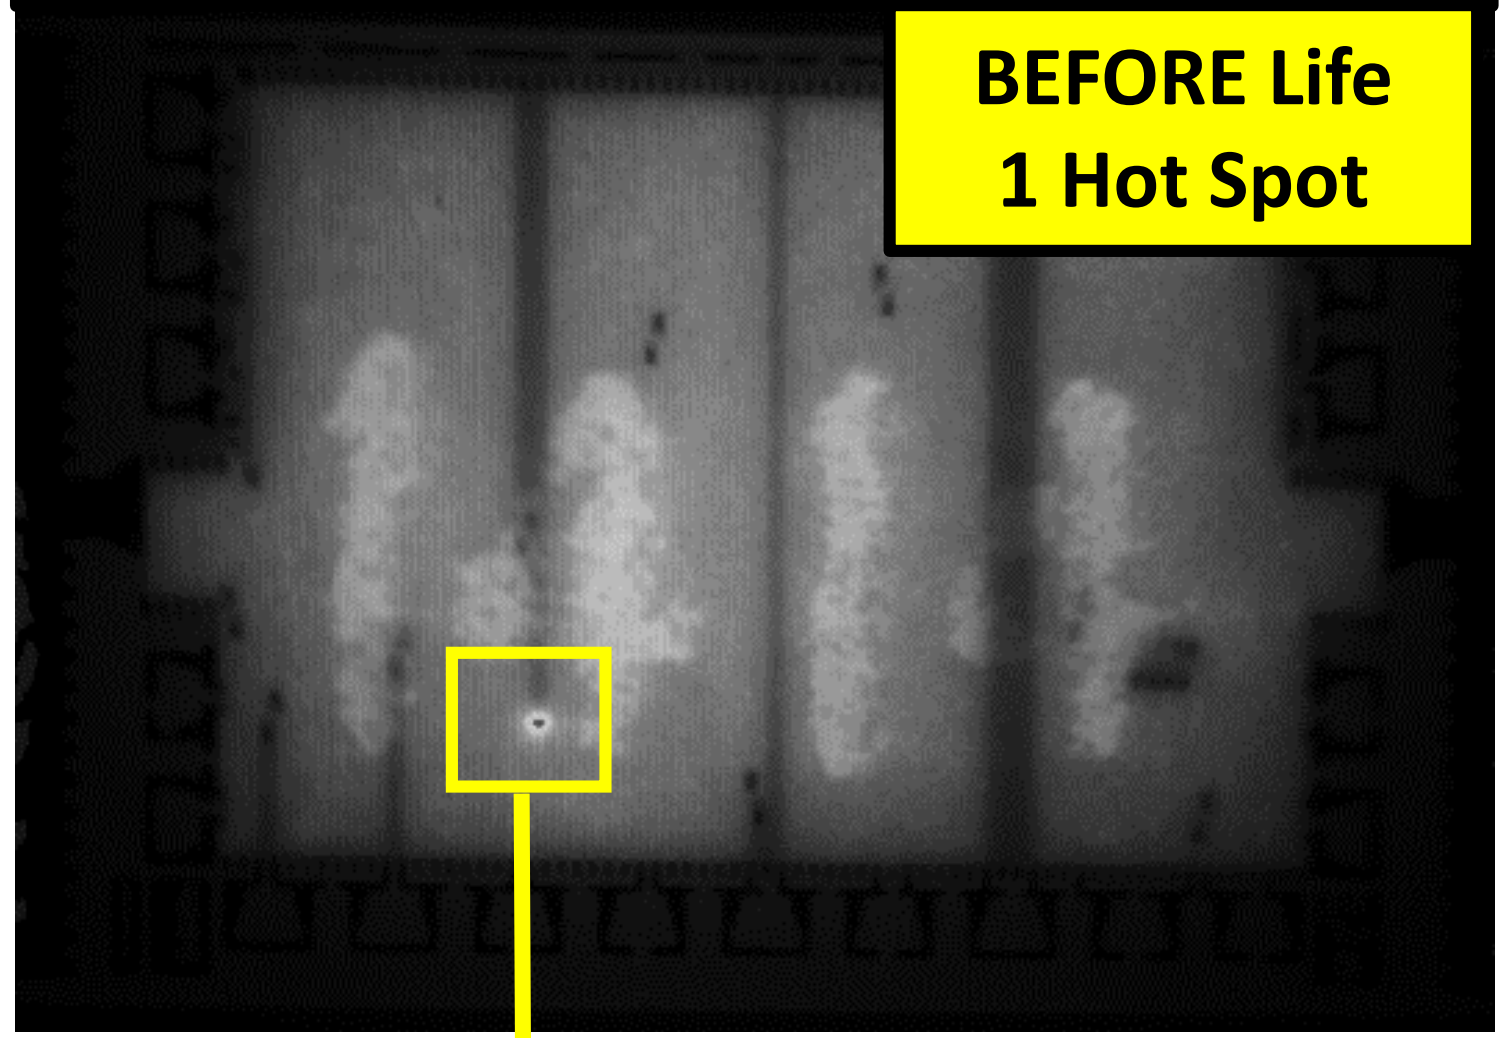
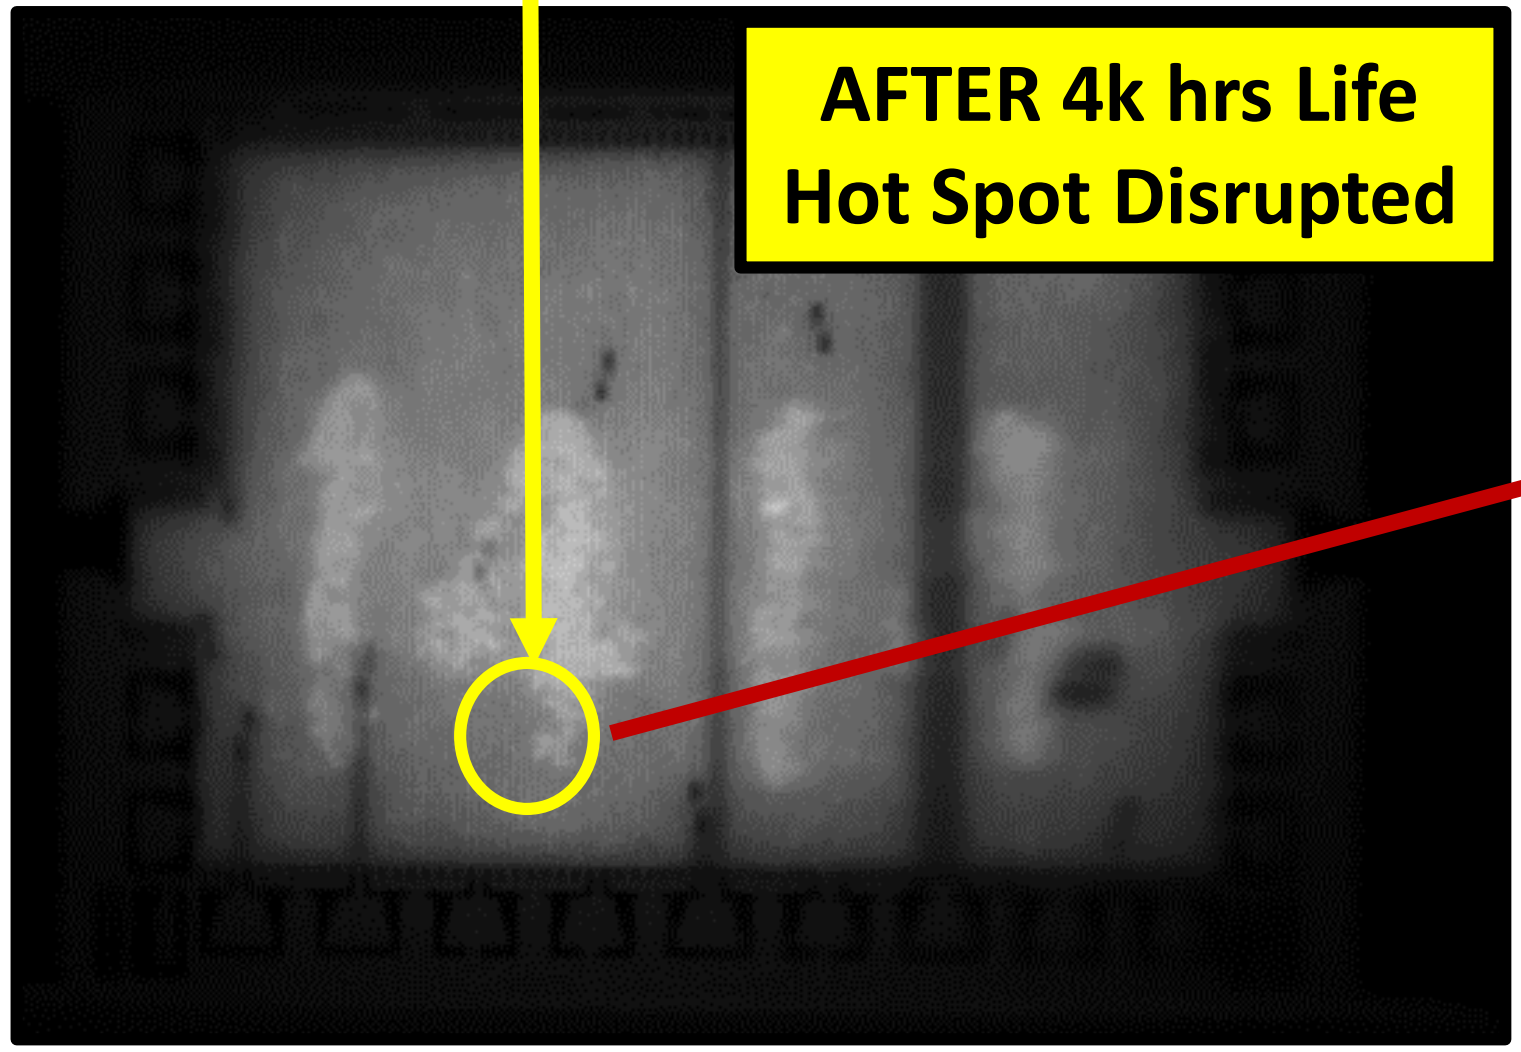
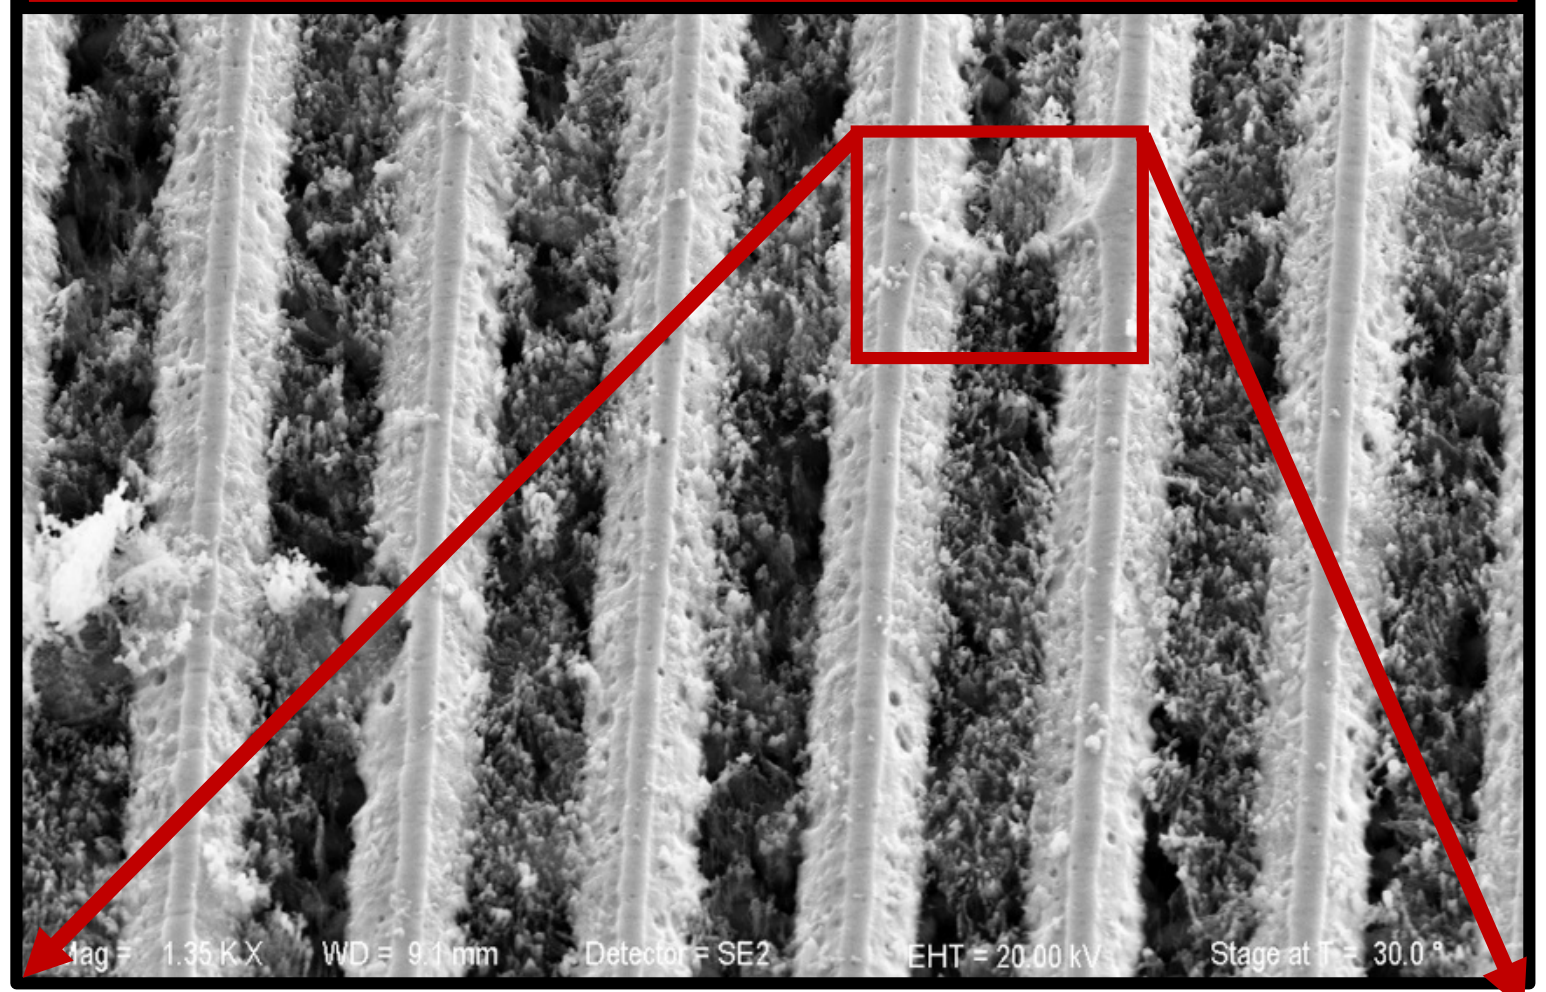
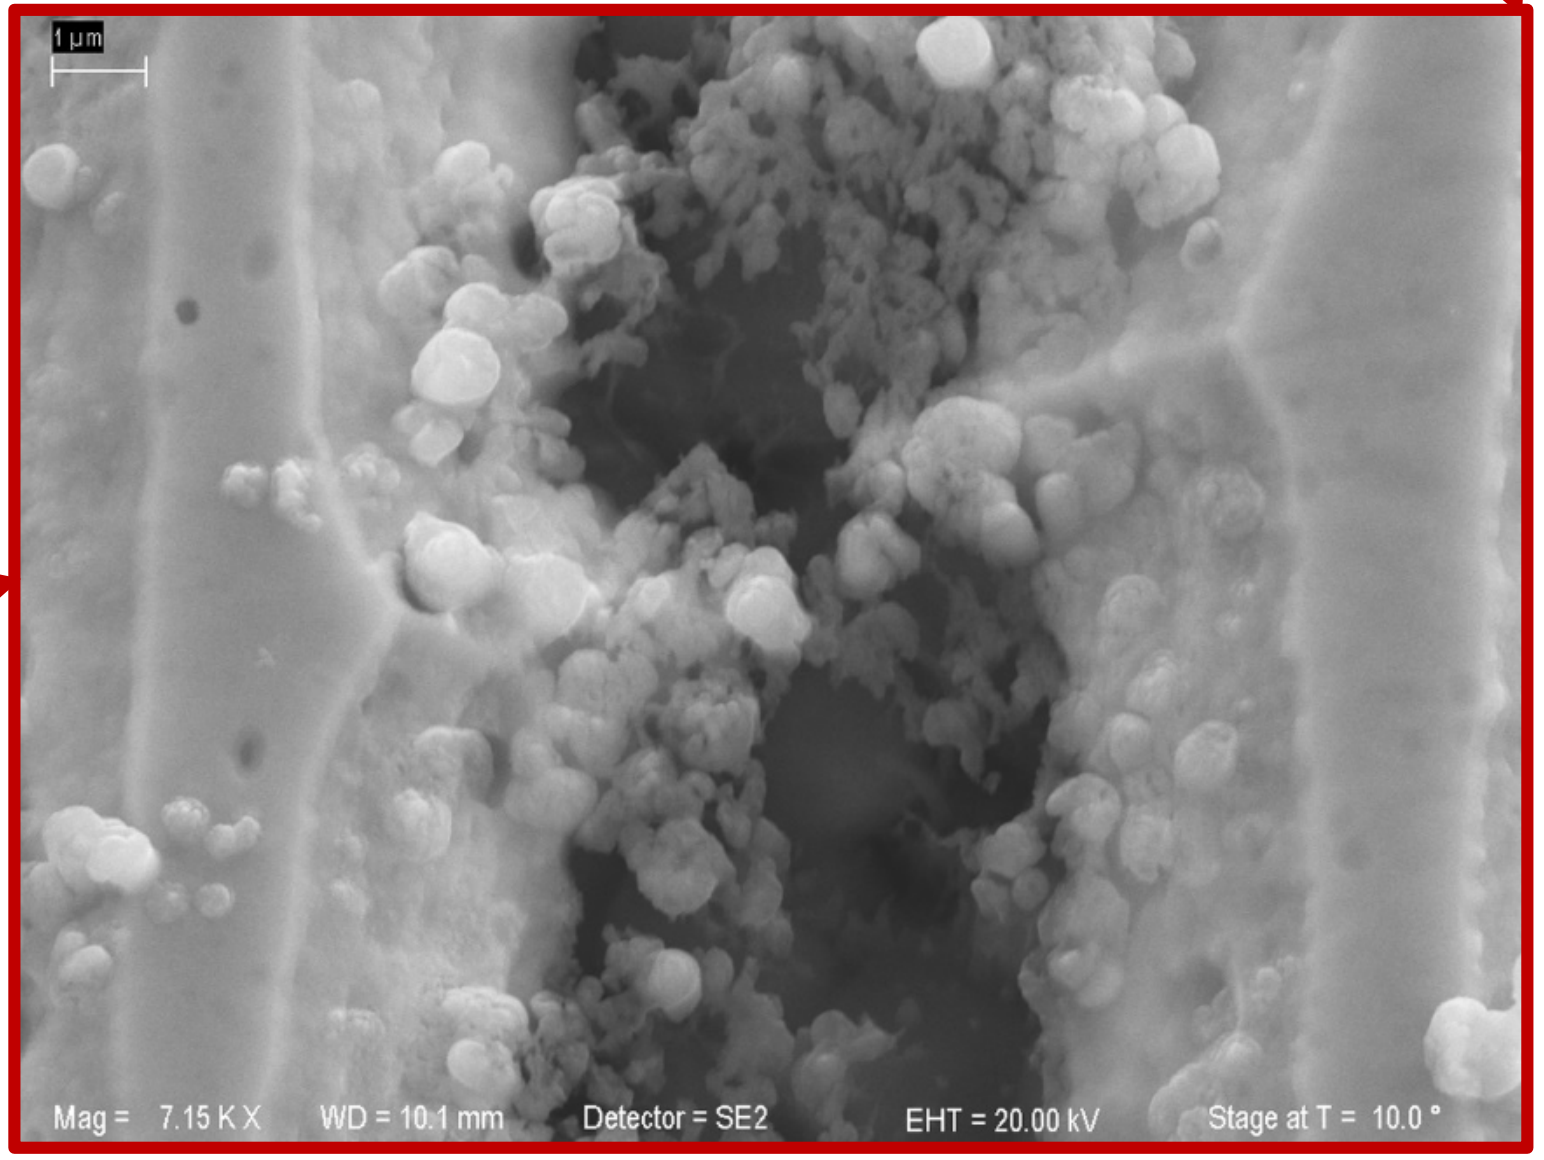
1206, 20kΩ, S/N 28, Type "A"

Fractured Bridge

***One bridge defect fractured* during life test causing ΔR ~19400 ppm**

Pulsed-Power Infrared Screen detected this bridge defect as a 'hot spot' BEFORE Life Test
