A Screening Method Using Pulsed-Power Combined with Infrared Imaging to Detect Pattern Defects in Bulk Metal Foil or Thin Film Resistors

Jay Brusse

ASRC AS&D at NASA Goddard Space Flight Center

NASA Goddard Space Flight Center

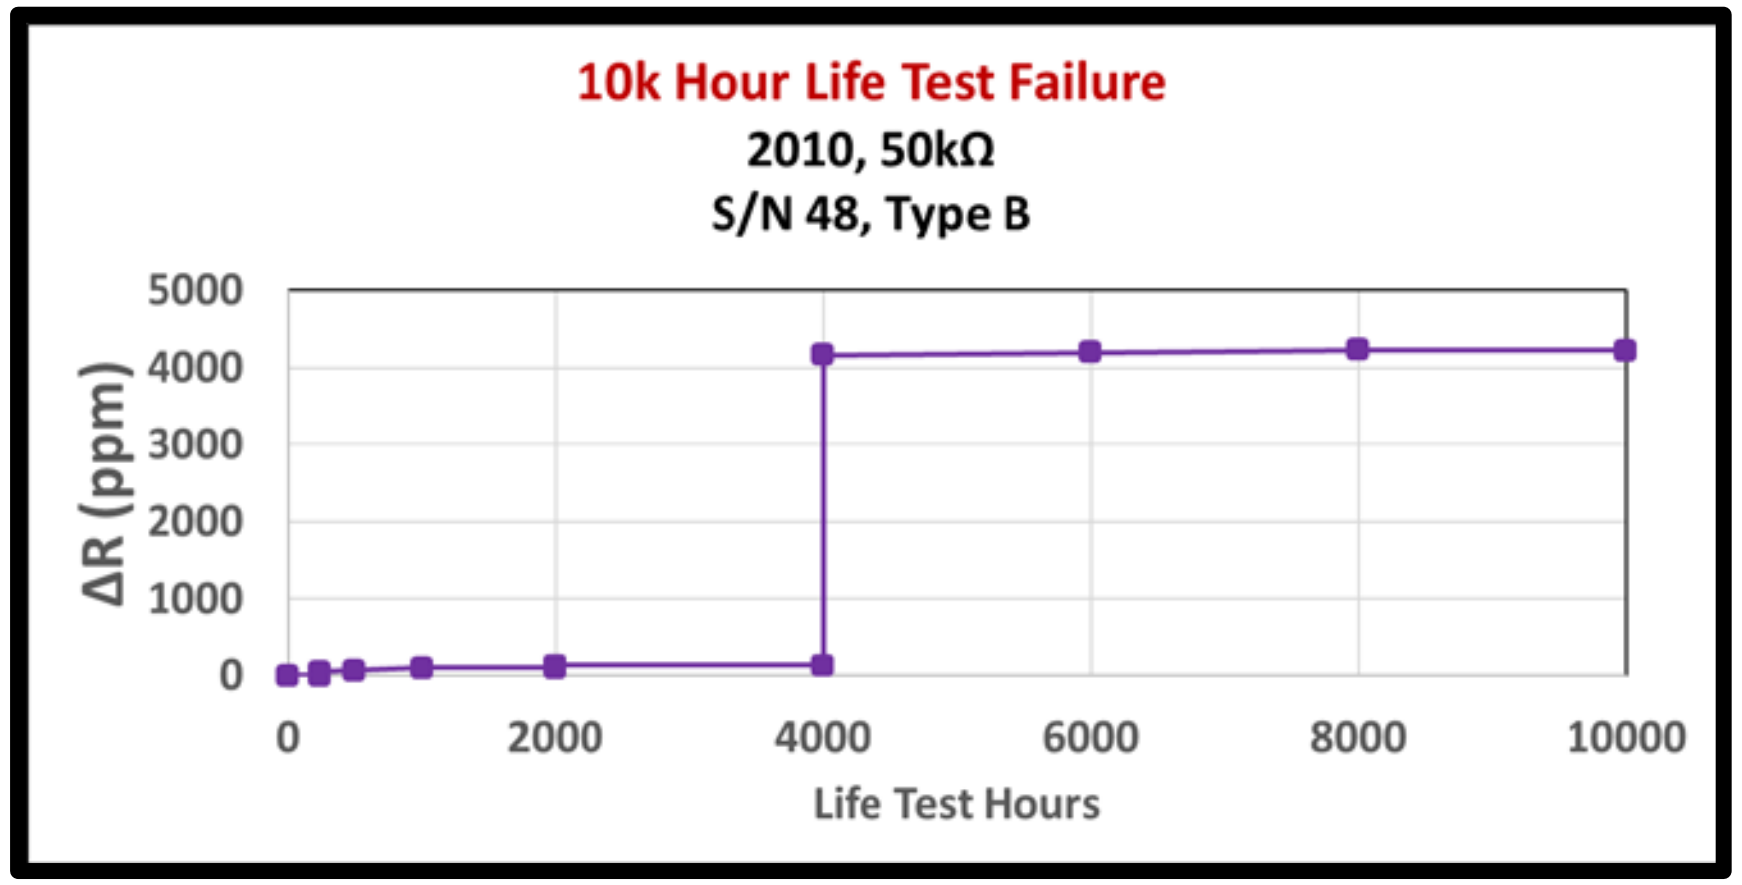
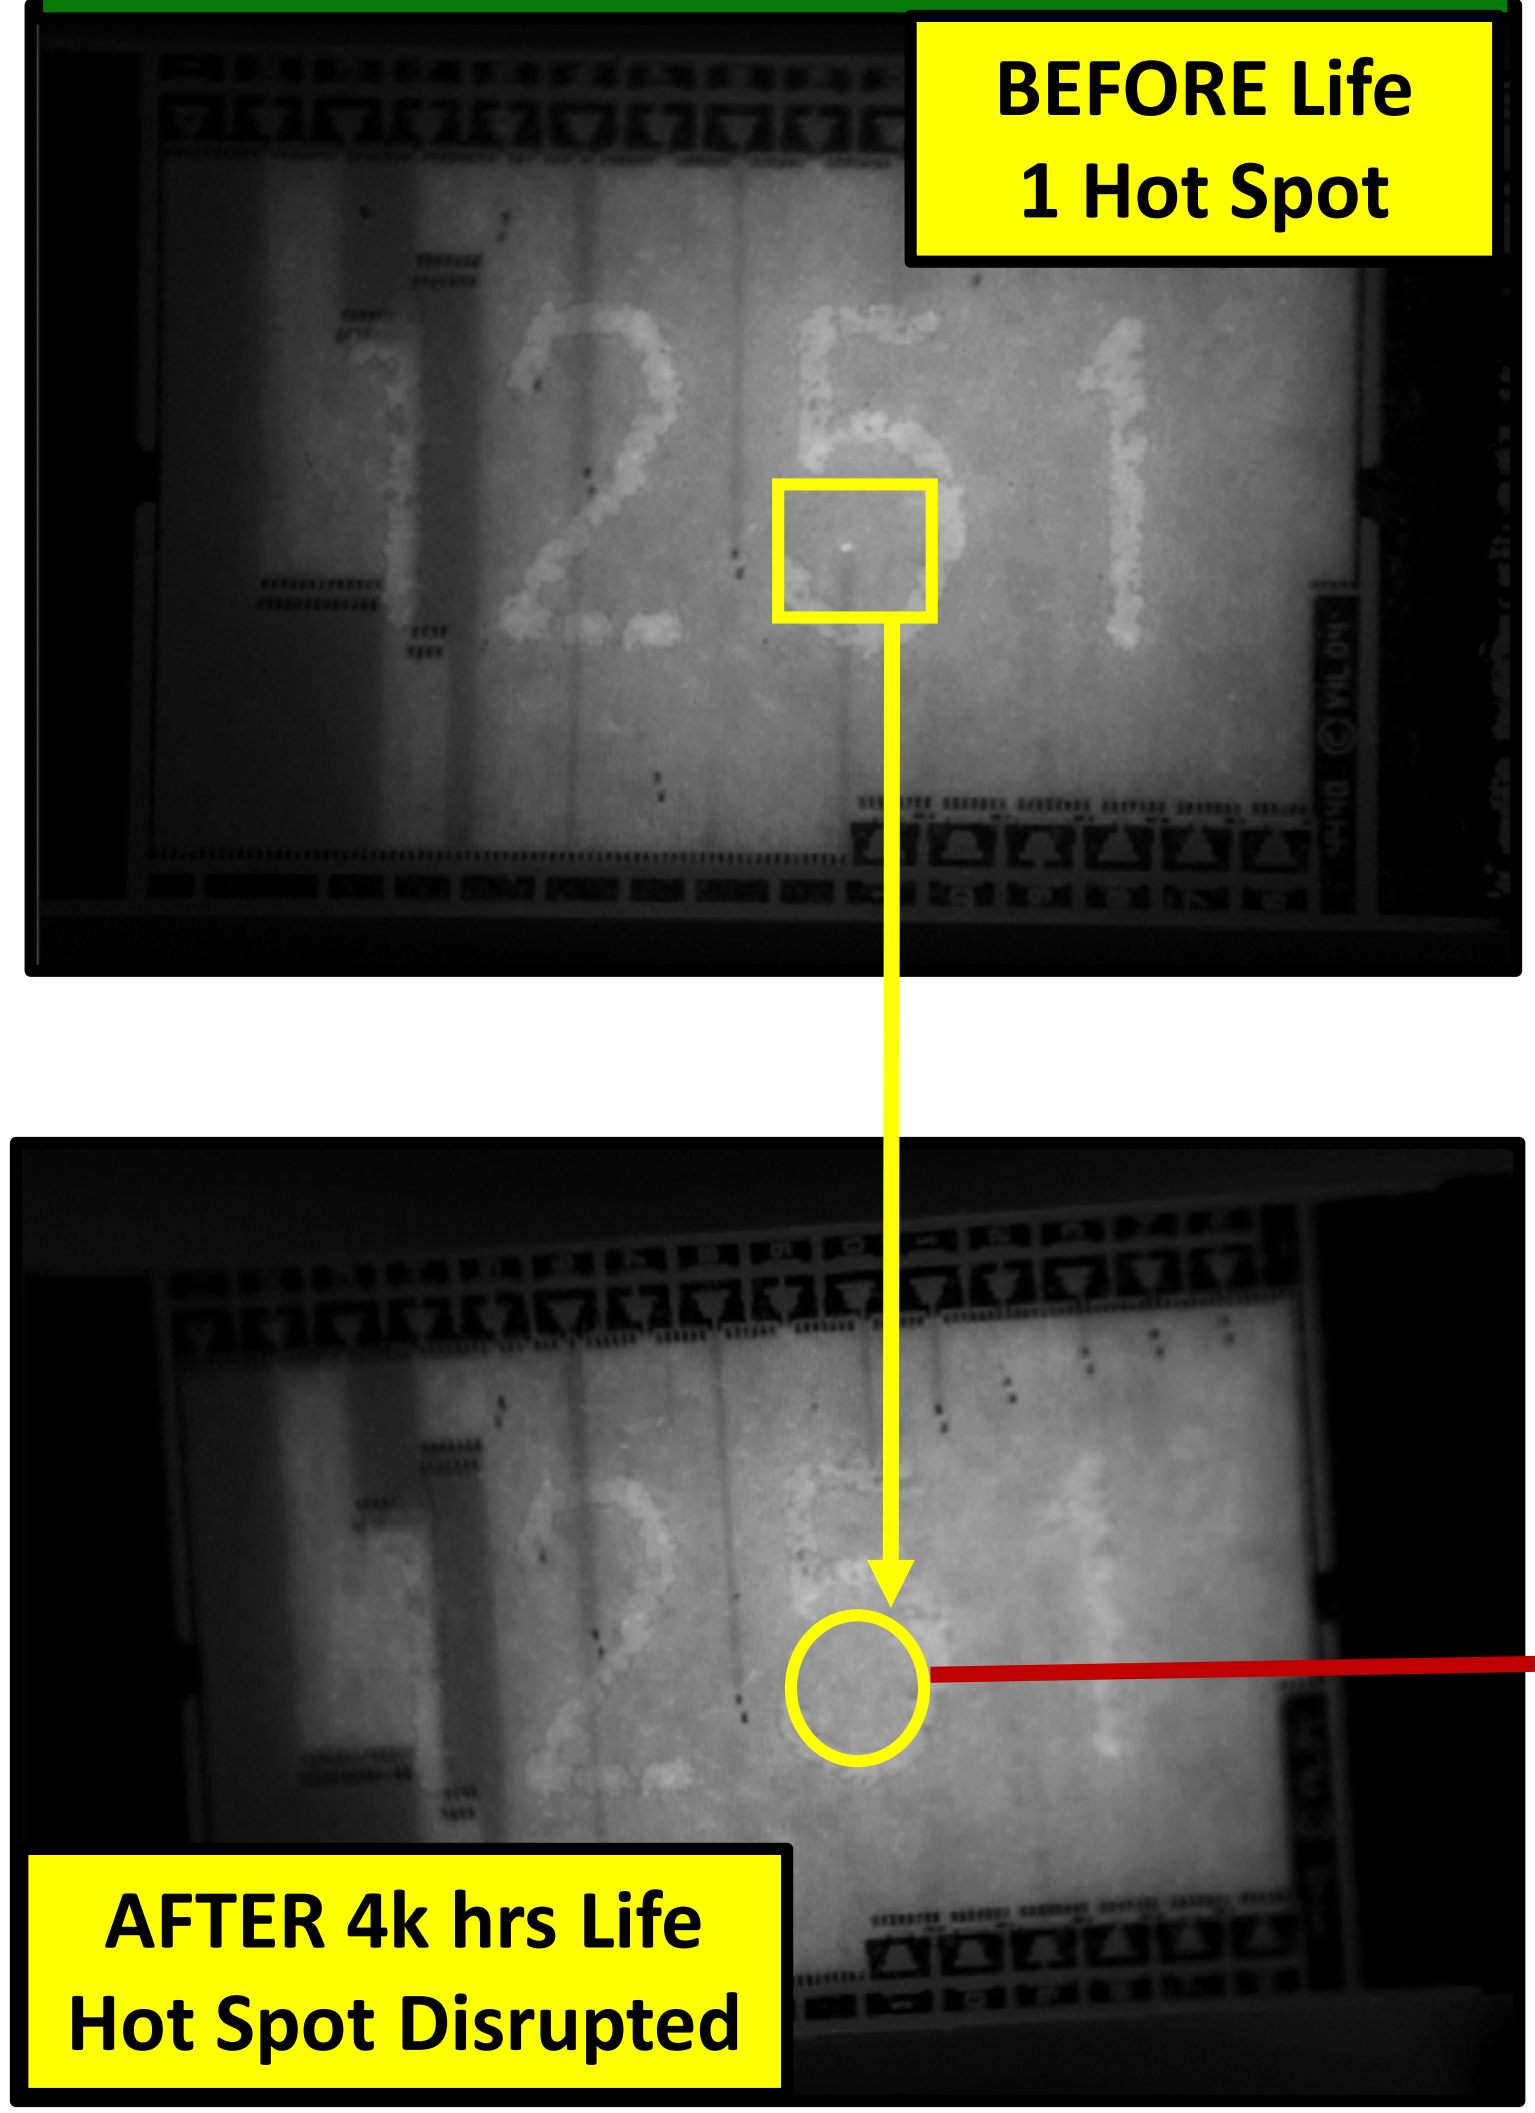
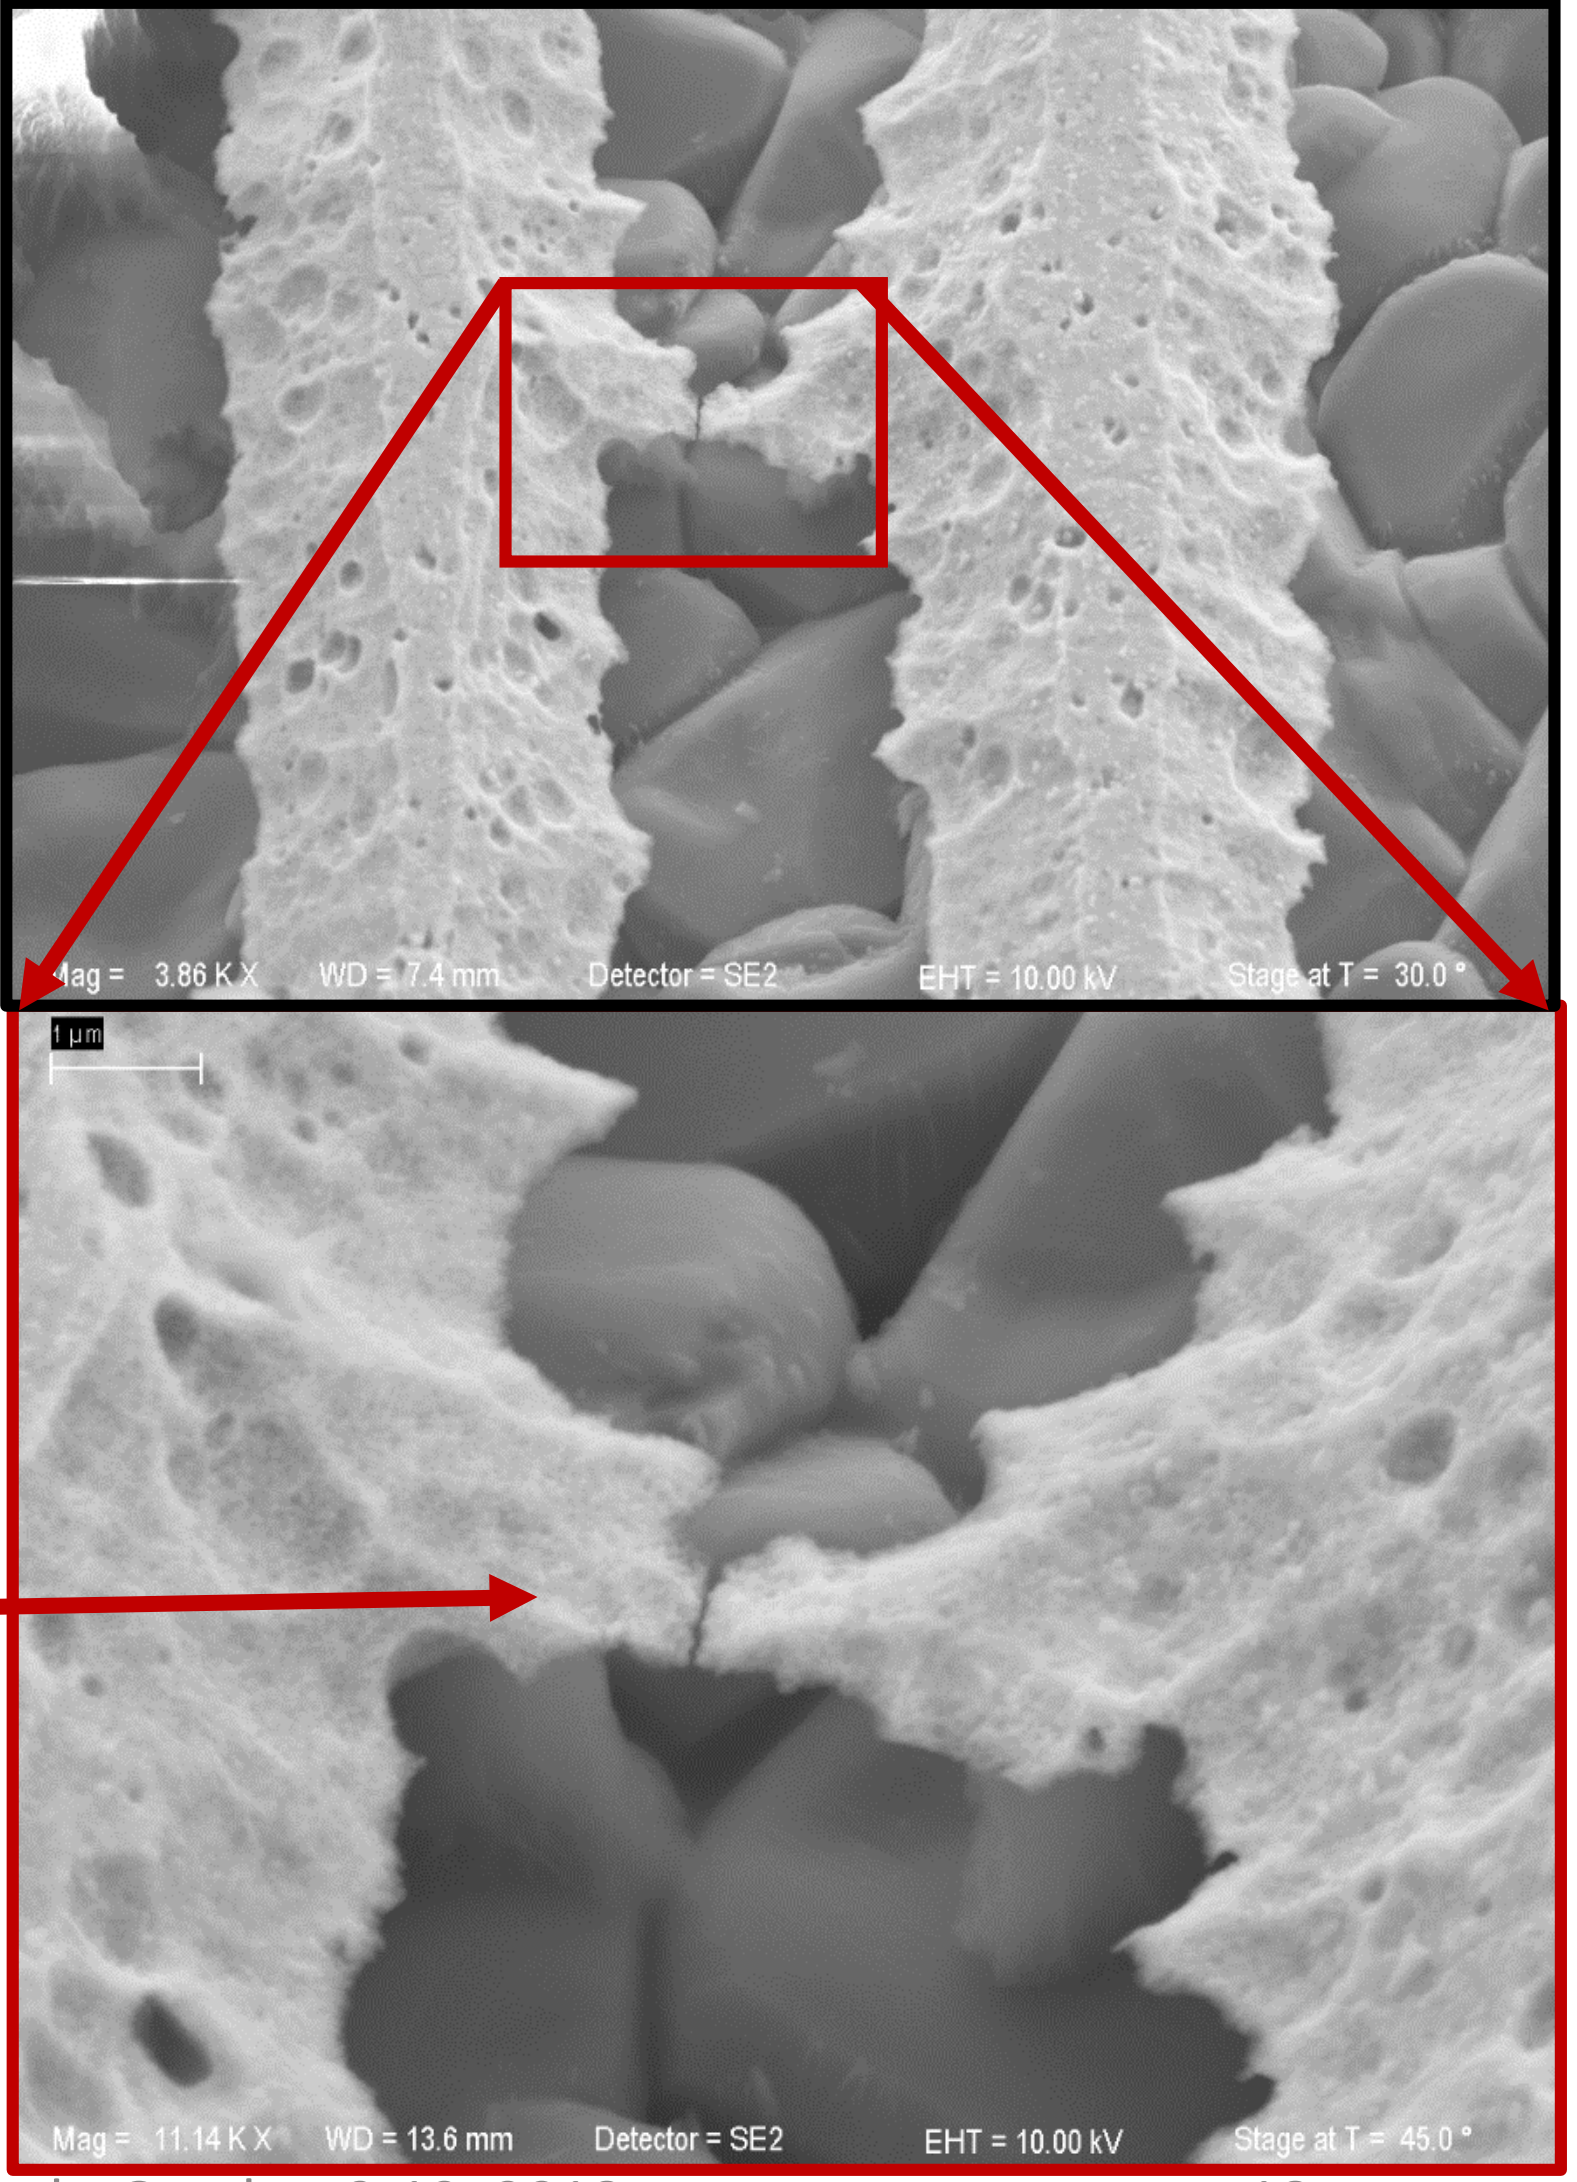
2010, 50kΩ, S/N 48, Type "B"

One bridge defect fractured **during life test causing ΔR ~4200 ppm**

Pulsed-Power Infrared Screen detected this bridge defect as a 'hot spot' BEFORE Life Test

Fractured Bridge

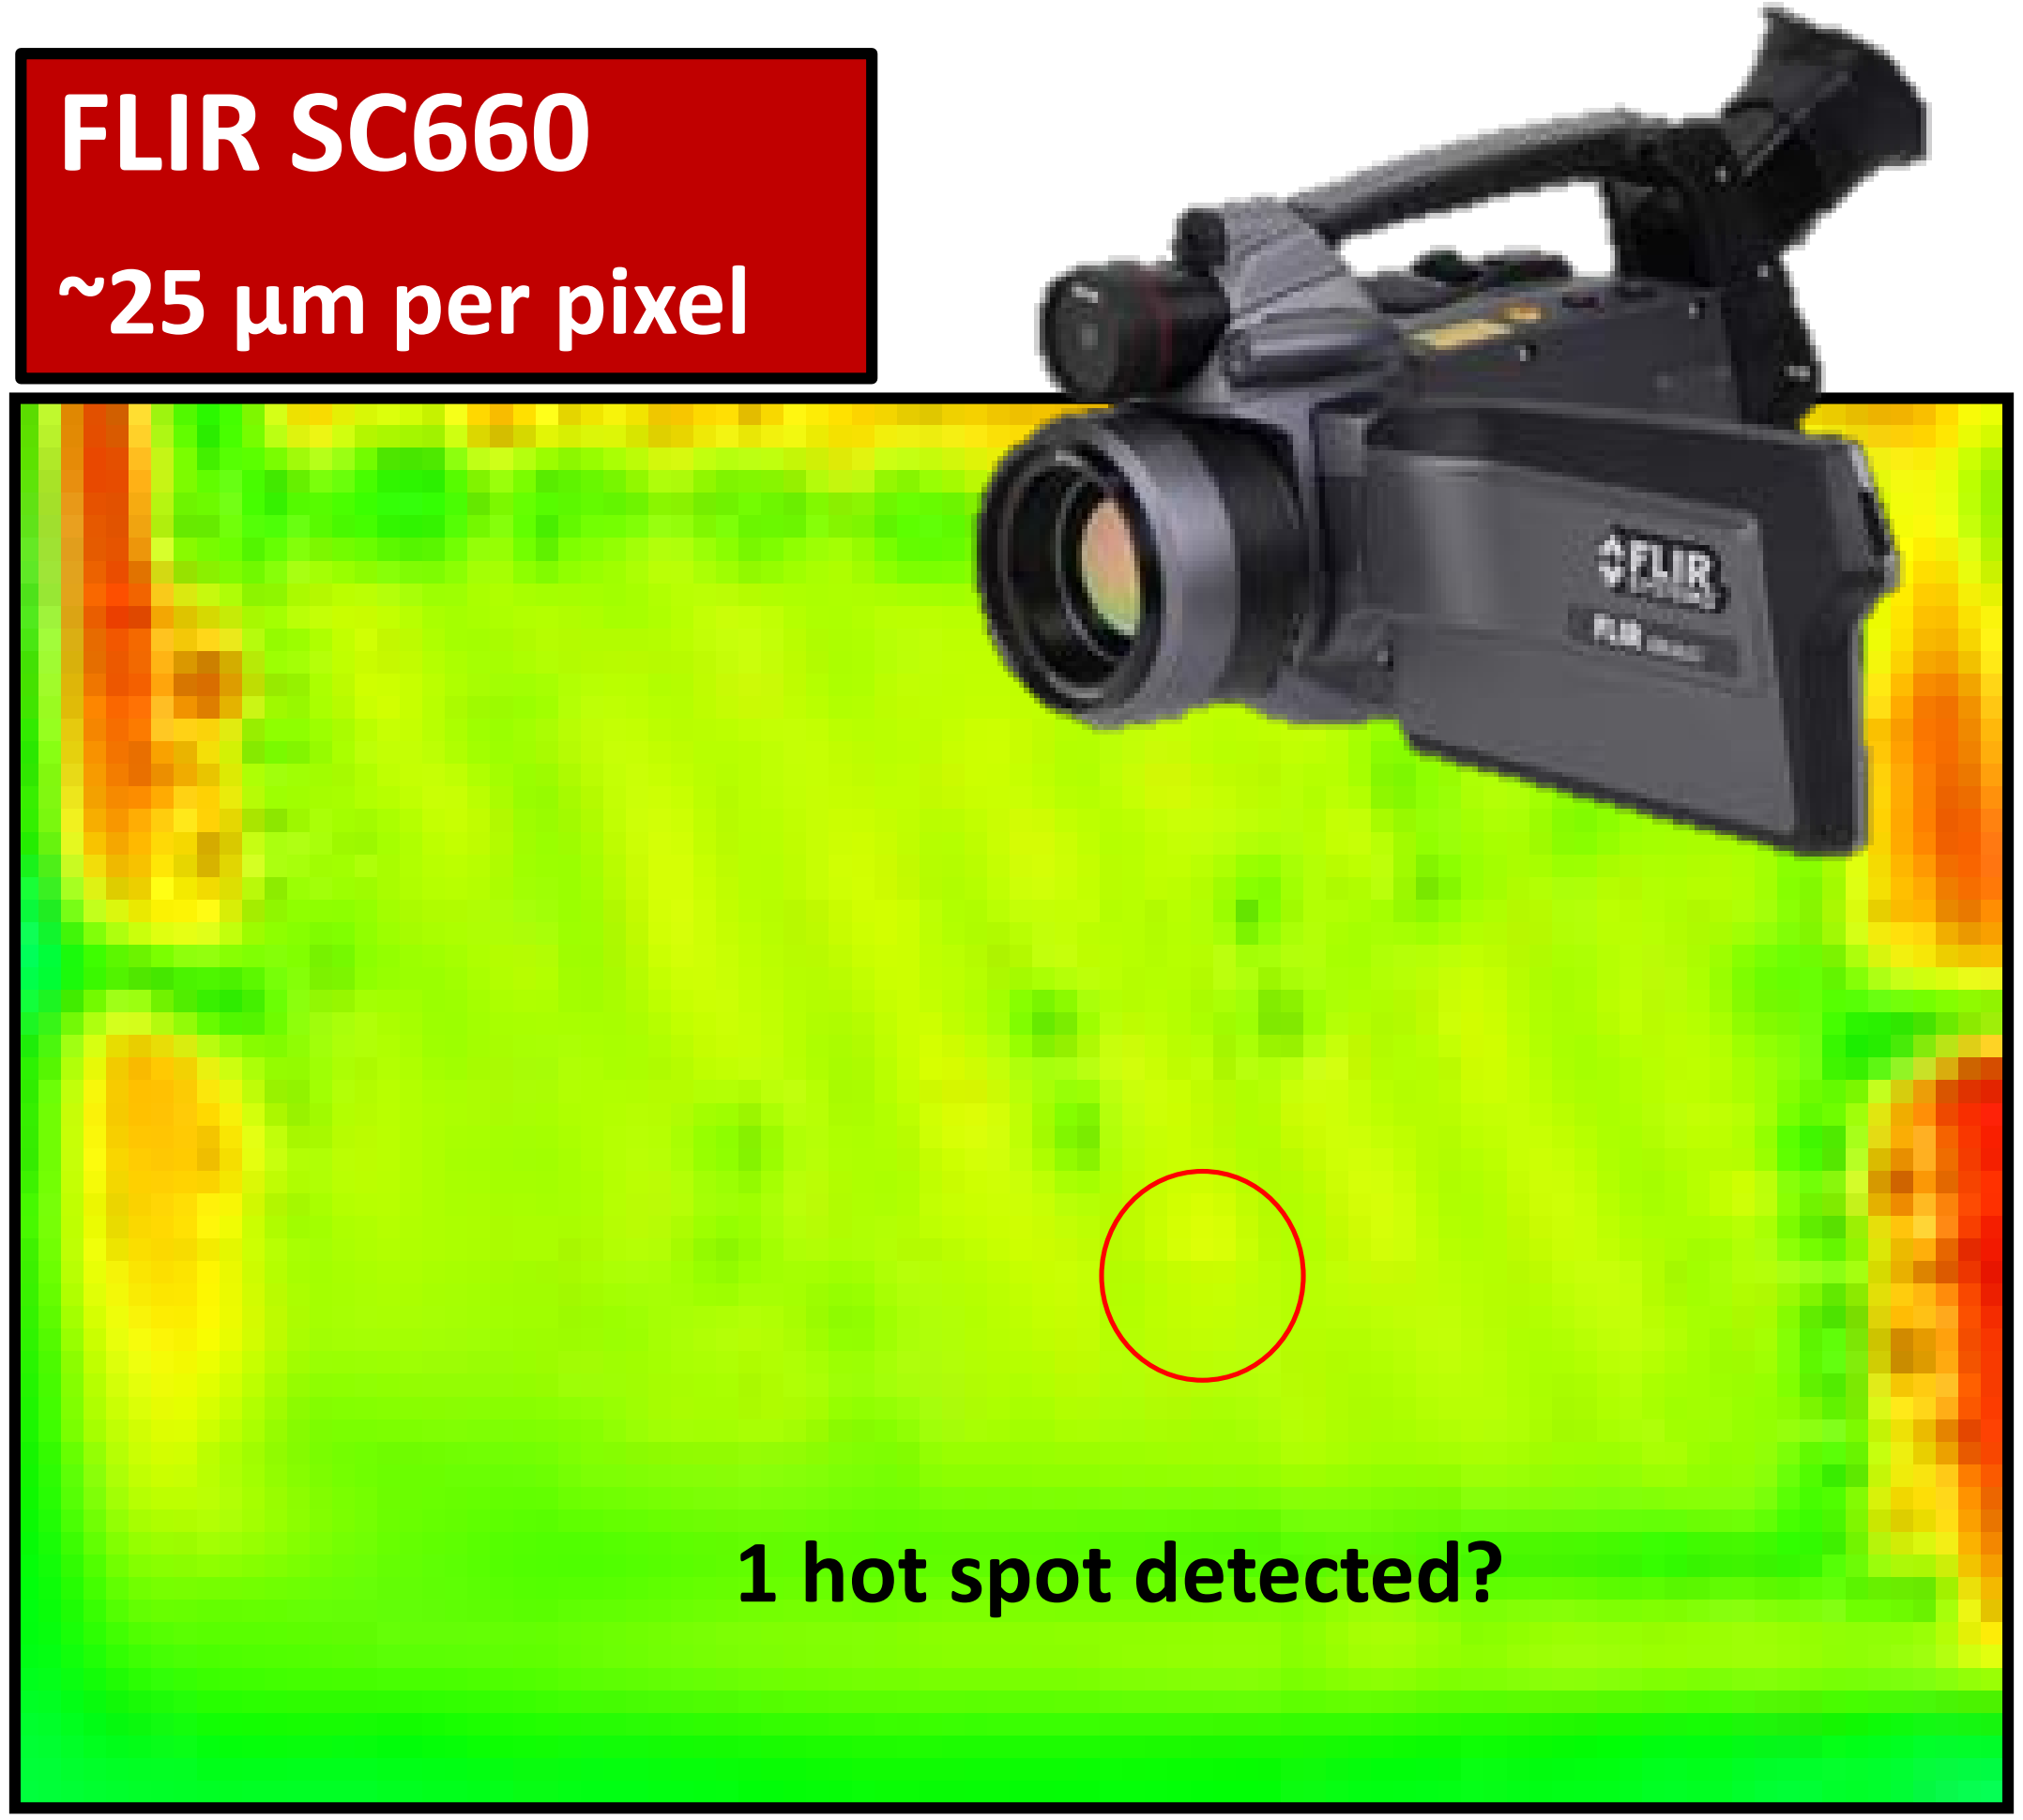
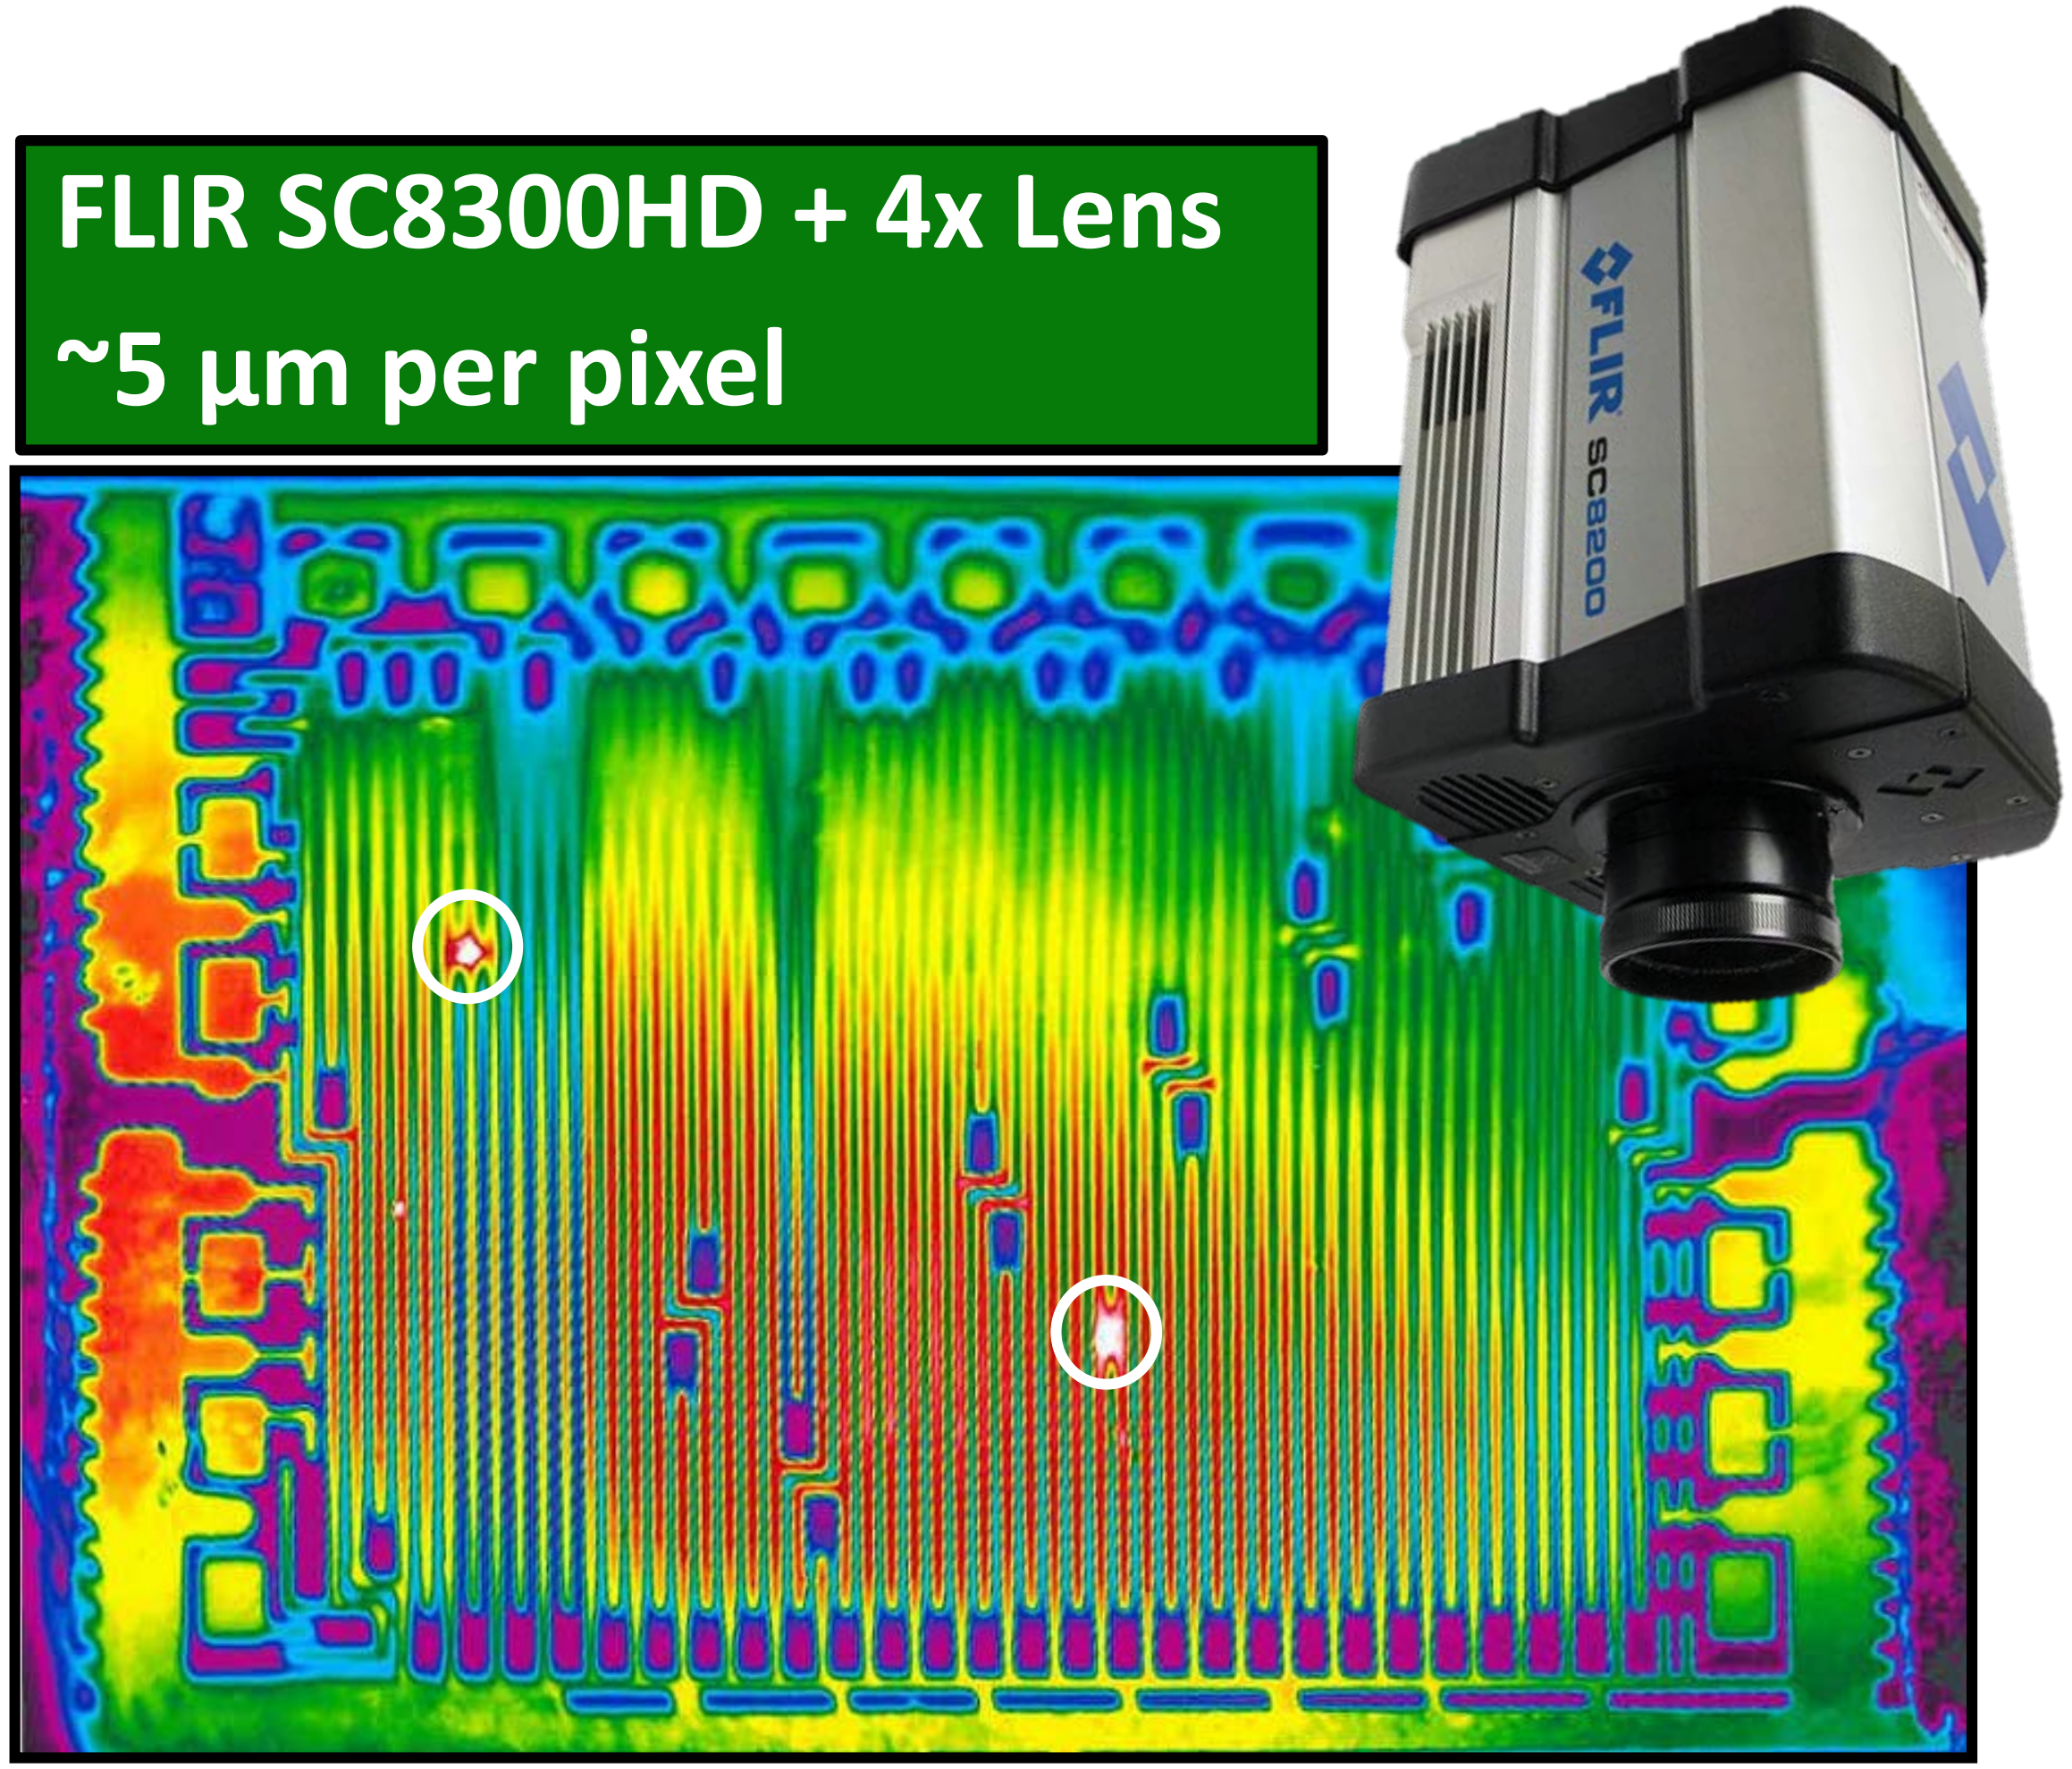
Inspecting the same resistor with 2 constriction defects while applying power pulses

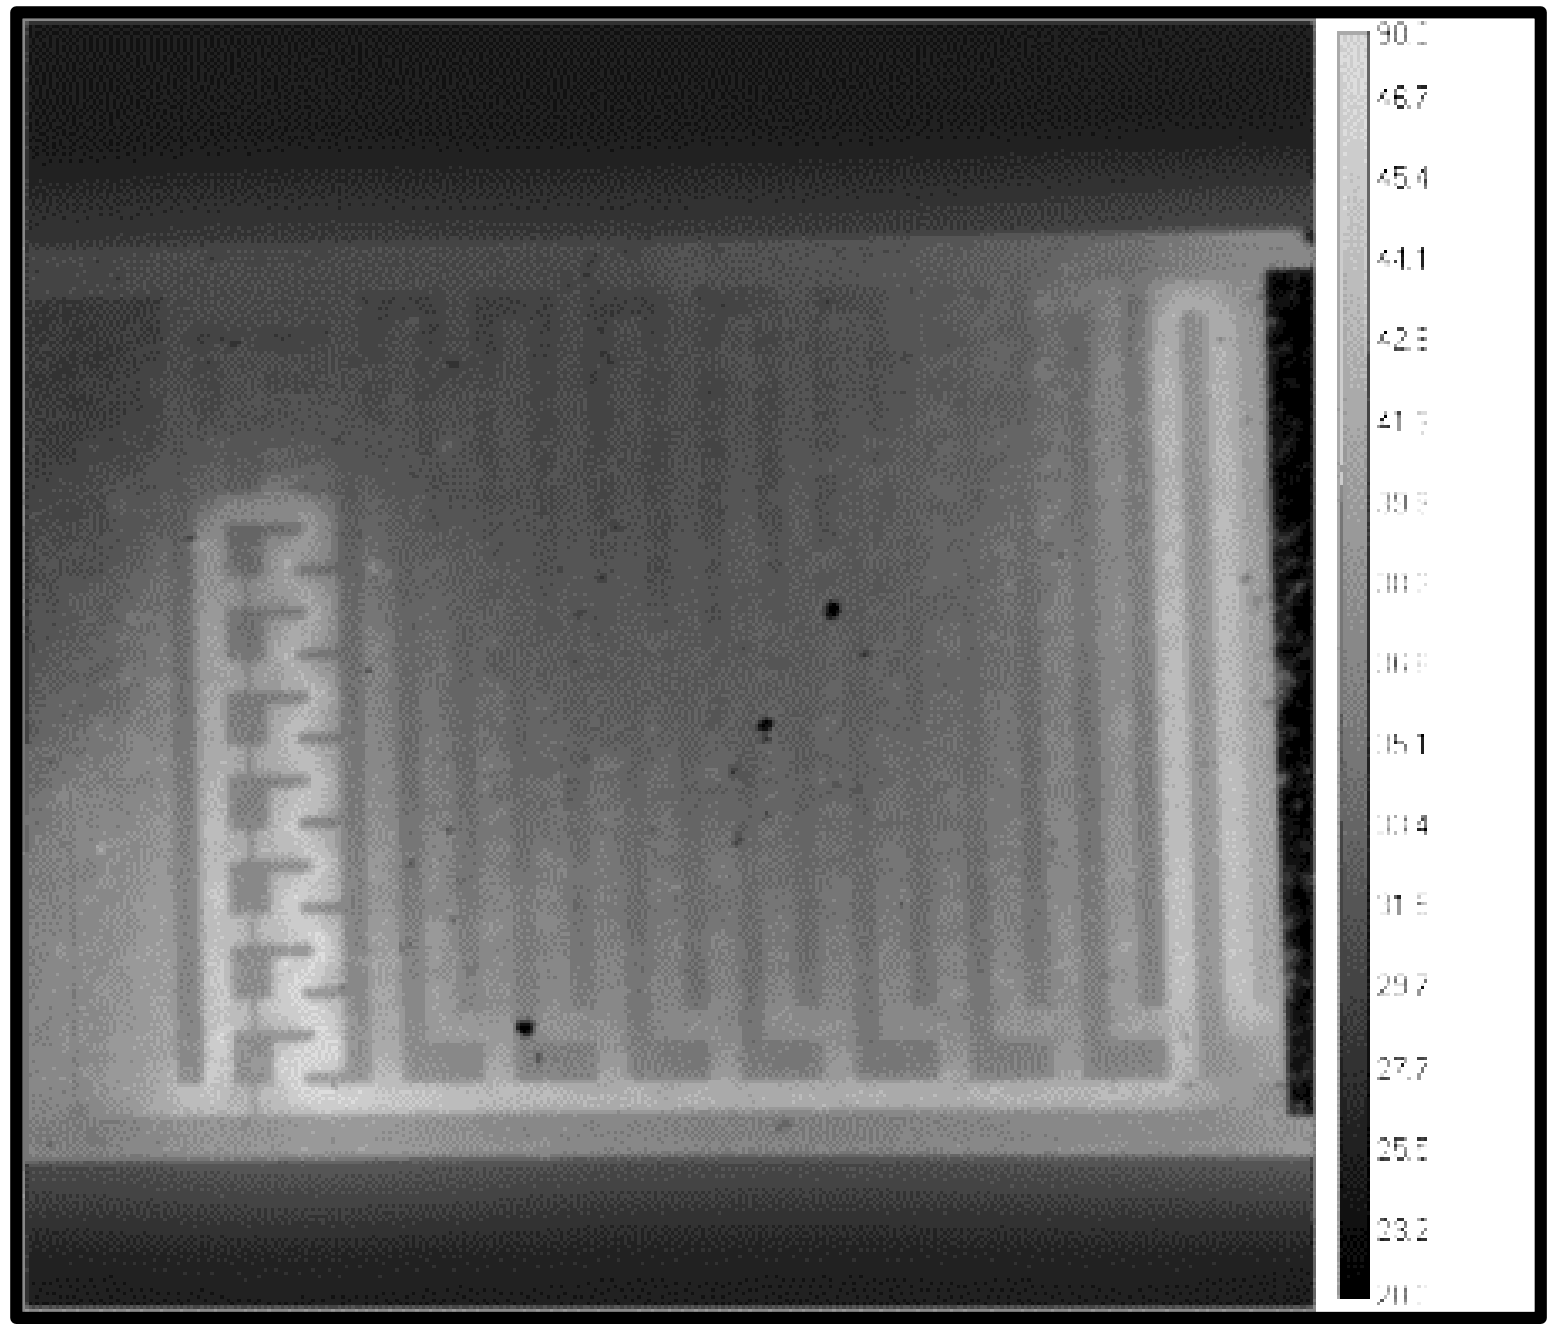
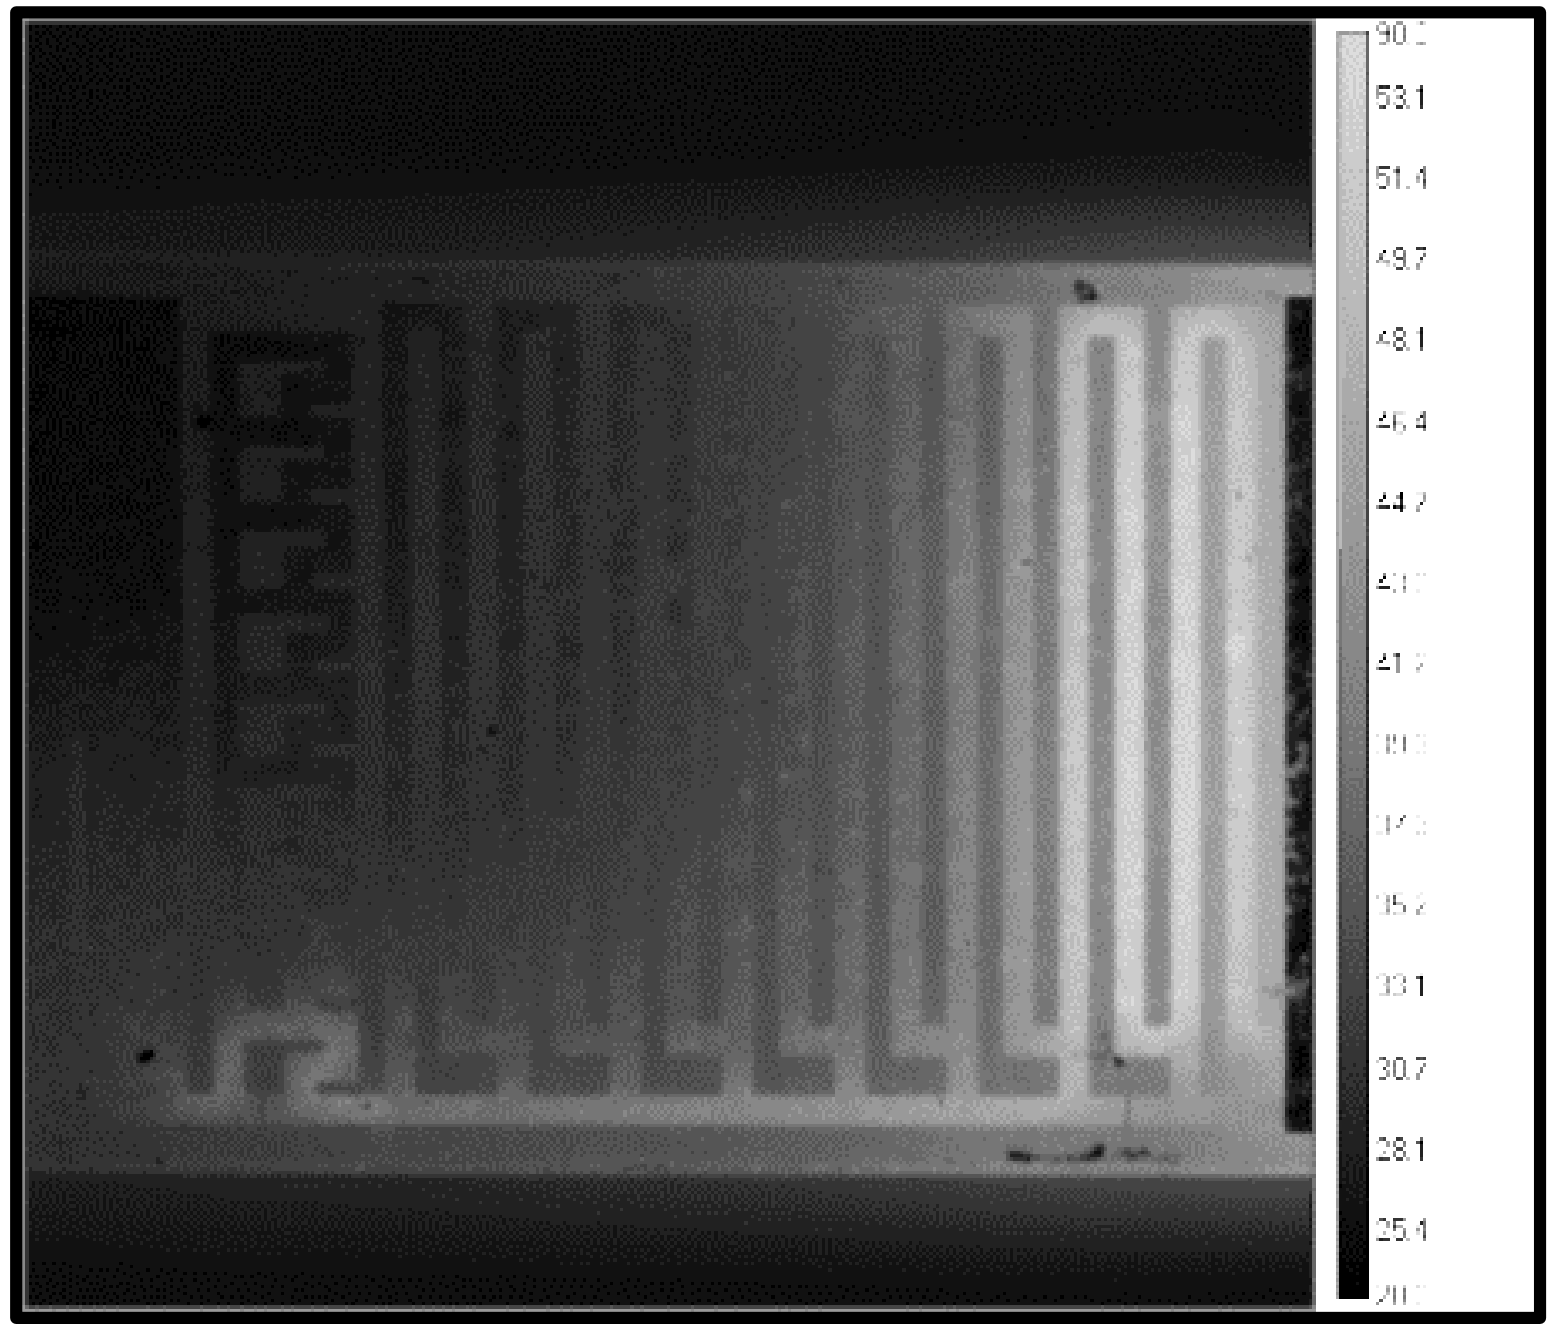
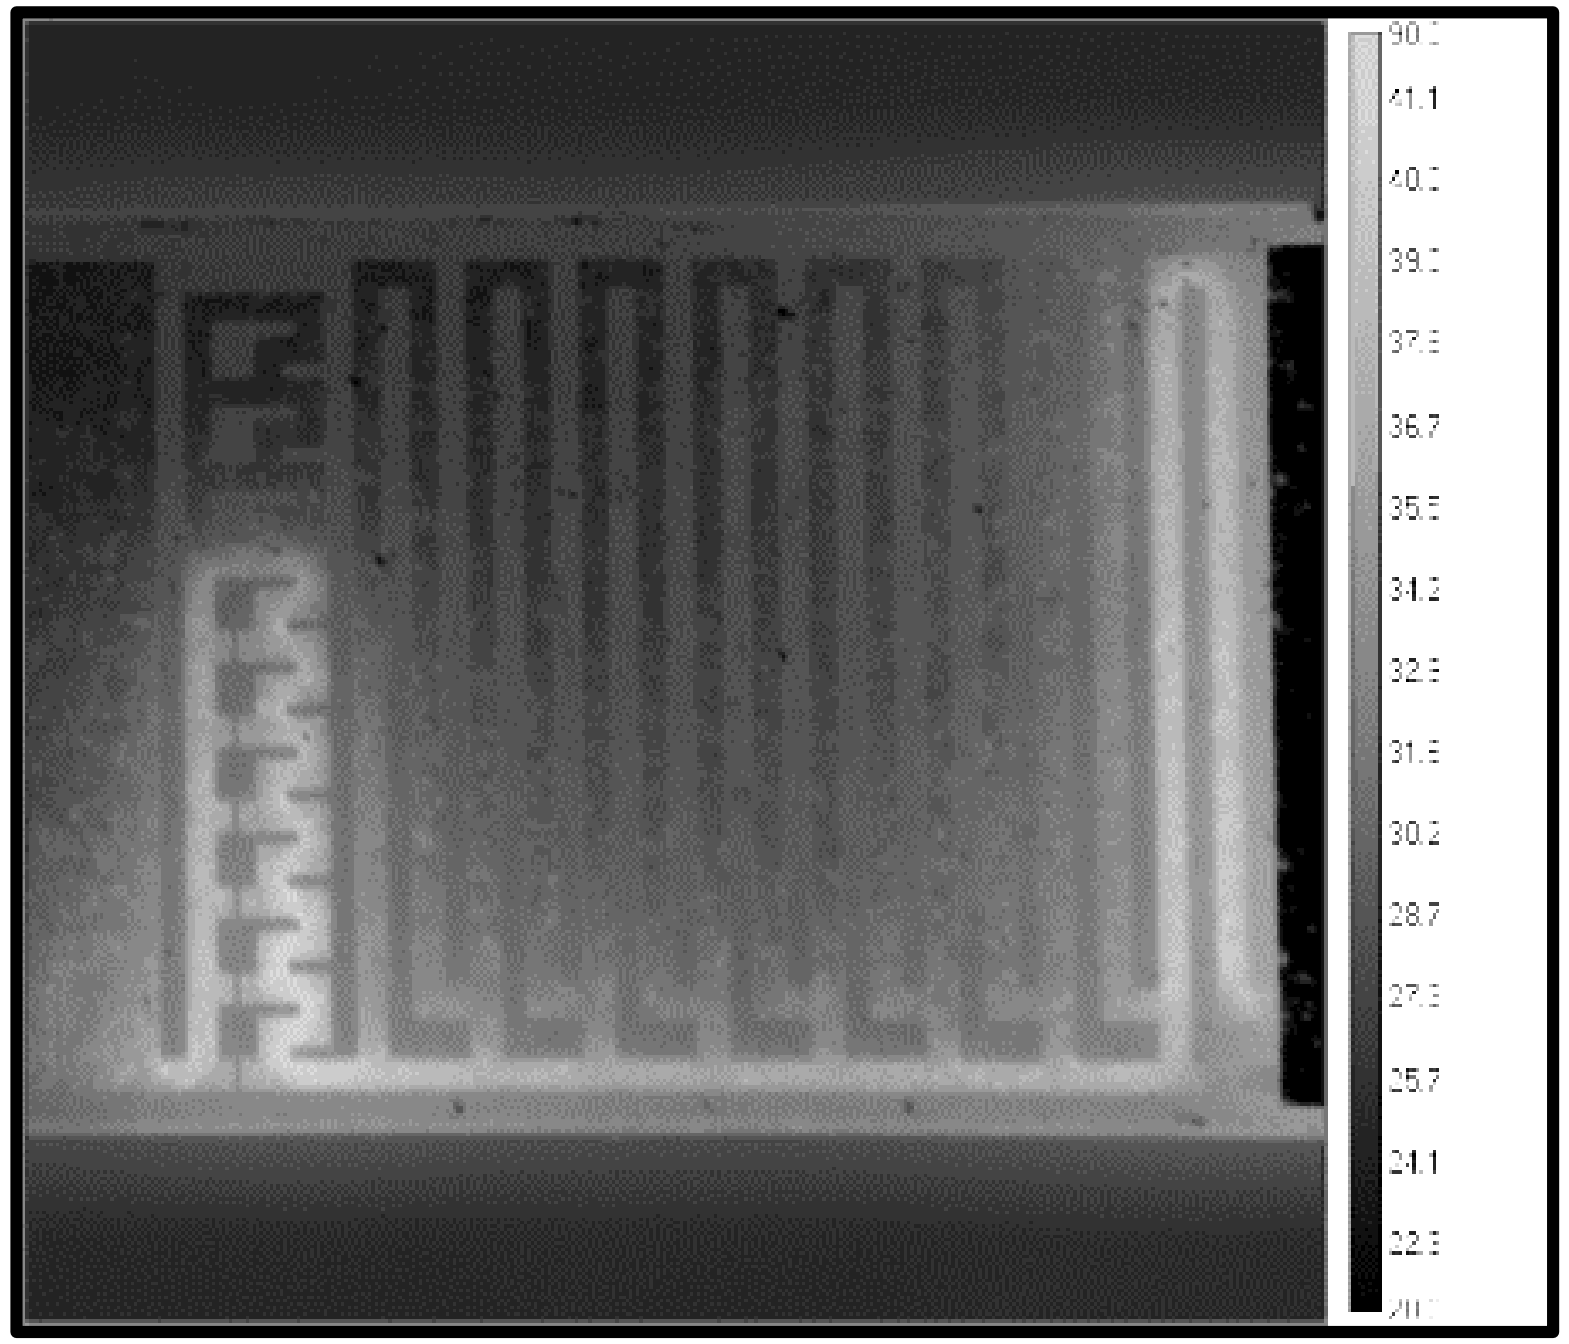
SMT Thin Film Resistors Inspected Using New Pulsed-Power Infrared Screening Method

Applying 6.25x Rated Power for 100 ms pulses; 10% duty cycle

Infrared Inspection Performed Without Removing Resistor Protective Coatings
