A Screening Method Using Pulsed-Power Combined with Infrared Imaging to Detect Pattern Defects in Bulk Metal Foil or Thin Film Resistors

Jay Brusse

ASRC AS&D at NASA Goddard Space Flight Center

NASA Goddard Space Flight Center

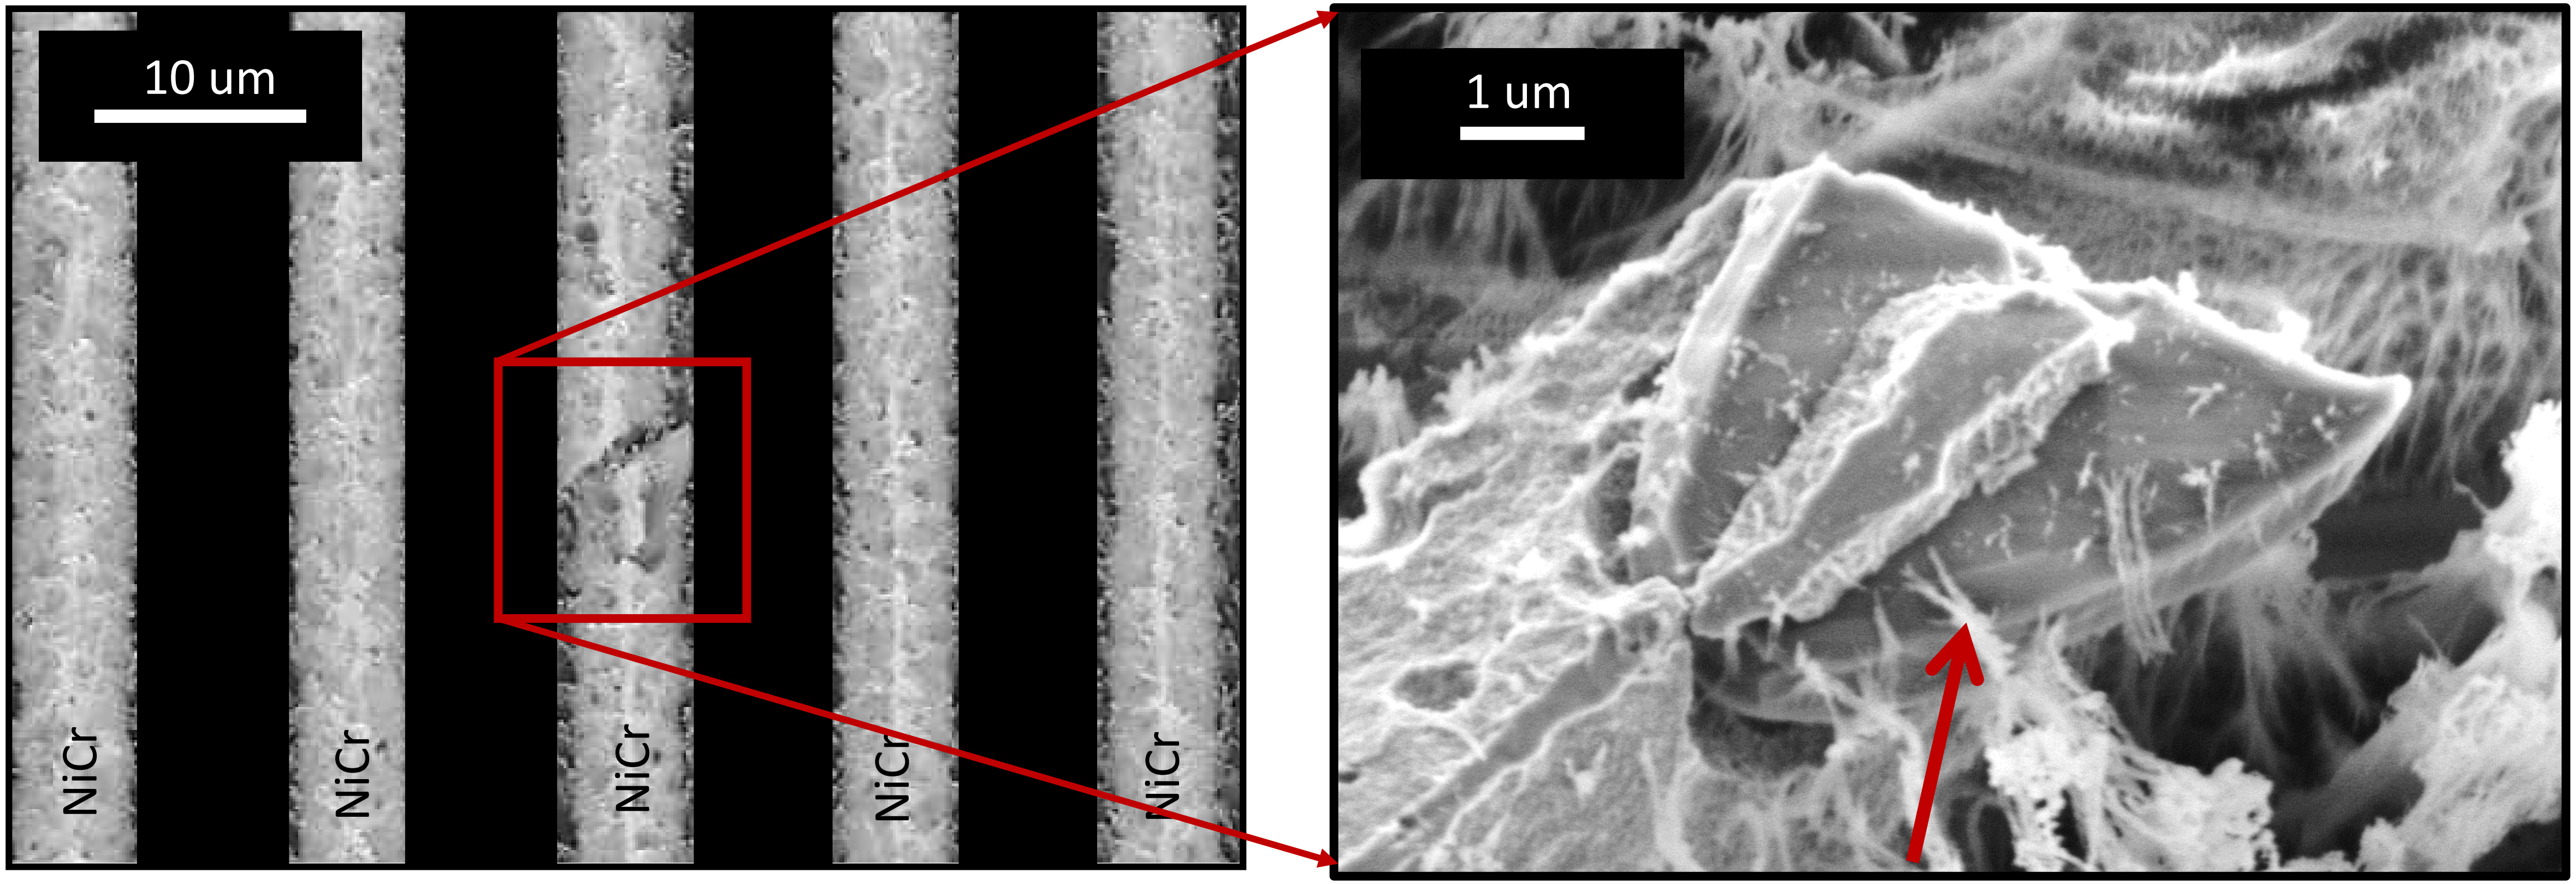
Embedded Al-N Particle in Foil Resistor Size 1206, 30 kΩ

Fractured NiCr Gridline With Embedded Al-N Particle

Aluminum Nitride Particle

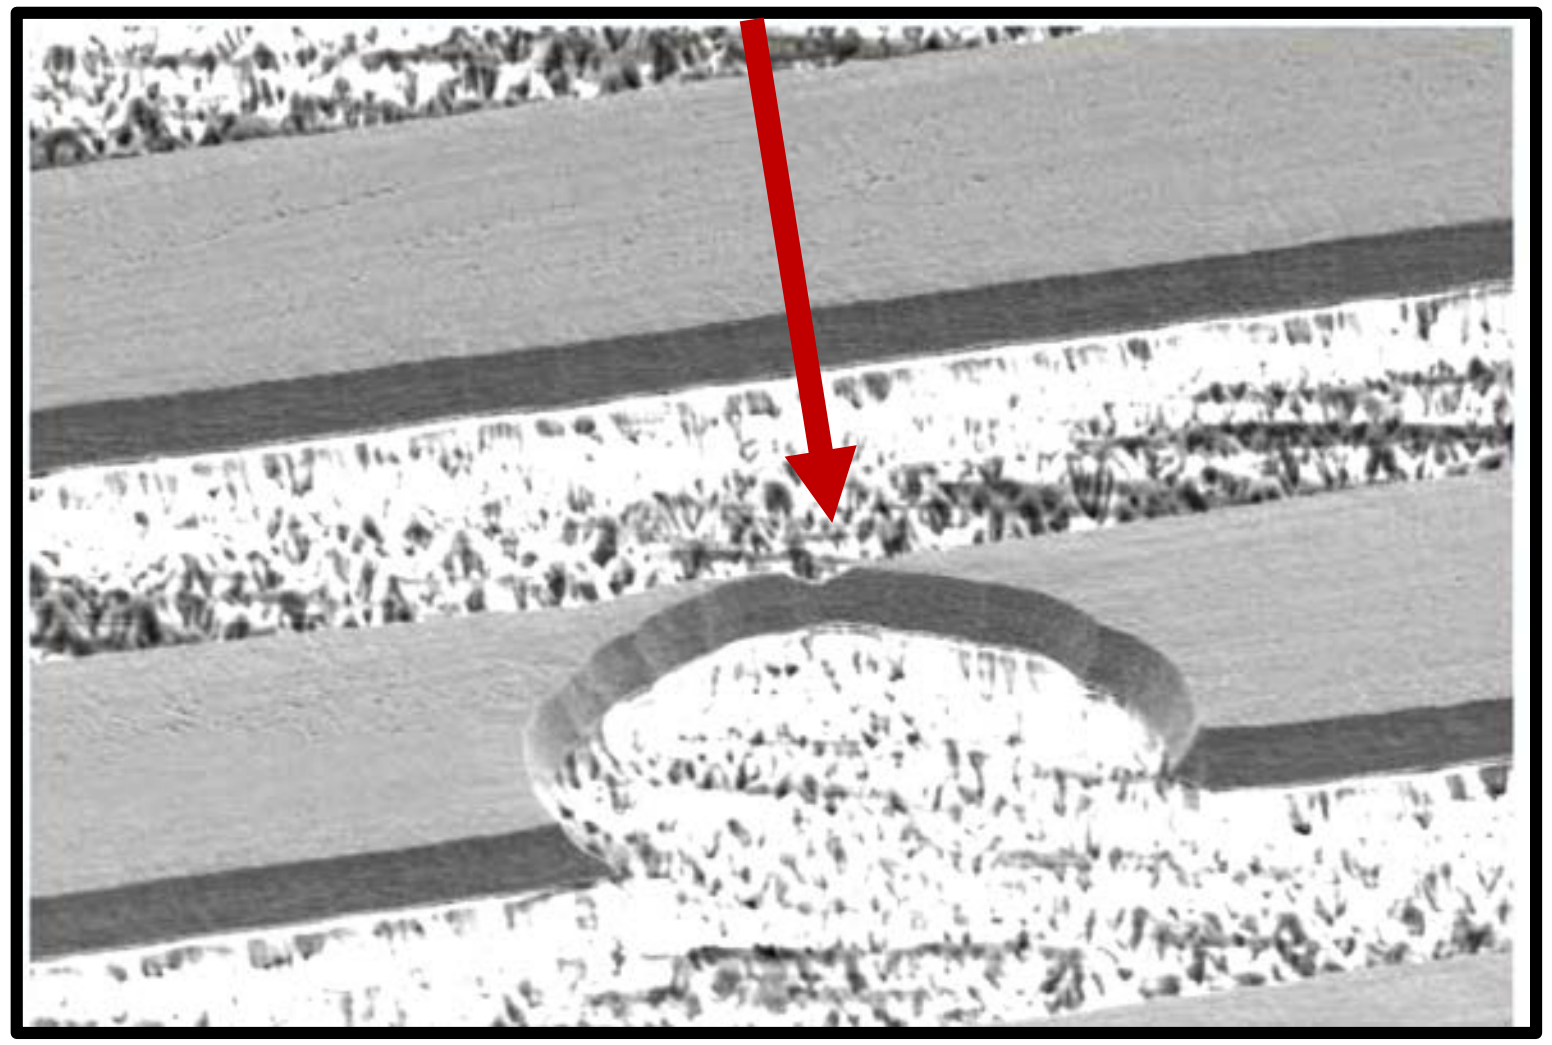
Void > 75% in Foil Resistor

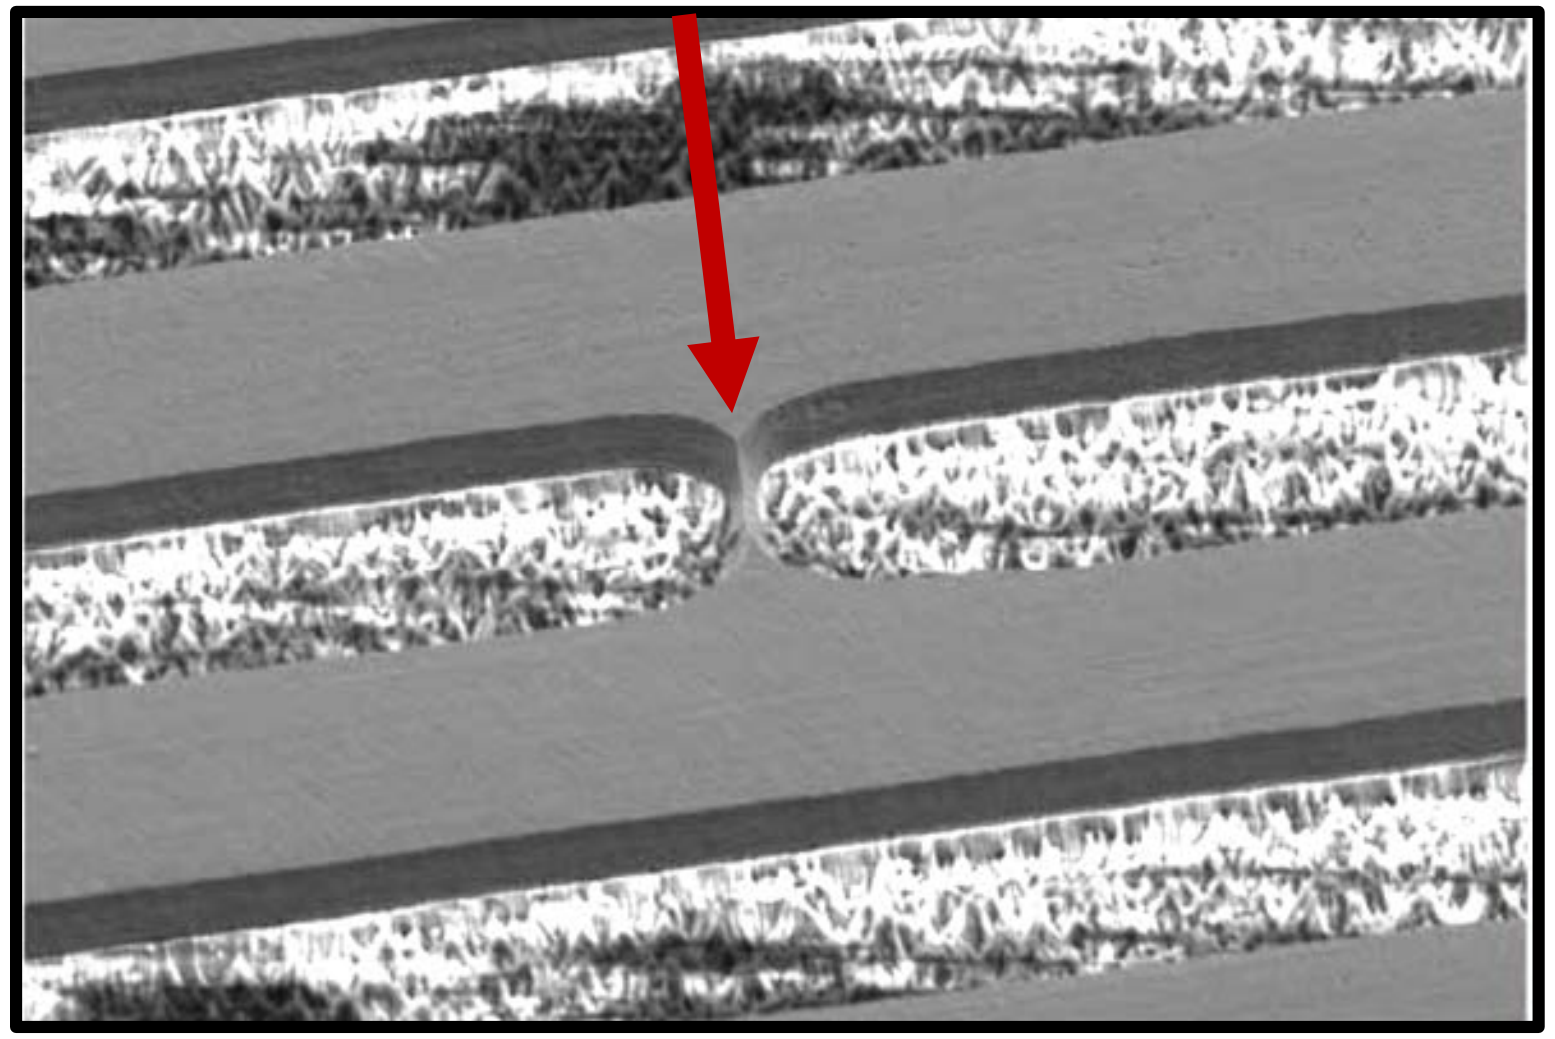
Bridge < 10% in Foil Resistor

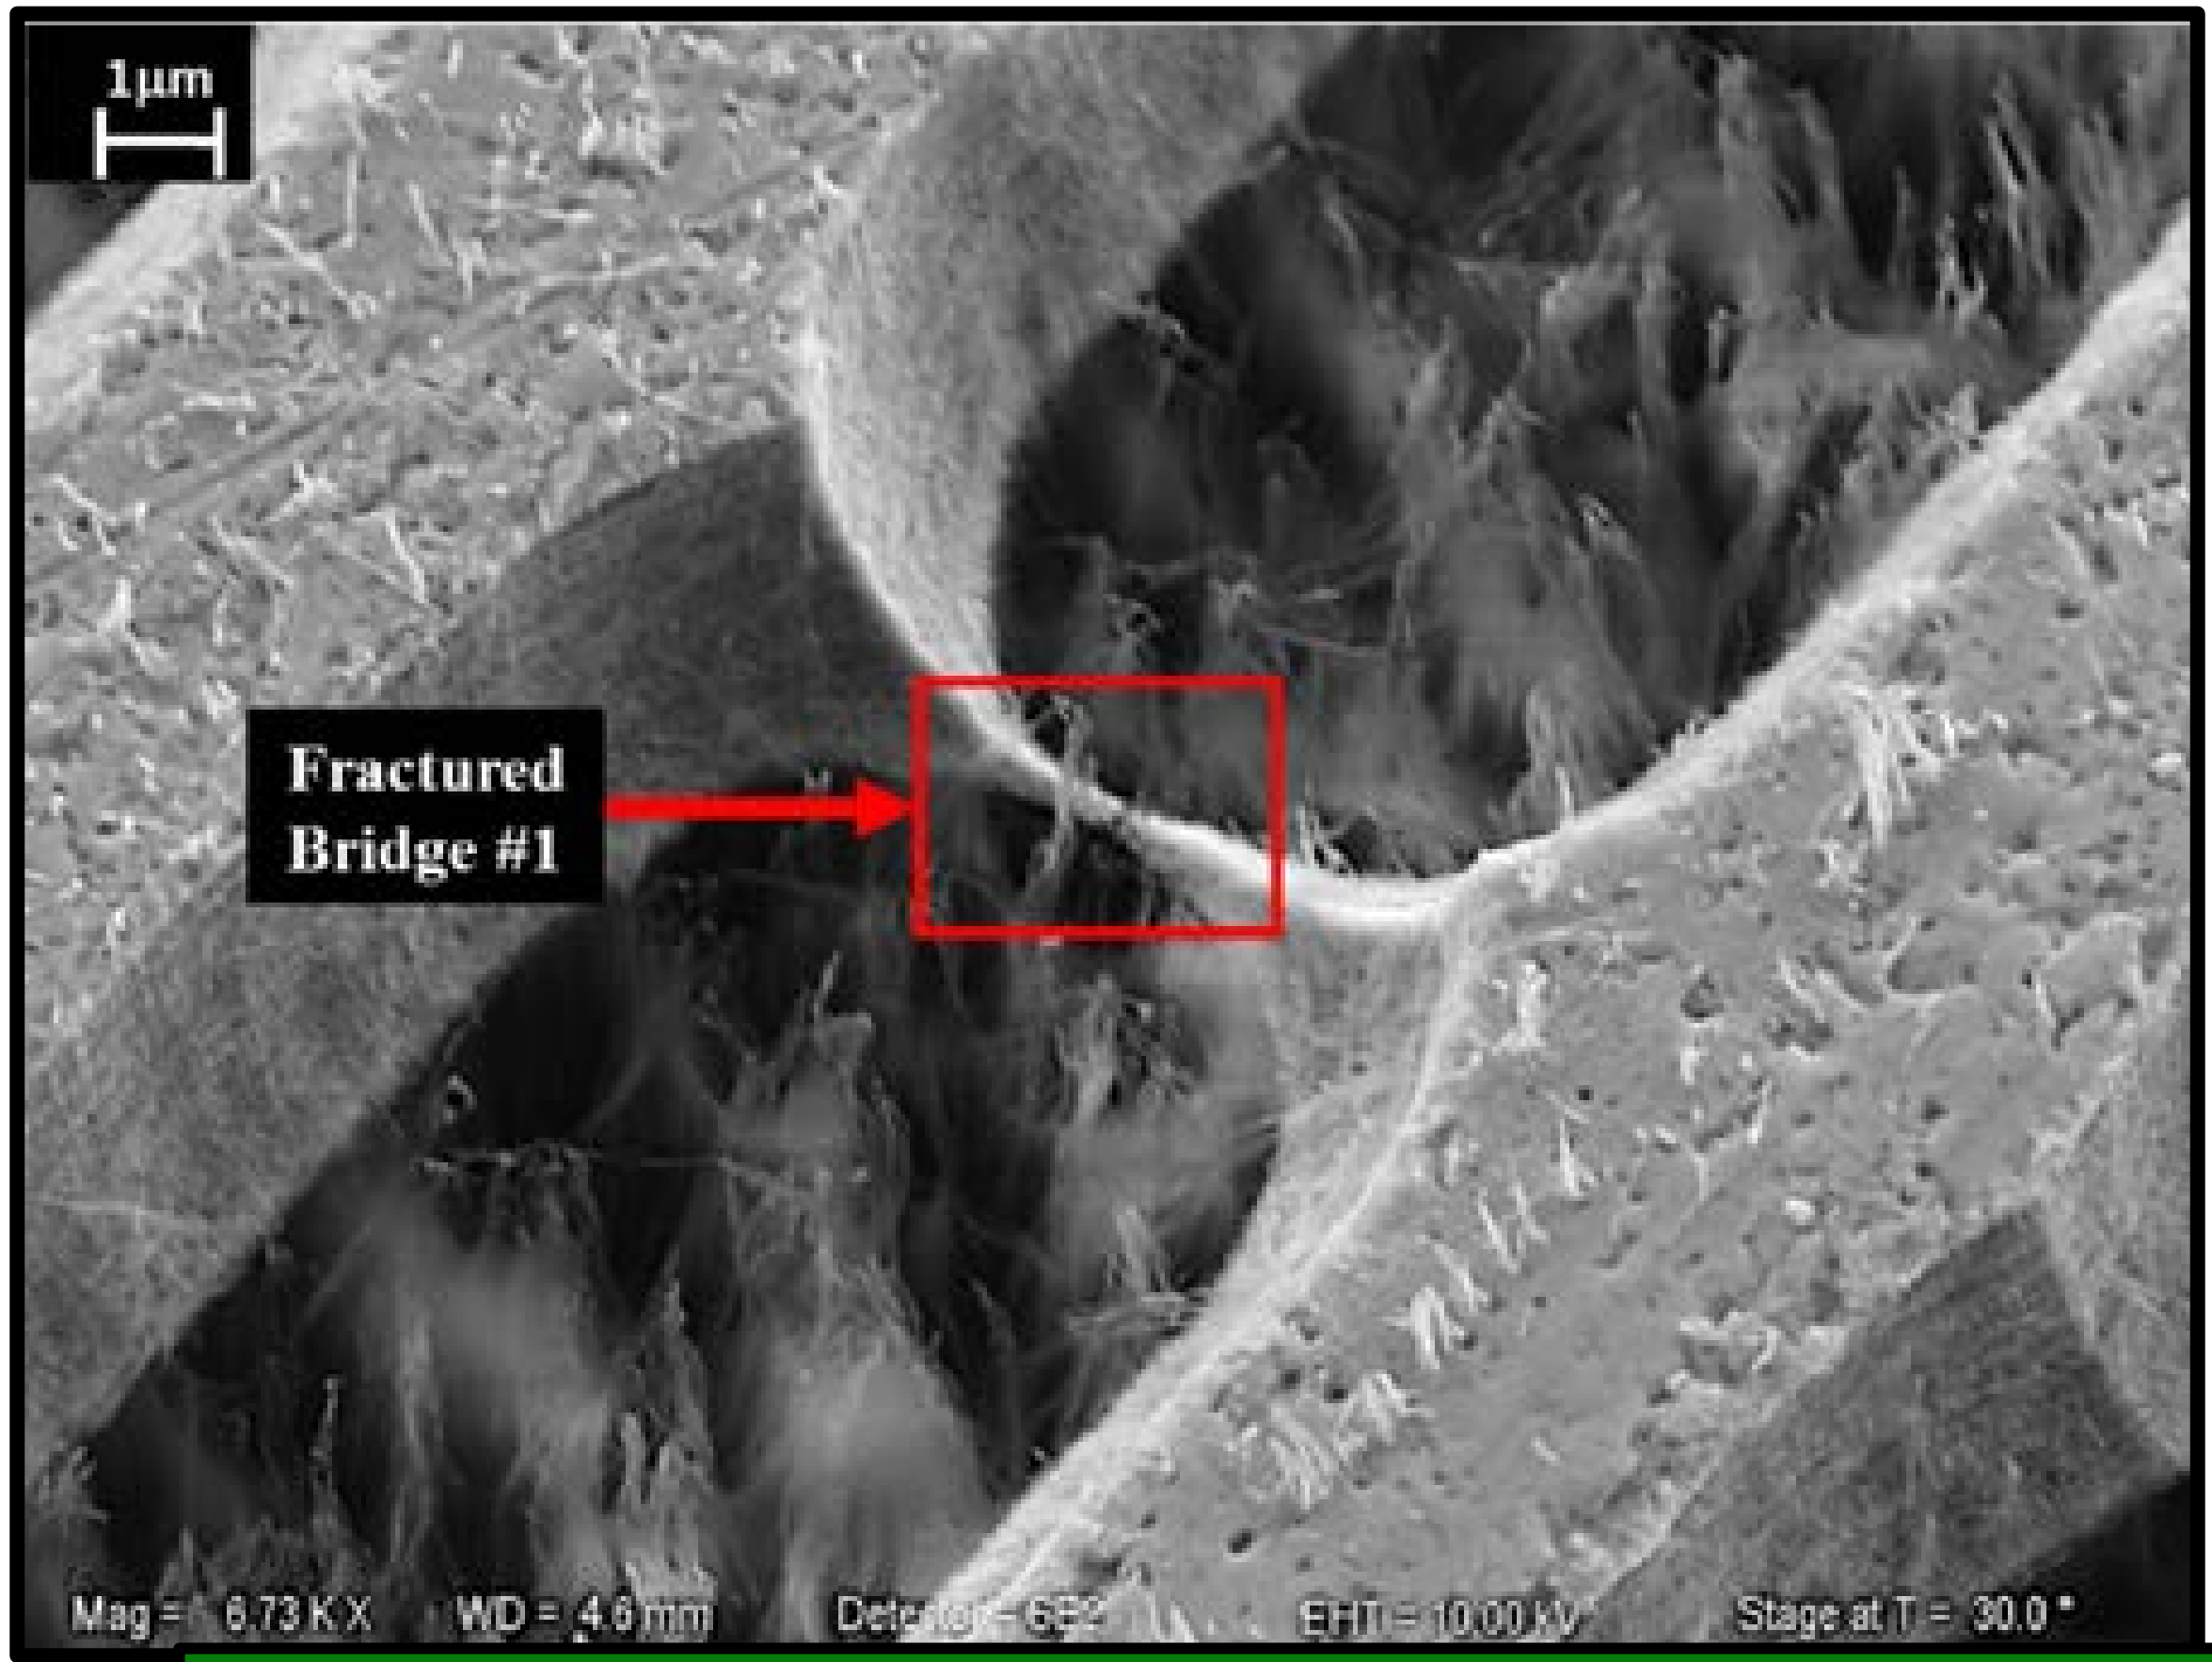
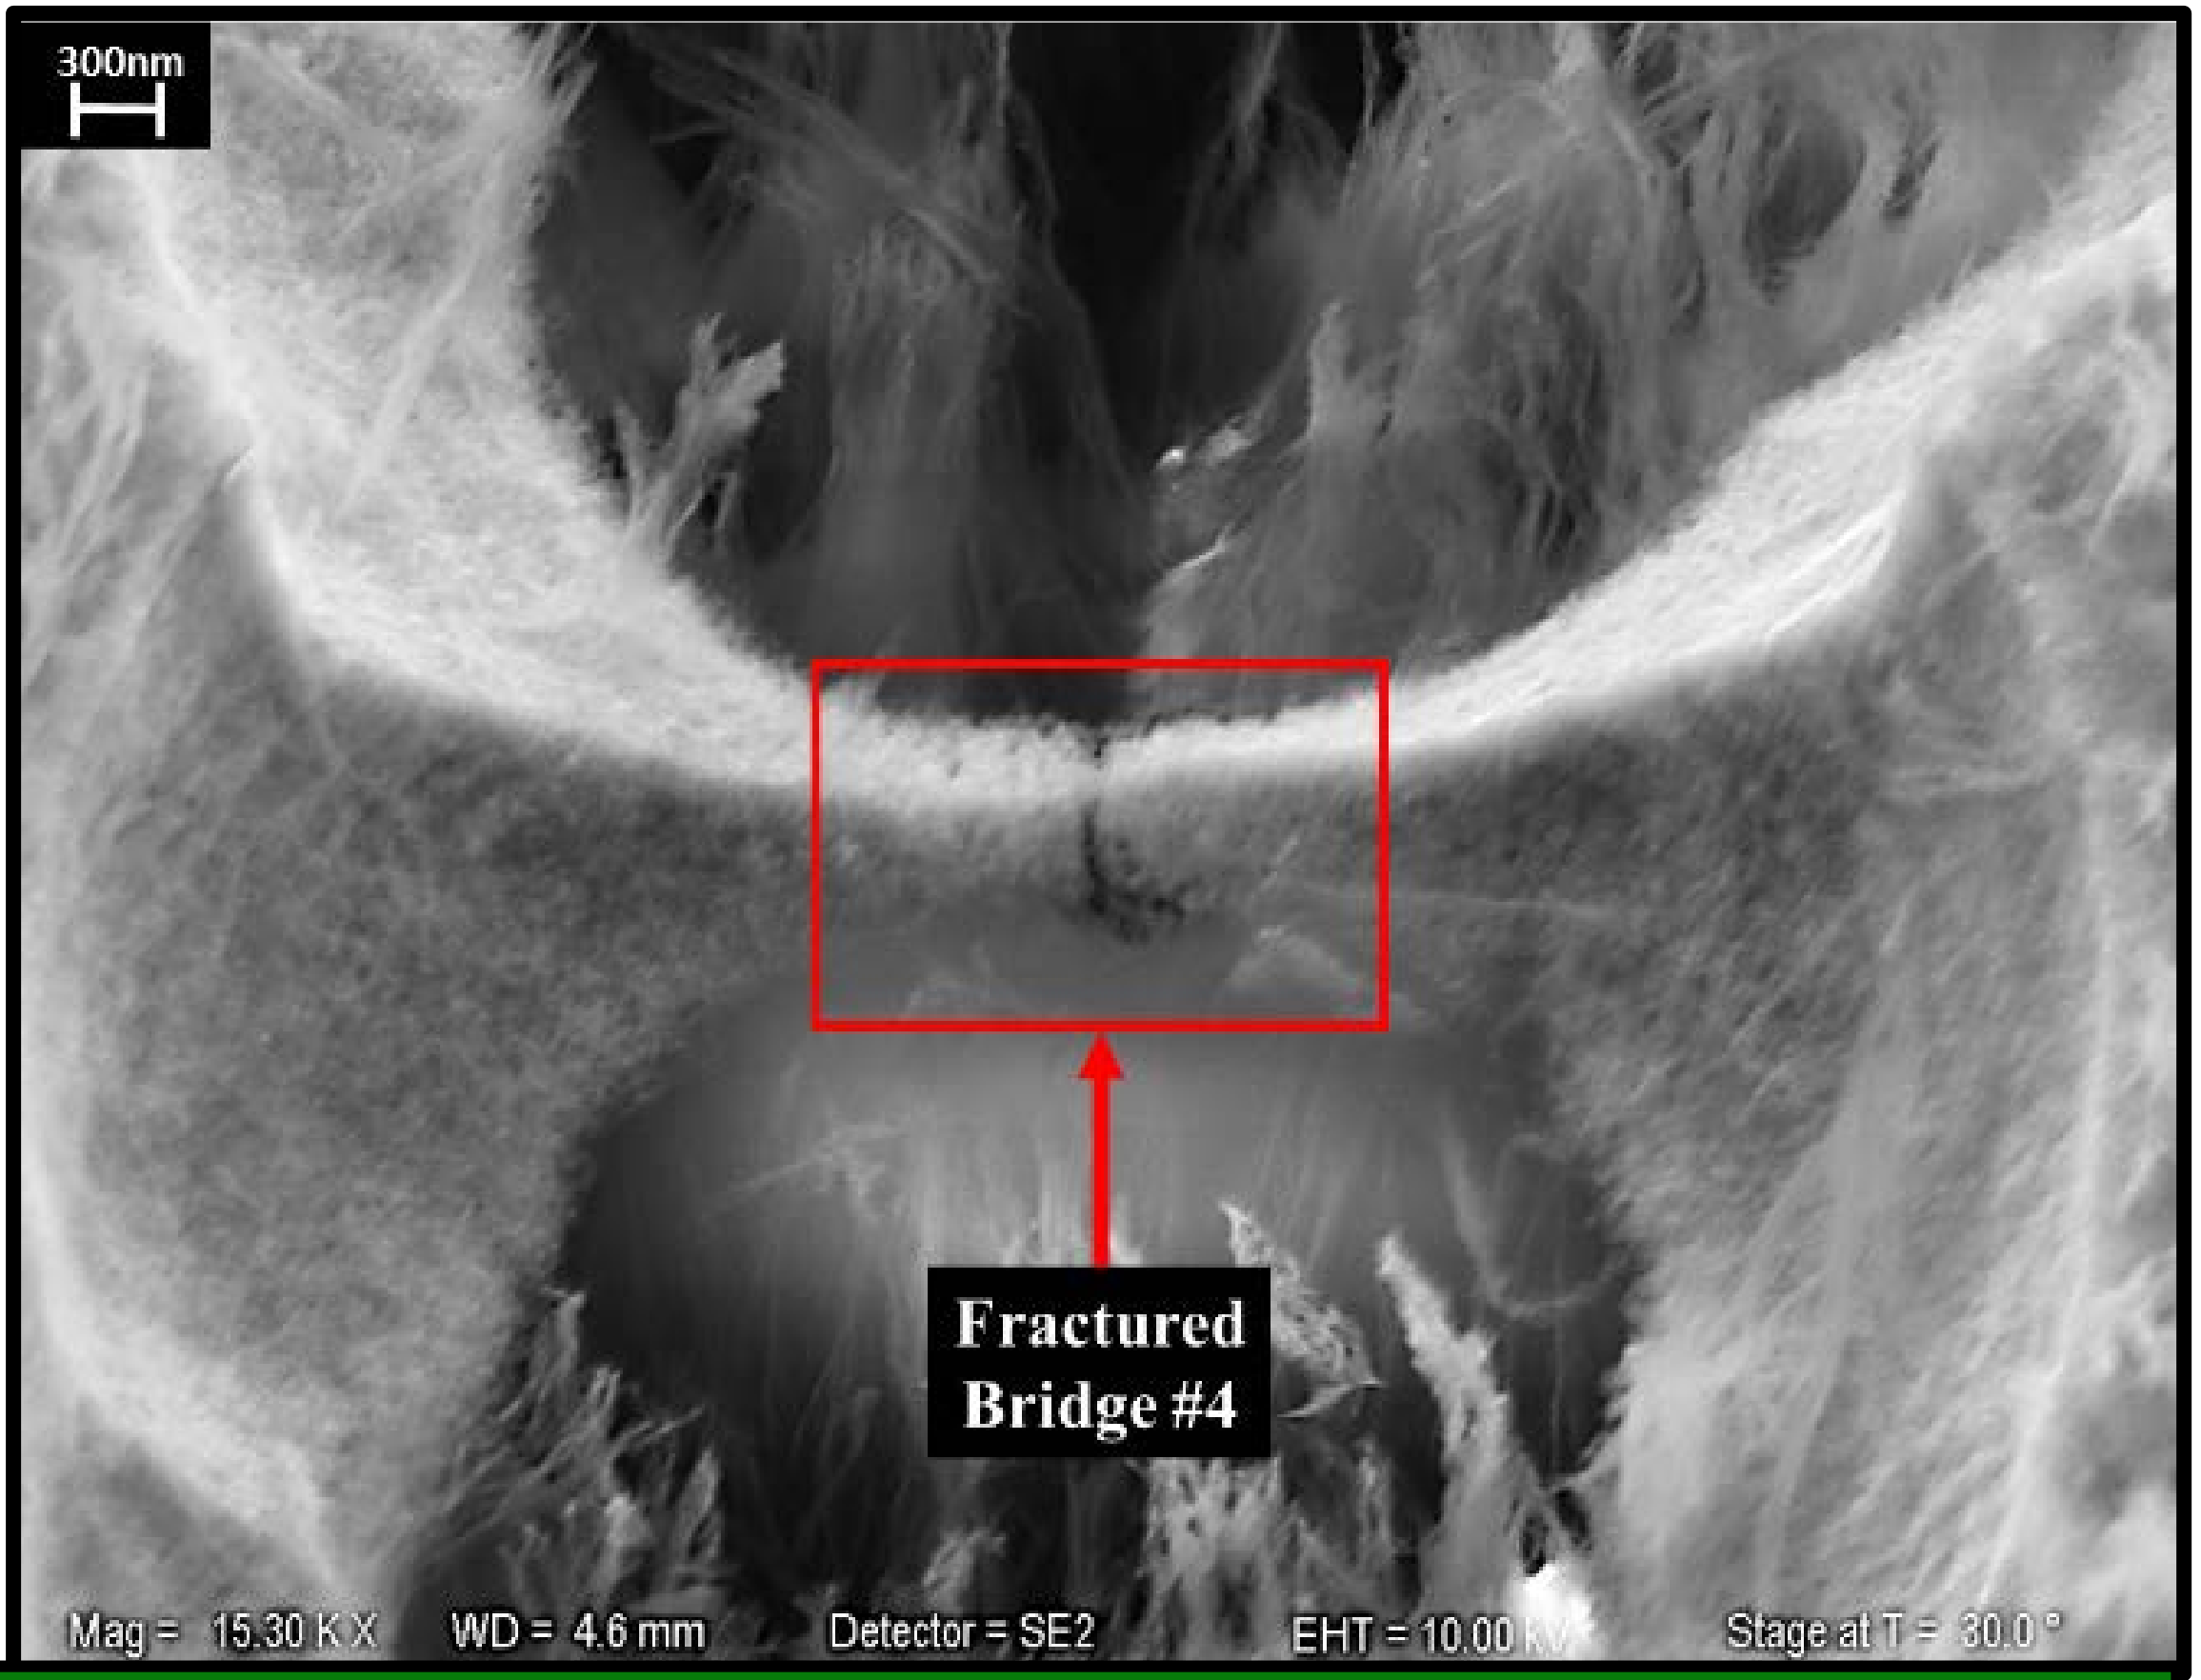
0805, 5.1kΩ, S/N 12, Type "C"

Two Positive Resistance Shifts During Life Test *ΔR1 = +10440ppm @ 250 hrs; ΔR2 = +815ppm @ 2000 hrs*

Conclusion:
This Resistor Exhibited Two Abrupt Positive ΔR Shifts During Life Test.
Both Shifts Were Caused by Thermomechanically-Induced Fatigue Fracture of Two Separate Foil Bridge Defects
