Failure Analysis after in orbit anomaly on COMEPA bimetallic thermostat TH47

5th Space Passive Component Days (SPCD), International Symposium

15-18 October 2024

ESA/ESTEC, Noordwijk, The Netherlands

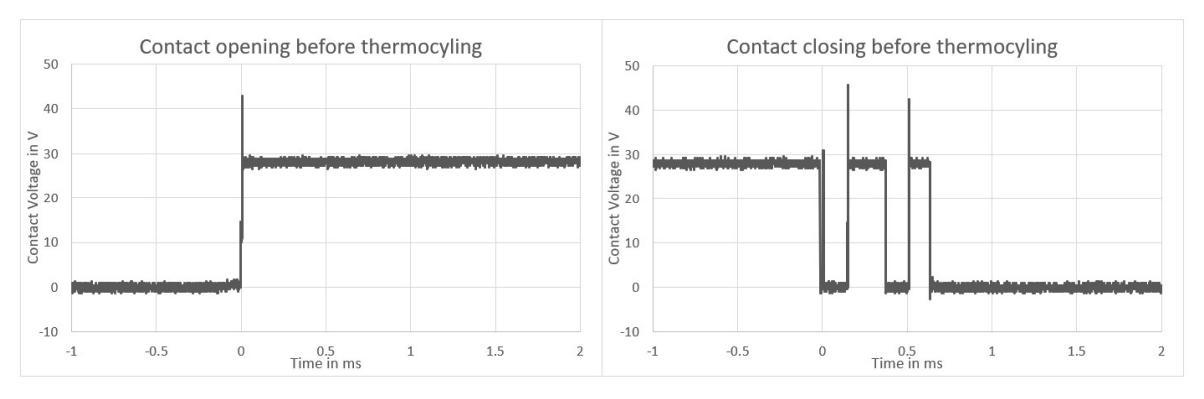
Figure 6: Switching Voltage Oscilloscope Plot at the beginning of Thermocycling

Figure 6 shows the voltage curves during the opening of the contact (on the left) and closing of the contact (on the right) switching's of the thermostat. The shown plots were recorded at the very beginning of the thermocycling, with no significant degradation of the contact yet observed. At the contact opening the voltage transferred very sharp from 0 volt to 28 volt. The small overshoot visible, is due to parasitic inductances in the loop. At the contact closing event, similar sharp transitions, with a significant bouncing's of the contact, can be seen. This bouncing back effect happens two times in total and can be considered normal for this kind of thermomechanical switches.
